# **SHORT-TERM CRACK SEALANT PERFORMANCE AND REDUCING BUMPS AND TRANSVERSE CRACKING IN NEW HOT MIX ASPHALT OVERLAYS OVER CRACK SEALANTS**

**Scott Shuler**

**November 2009**

**COLORADO DEPARTMENT OF TRANSPORTATION  
DTD APPLIED RESEARCH AND INNOVATION BRANCH**

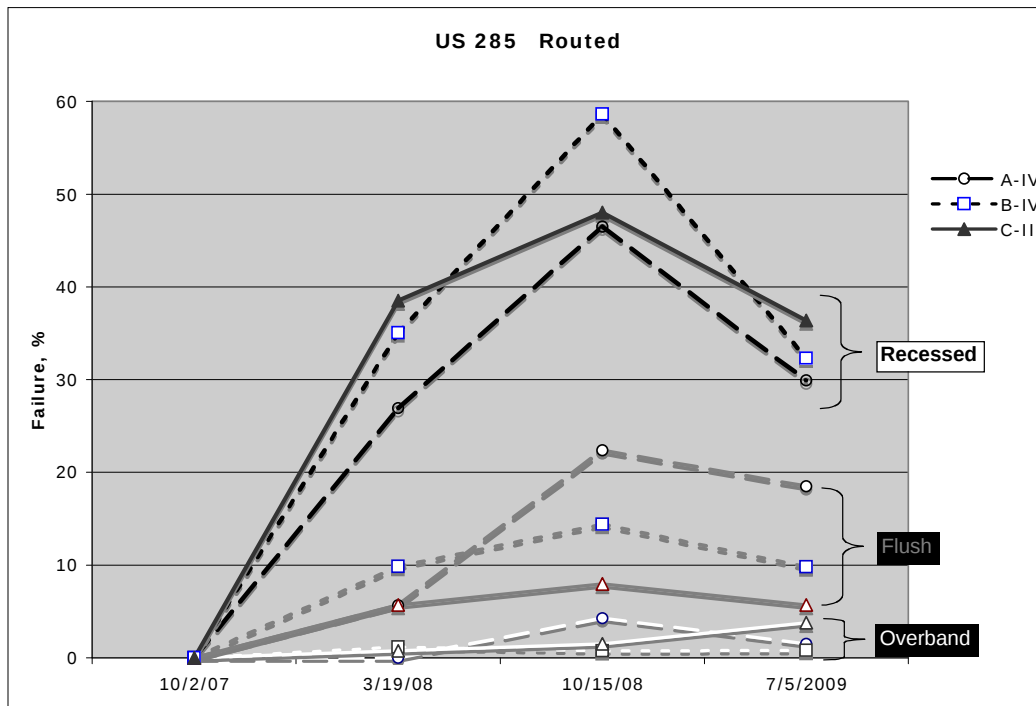
**Figure 6. Sealant Performance on US285-Cracks Prepared by Routing**

Analysis of the results from this study is challenging. There is variation in the data and few trends stand out consistently with the exception of one. It appears that for most of the conditions studied performance of the crack sealants has not followed a linear path of an increase in failure over time, as might be expected. Instead, the failures increased from installation in October 2007 to the first survey in March 2008, continued to increase until the second survey in October 2008, then declined at the third survey in July 2009 to levels of failure approximately equal to that observed in March 2008. There are eight exceptions to this. These are on Figure 3, where Supplier A for the flush, routed application shows a consistent increase in failure rate over time to a total of 10 percent failure and Supplier B for the flush and overband, routed application shows a consistent increase in failure rate over time to a total of 3 and 4 percent failure. Also, from Figure 4 Supplier C increases to approximately 7 percent failure for the hot air lance and recessed application. Products B and C in Figure 6 for routed and overbanded application on

US285 reach approximately 2 and 4 percent failure. And Figure 8 indicates that Supplier B reaches 15 percent failure for the air blow and overband process on US285. Supplier C reaches 4 percent failure on US350 in Figure 10 for a hot air lance and flush application and Supplier A-I has an 11 percent failure rate on US350 for the air blow and overband application shown on Figure 11.

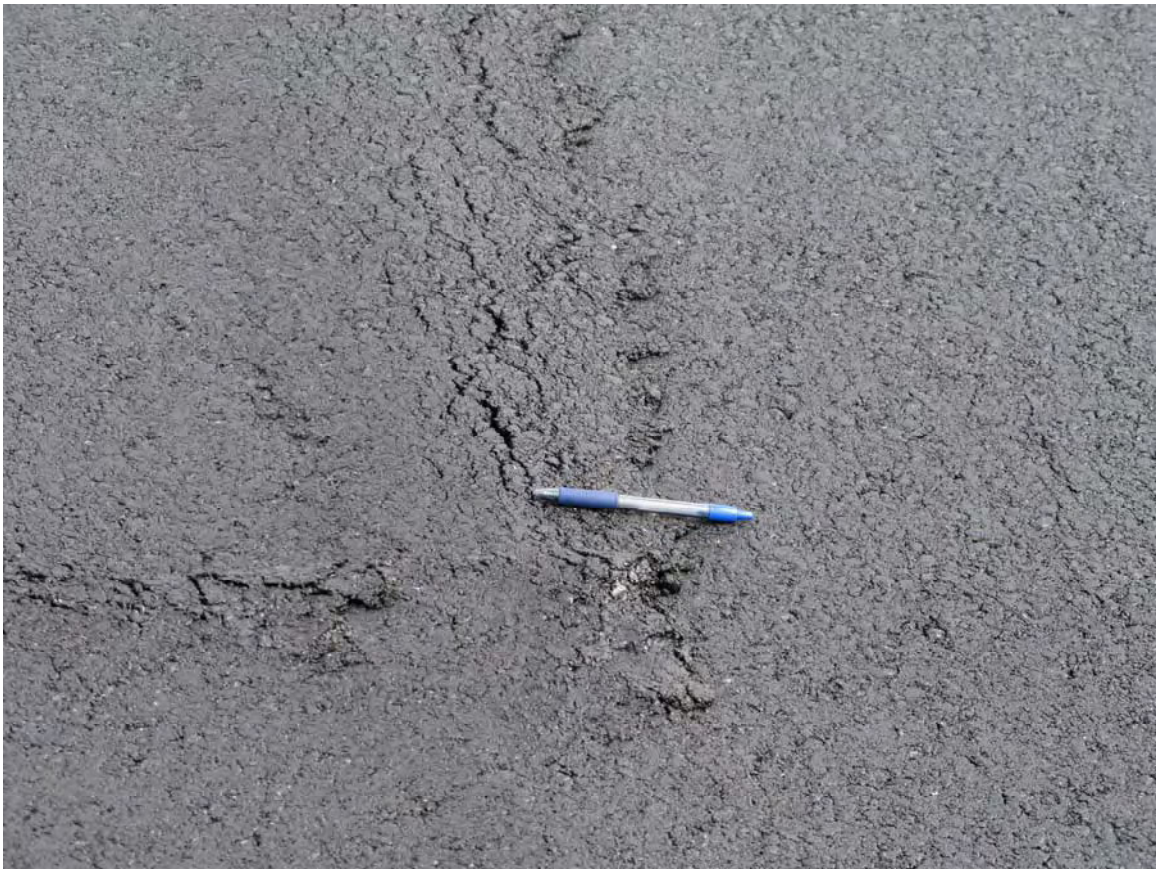
\*\* Cracks 271 and 272 were the only ones with evidence of bumps and transverse cracks during construction on September 2.

330 to crack 1. The experiment was repeated with some exceptions as shown in Table 7 in an attempt to create the bumps and transverse cracks witnessed at cracks 271 and 272 in the southbound lane on September 2. The first evidence of bumps and cracks occurred at cracks 271 to 275 as shown in Figure 13. These bumps were much more severe than those witnessed on September 2 in the southbound lane.

**Figure 13. Bump and Transverse Cracks Over Crack 271**

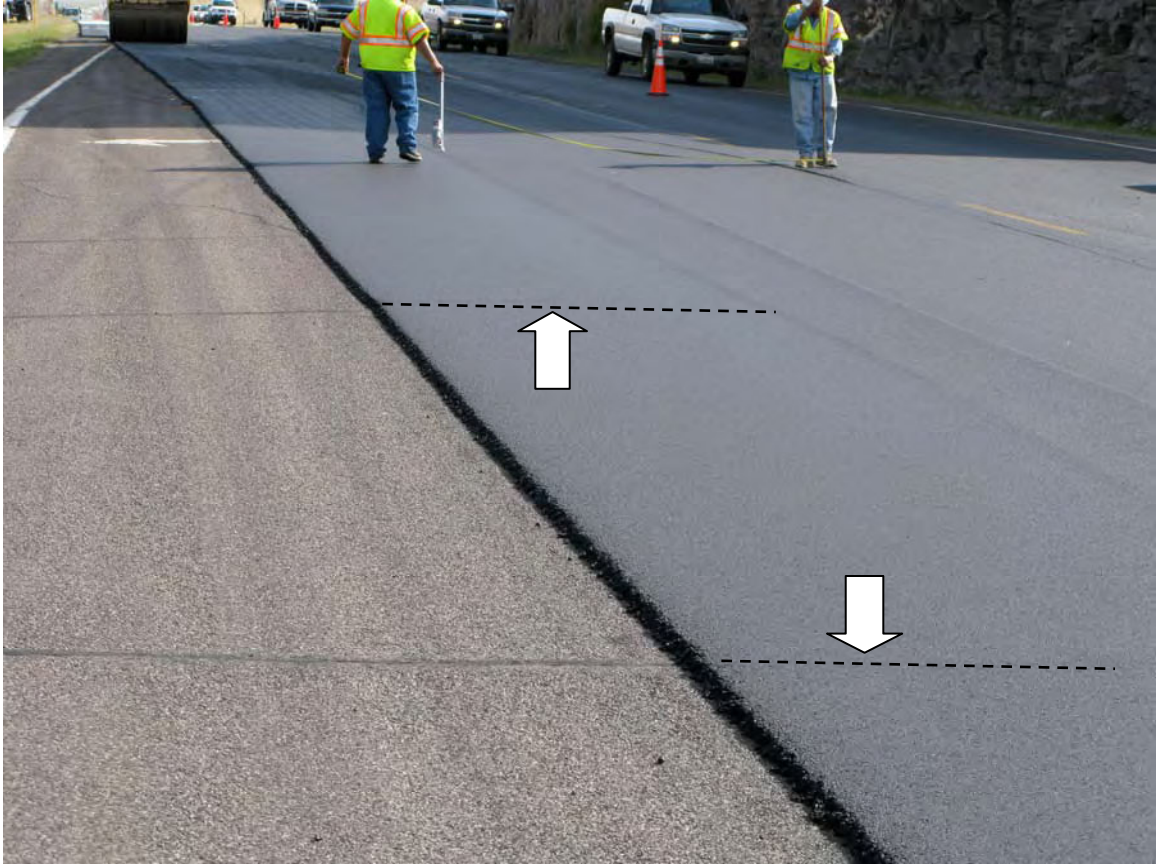
A second and third attempt to create the bumps and transverse cracks was done over cracks 199 to 204 and again at cracks 127 to 132. The results of this experiment are shown in Figures 14 and 15. The severity of the cracks and bumps appeared directly related to the number of passes of the vibrating roller. As cracks began to appear after the first pass of the roller, the contractor was reluctant to continue the experiment with additional roller passes. The severity of the cracks and bump shown over crack 271 was not observed over cracks 199 to 204 or 127 to 131 due to fewer passes of the vibrating rollers.

**Figure 14. Bumps and Transverse Cracks Over Cracks 129, 130 and 131 Northbound**

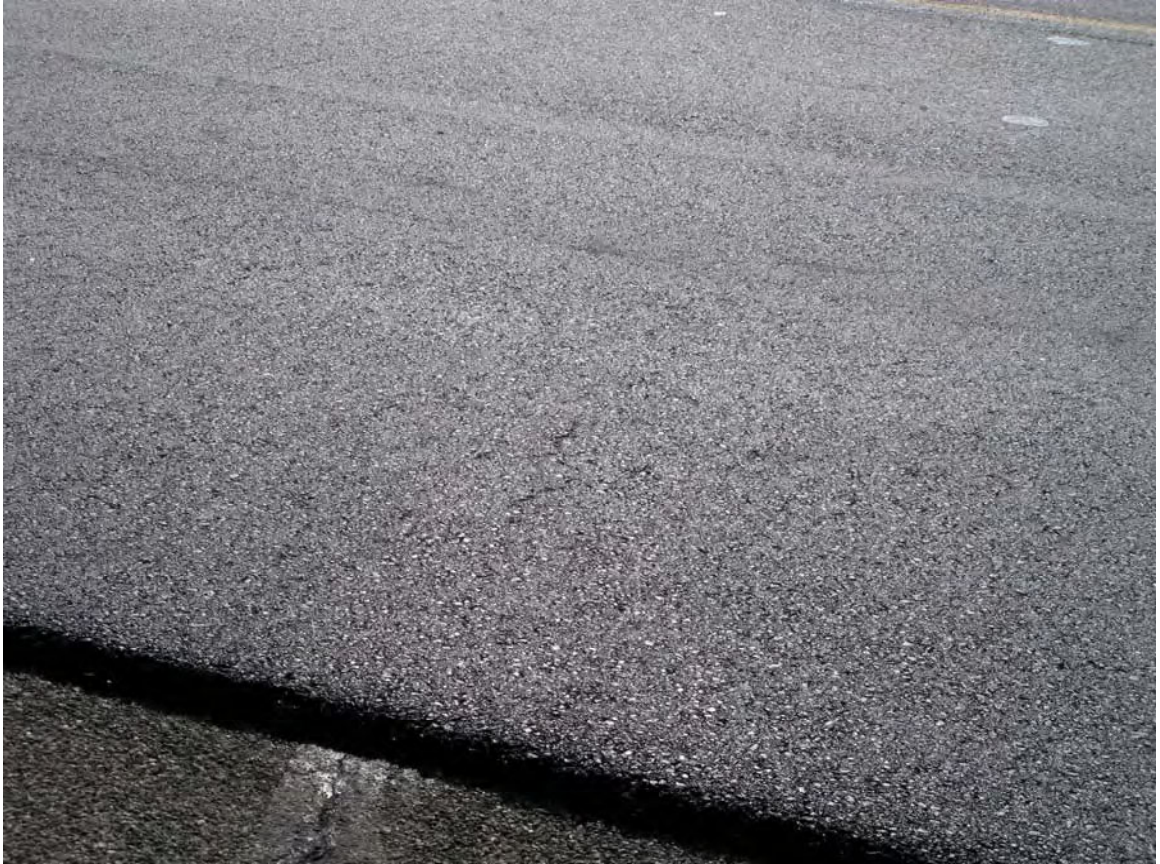
**Figure 15. Transverse Crack Forming Over Crack 201 Northbound**
