BULLETIN 330

JANUARY, 1928

COLORADO PAVEMENT AND SUBGRADE STUDIES

BY O. V. ADAMS, TESTING ENGINEER,
COLORADO EXPERIMENT STATION

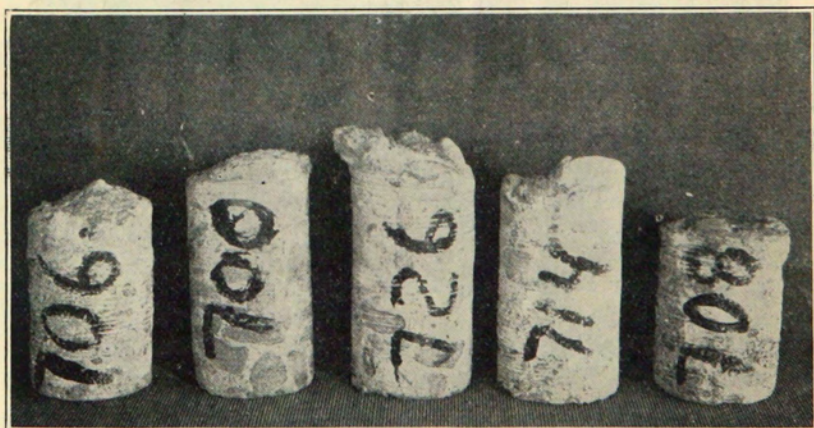
Figure 7.—Concrete cores as received from field. Note variable length and uneven condition of ends which came from under side of pavement.
