OPEN-FILE REPORT 00-10

# **History, Geology, and Environmental Setting of the Lower Fair Day Mine, Arapaho/Roosevelt National Forest, Boulder County, Colorado**

**By John Neubert and Robert H. Wood II**

Colorado Geological Survey  
Division of Minerals and Geology  
Department of Natural Resources  
Denver, Colorado  
2000

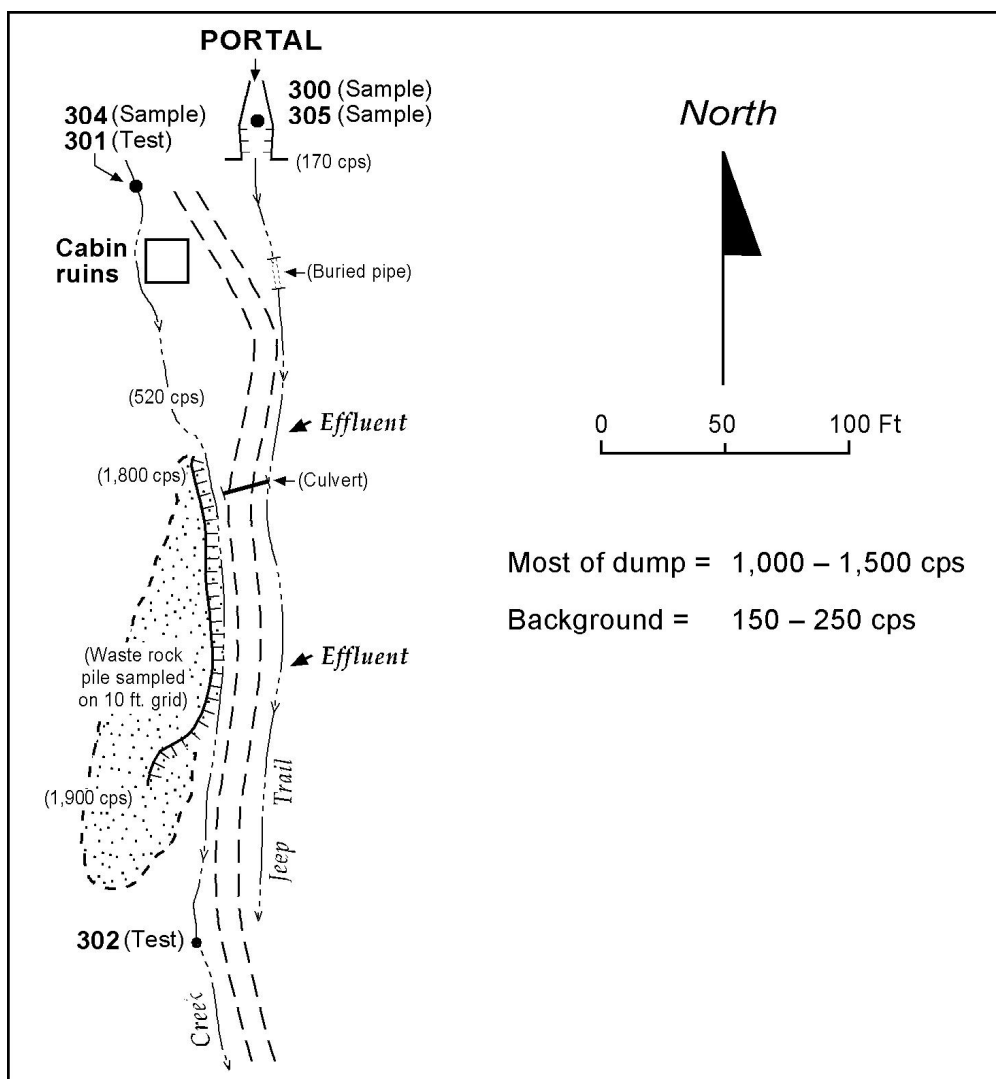
The lower adit has “Devils Den” spray painted in blue on a timber above the portal. The portal is about 7 feet high and 6 feet wide, and the adit is open for at least 20 feet. As of 1967, this lower adit was caved at an unspecified depth (Baker, 1967). Wire mesh on the ceiling just inside the portal helps prevent the roof from caving. Slow-moving water flows from the working.

**Figure 2. Sketch map of the lower adit and waste-rock pile at the Fair Day Mine.**

Above the lower adit of the Fair Day Mine (Figure 2), the unnamed tributary of James Creek was flowing between 45 and 60 gpm in June and August, and test results showed pH of 7.04 and 7.60 and conductivity of 117  $\mu\text{S}$  and 135  $\mu\text{S}$ , respectively. Lab results show the tributary water meets standards in all of the analyzed parameters (Table 2, sample #463/4440-2.304).

Immediately below the waste-rock pile, and downstream of the confluence with the small amount of effluent from the culvert (Figure 2, test #302), water in the unnamed tributary showed pH of 7.66 and conductivity of 135  $\mu\text{S}$  in a June test. No samples were collected.

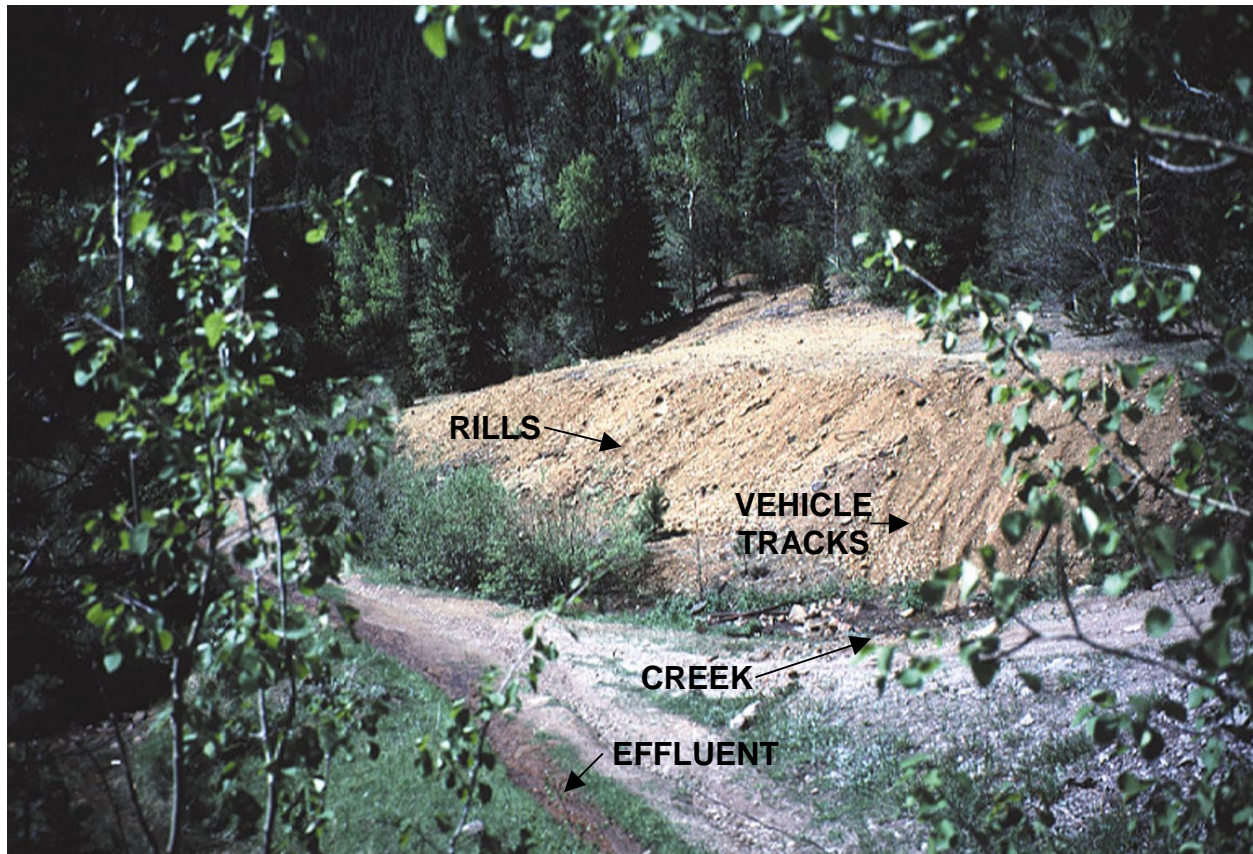
The 800-cubic-yard waste-rock pile toes into the west side of the unnamed tributary for about 30 feet and lies very close to the creek for another 70 feet. The pile is thickest to the north, gradually thinning to the south. Rills cut the face of the sparsely vegetated dump, and minor sheet wash erosion is evident. ATV and motorcycle tracks are on the bench and face. (See Figure 3.)

**Figure 3. Photograph showing waste-rock pile for the lower Fair Day adit, looking downstream.**

Waste rock comprises biotite schist, hematite-rich schist, sillimanite(?) schist, and granite, although most is broken too small to identify. The pile has a light-red iron stain, with small areas stained yellow. No sulfides were identified, although pyrite and some base-metal sulfides occur in the vein and probably are in the waste rock. A composite sample from the dump produced a paste pH of less than 5 and a net acid-generating capability. Lab results show the pile is weakly to moderately mineralized, with high aluminum and iron concentrations; anomalous arsenic,
