COLORADO RIVER FLOOD RISK ANALYSES

**Connected Lakes
Duke Lake
30 Road Pond
Corn Lake
Island Acres Ponds
Parachute Pond
Rifle Rest Area Pond**

the Colorado Water Conservation Board

January 1995

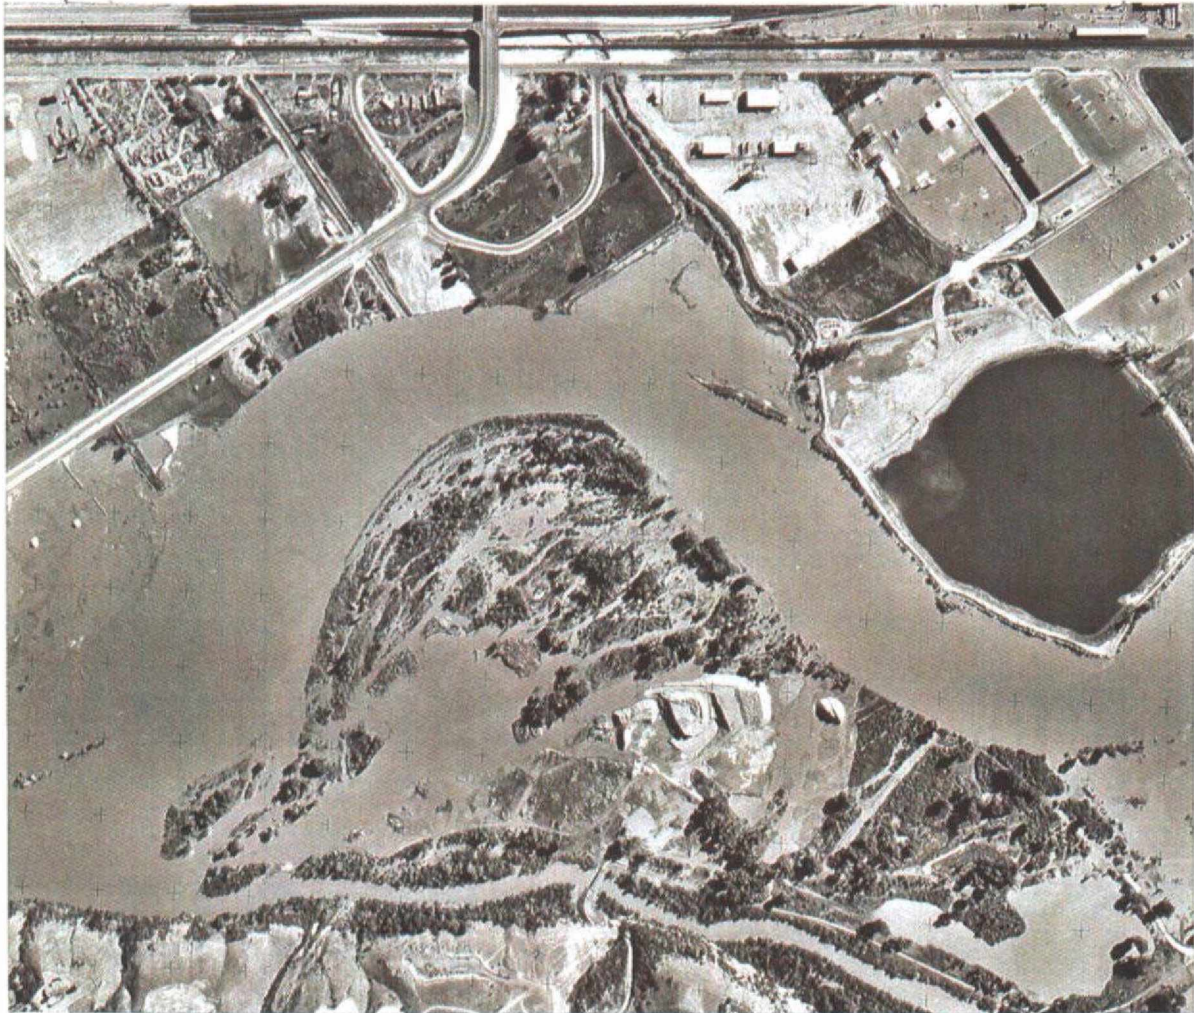
1984 Flooding

Connected Lakes and Duke Lake were entirely inundated in 1983 and 1984. Due to the protection provided by the levee system constructed for Connected Lakes in 1991 and by the Pepsi-Cola Plant levee system and due to smaller flows, no flood inundation occurred during the 1993 flood event. That levee construction led to higher stream velocities. This reach of the Colorado River was already subject to severe bank erosion and channel migration before the levee construction. During the 1983 and 1984 floods part of the river was flowing through the site. The constriction caused by the levee work has made those problems more severe because of the higher flood stages and velocities. The entire area lies within the 100-year floodplain.

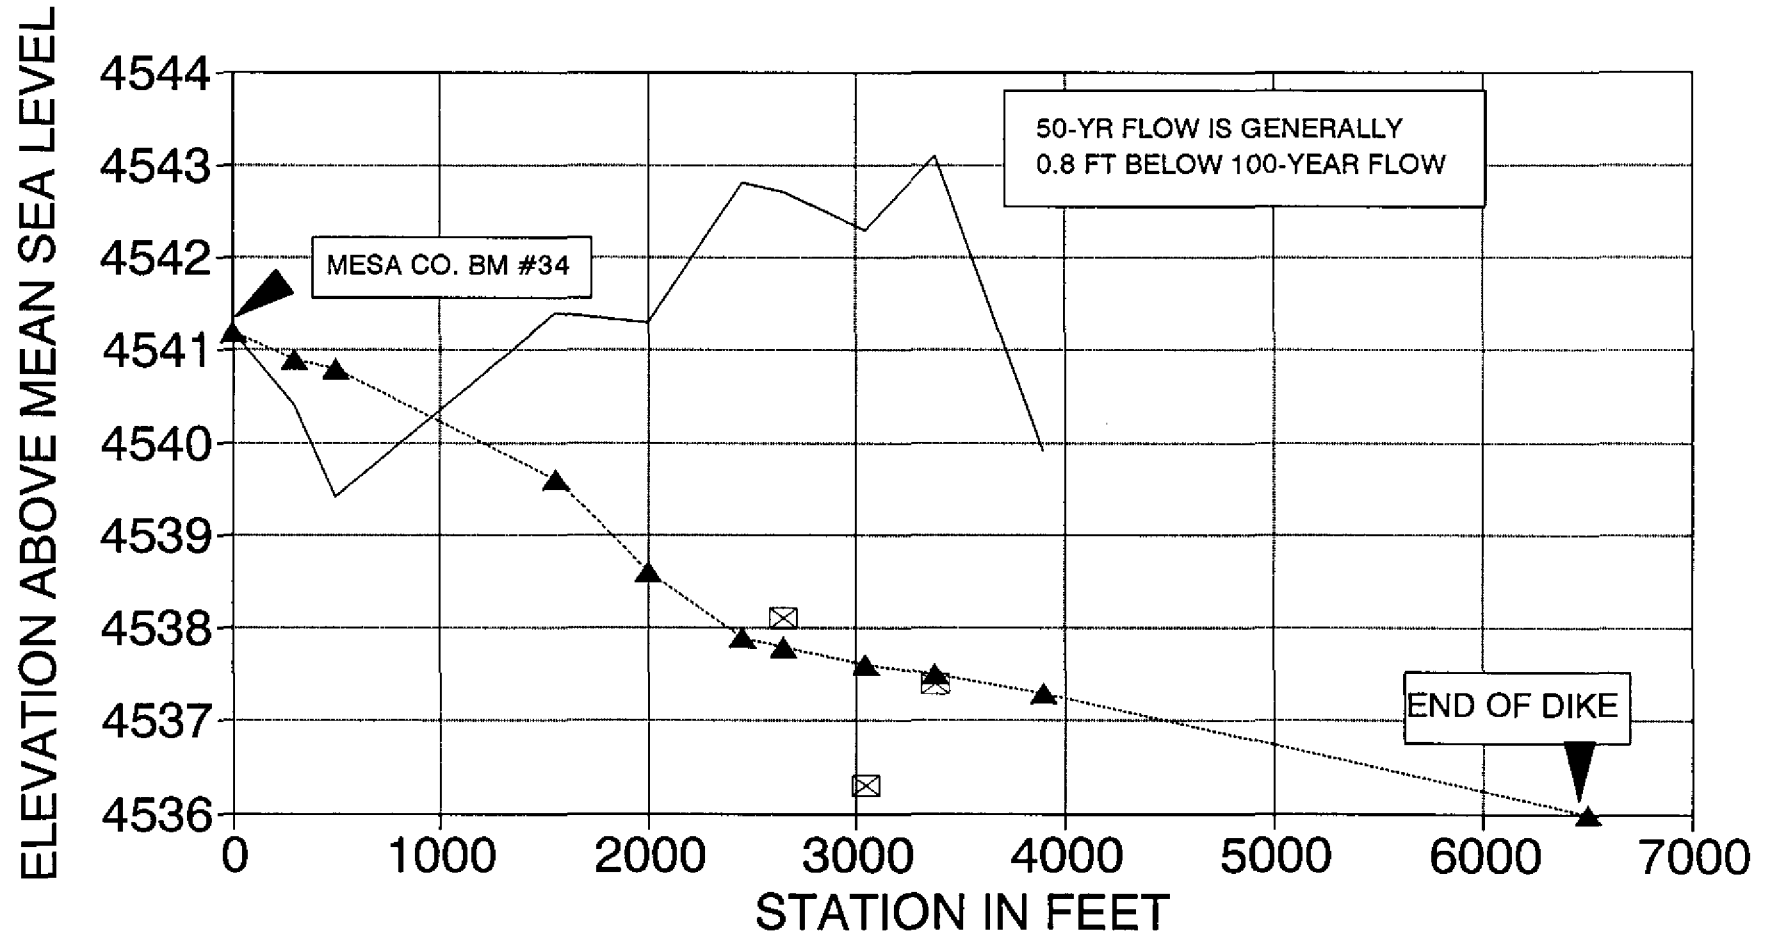
COLORADO RIVER "DIKE" PROFILE

The profile sheet for the Connected Lakes and Duke Lake, which is included at the end of this section, shows the levee around a portion of the State Park, as it exists today. It also shows the currently effective 100-year flood elevation from the FIS without incorporating the effects of the 1991 levees on those elevations.

During a 50-year and a 100-year flood there would be a problem at Connected Lakes and Duke Lake. If the existing levee were not modified and reinforced with riprap on the river face, there would severe erosion to the levee protecting the Connected Lakes. There would also be failure with overflows into Duke Lake. There would be a direct connection between the lakes and the

Even with the substantial work that has been done at the state park, at the residential areas within the Connected Lakes subdivision and at the Pepsi-Cola Plant since 1984, there is additional work that would have to be done to provide 50-year and 100-year flood protection. The levee system would need to be raised to keep Duke Lake (and, therefore, Connected Lakes) out of the 50-year floodplain. That levee and the existing dike around the remainder of the site would clearly require erosion and slope protection. The erosion protection would need to be engineered to minimize the risk of undermining by a flood. There would need to be additional freeboard in some locations. Before such mitigation measures were undertaken, an engineering analysis would be needed. A 50-year flood protection project may be feasible for the stream reach from the Redlands Parkway upstream to Highway 340.

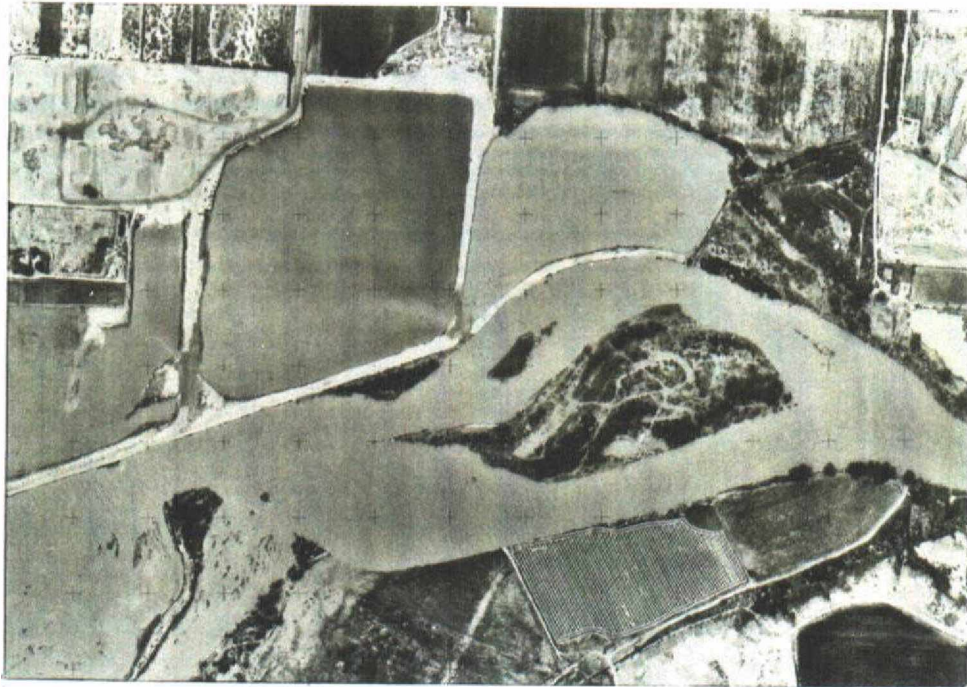
1983 Flooding

30 Road Pond experienced some flooding in 1983 and 1984. The pond is located on a historic meander path of the river along with the pond to its immediate east (upstream) and to its immediate west (downstream). Floodwaters entered the meander path and then continued into the first pond, the one just east of 30 Road Pond. Water then overflowed to the west into 30 Road Pond and then into the third pond to the west. There was also some underground conveyance through the levees separating the ponds from one another. 30 Road Pond had an overflow back into the river at its southwest corner. The aerial photo shows all of this except the underground flow.

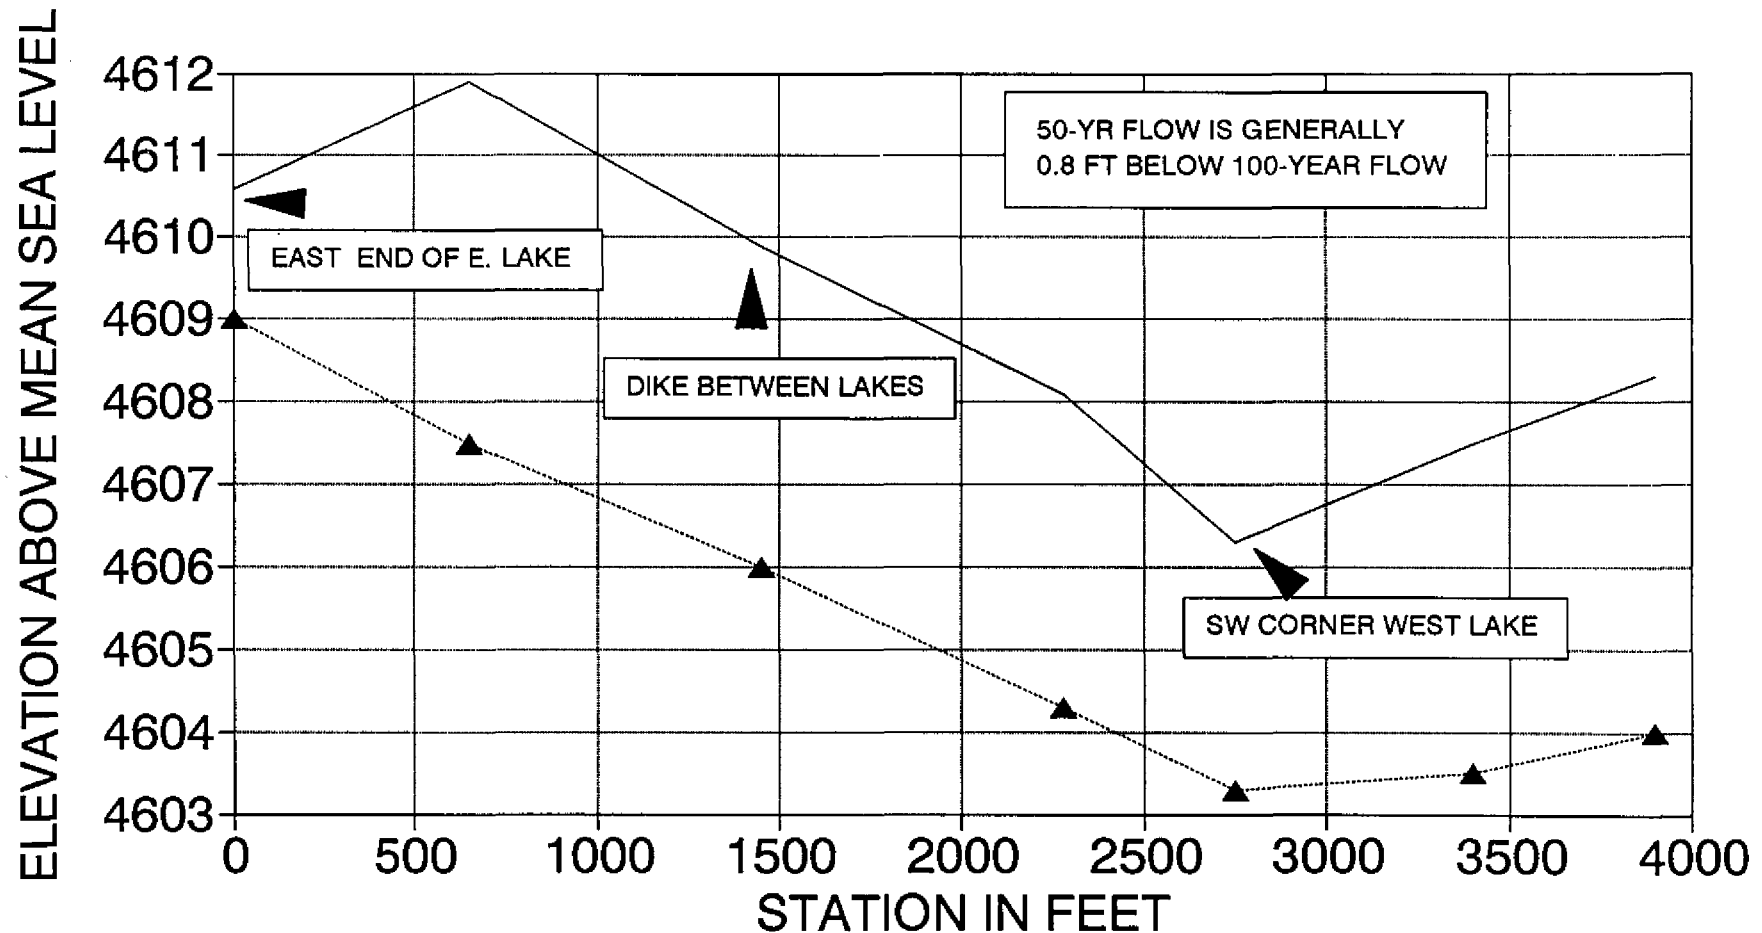
COLORADO RIVER "DIKE" PROFILE

The profile sheet for 30 Road Pond is included at the end of this section. It shows current levee elevations and the effective 100-year flood elevations from the F.I.S.

During a 50-year or a 100-year flood it appears that 30 Road Pond would remain safe from floodwaters in the river directly overtopping the levee along the southern pond embankment. There is currently no bank protection, so the risk of erosion should be considered as a potential problem during a large flood.

In 1984 the pond embankment next to the river was approximately 1 foot above the 100-year flood elevations, but the embankment was not designed to accepted levee standards. Since that time it appears that the embankment has been raised another two feet. The pond is still shown as being in the 100-year floodplain in the Mesa County Flood Insurance Study.

The southern pond embankment can currently provide 100-year protection with some freeboard. At the upstream (eastern) end of the three-pond system a tieback levee would be needed to prevent floodwater from entering the ponds via the historic meander path.

There is no erosion protection and no protection from seepage. The embankment could be improved to protect it from erosion and seepage. A flatter side slope (approximately 1 on 3) toward the south (toward the river) could be provided by filling along the embankment. Willows planted at the toe of that fill slope should stabilize it.

At the western end of the three-pond system and at the western end of 30 Road Pond the levee needs to be elevated to prevent rising pond water from spilling into the Colorado River during periods of high groundwater.

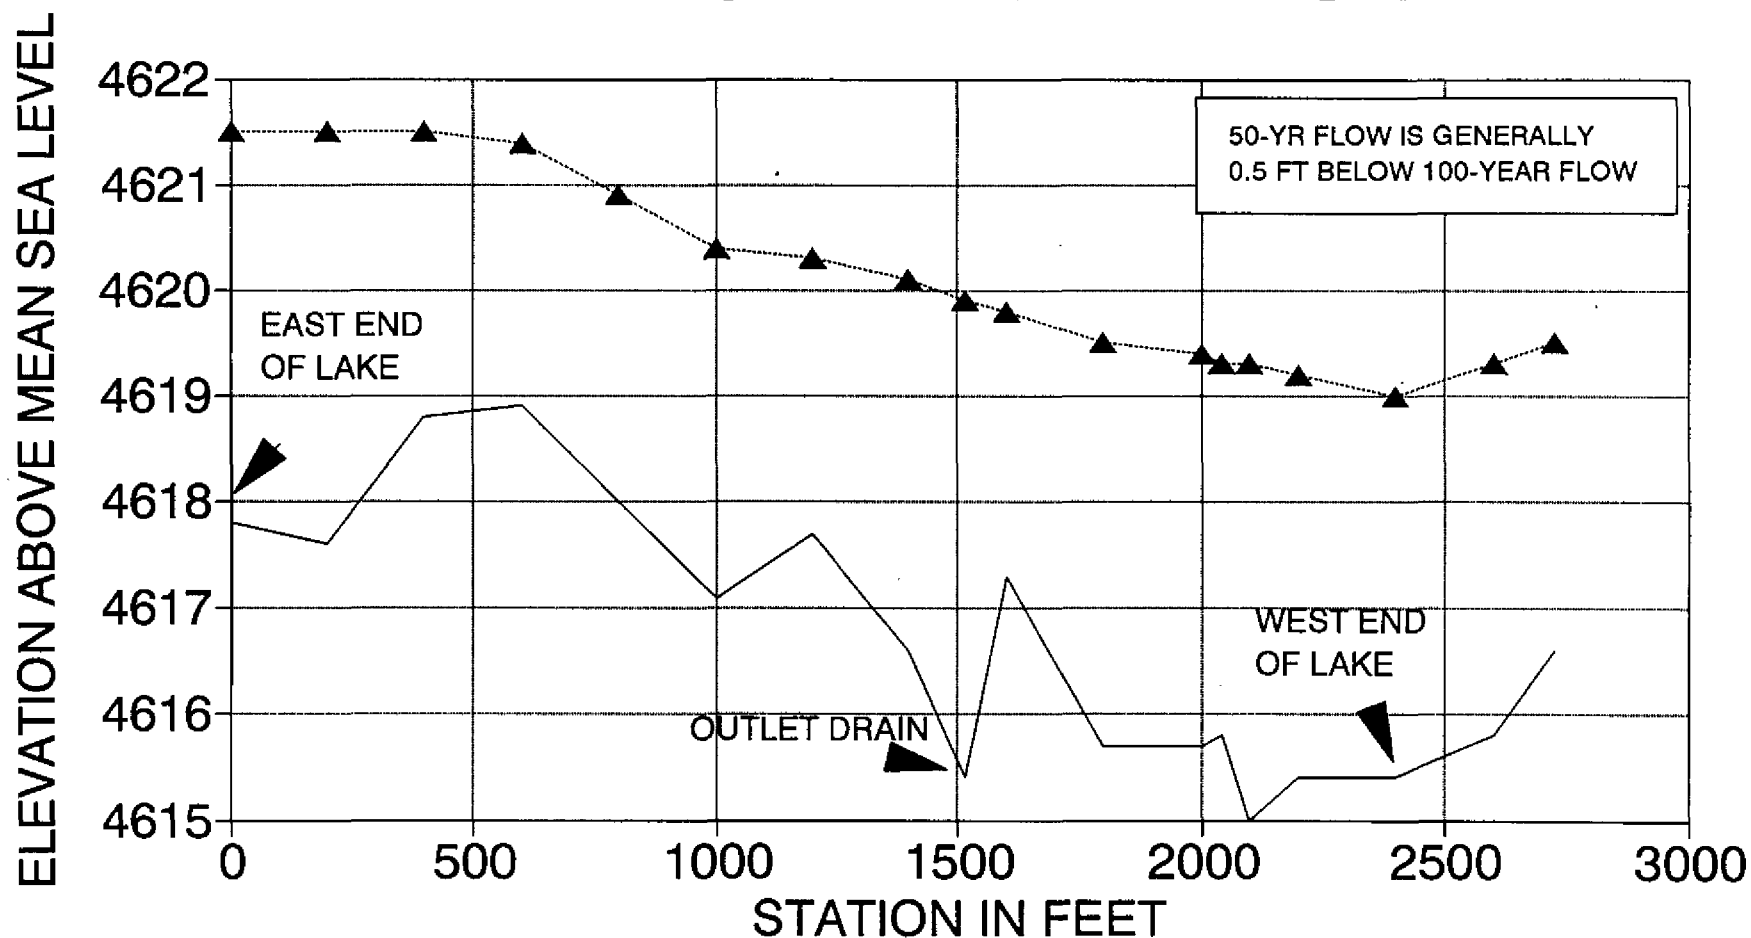
COLORADO RIVER "DIKE" PROFILE

A field survey was conducted at Corn Lake on January 20, 1995. It included an examination of existing conditions along the river bank and an elevation survey of the levee on the east, south and west sides of the lake.

To provide 100-year protection at Corn Lake, a 7 foot high levee system would be required, which would be an expensive project. A levee to protect Corn Lake from a 50-year flood would also be very expensive. A 2800 foot long levee system with an average height of 5 feet would be required. The levee system would require erosion protection as well. There may be no cost-effective mitigation measures for the flood hazard at Corn Lake. Before such a conclusion was finalized, an engineering analysis would be needed.

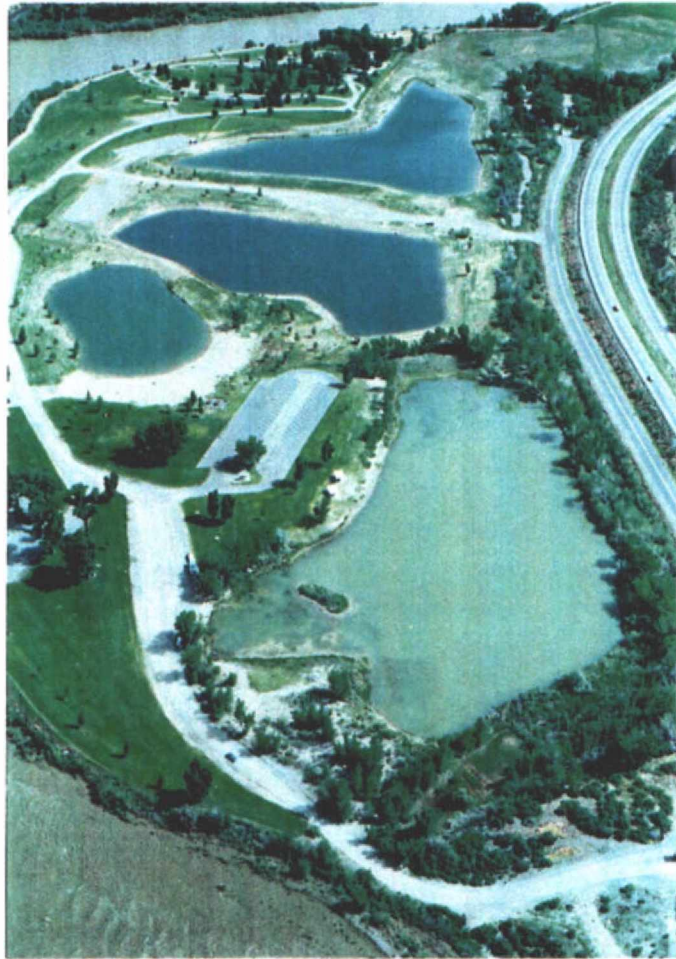
1993 Flooding

An aerial photo of flooding at Island Acres State Park in 1993 is included on the preceding page. Unfortunately no photos of flooding in 1983 or 1984 were available. There was some anecdotal information about the flooding there, however. In both years the site was inundated. In 1984 the flood damage was severe enough to warrant emergency recovery assistance from FEMA as part of the Presidential Disaster Declaration. The one pond that was in the park at that time was inundated. (The other ponds were excavated after the 1984 flood.) The pre-existing levee that had been destroyed was rebuilt through that project. In 1993 floodwaters came within 2 or 3 feet of overtopping the levee which was constructed along the riverbank in 1985. In the 1993 photo it appears that the southernmost pond (the pond that is the furthest downstream) experienced seepage from the river, indicating a need for greater protection above ground and below ground.

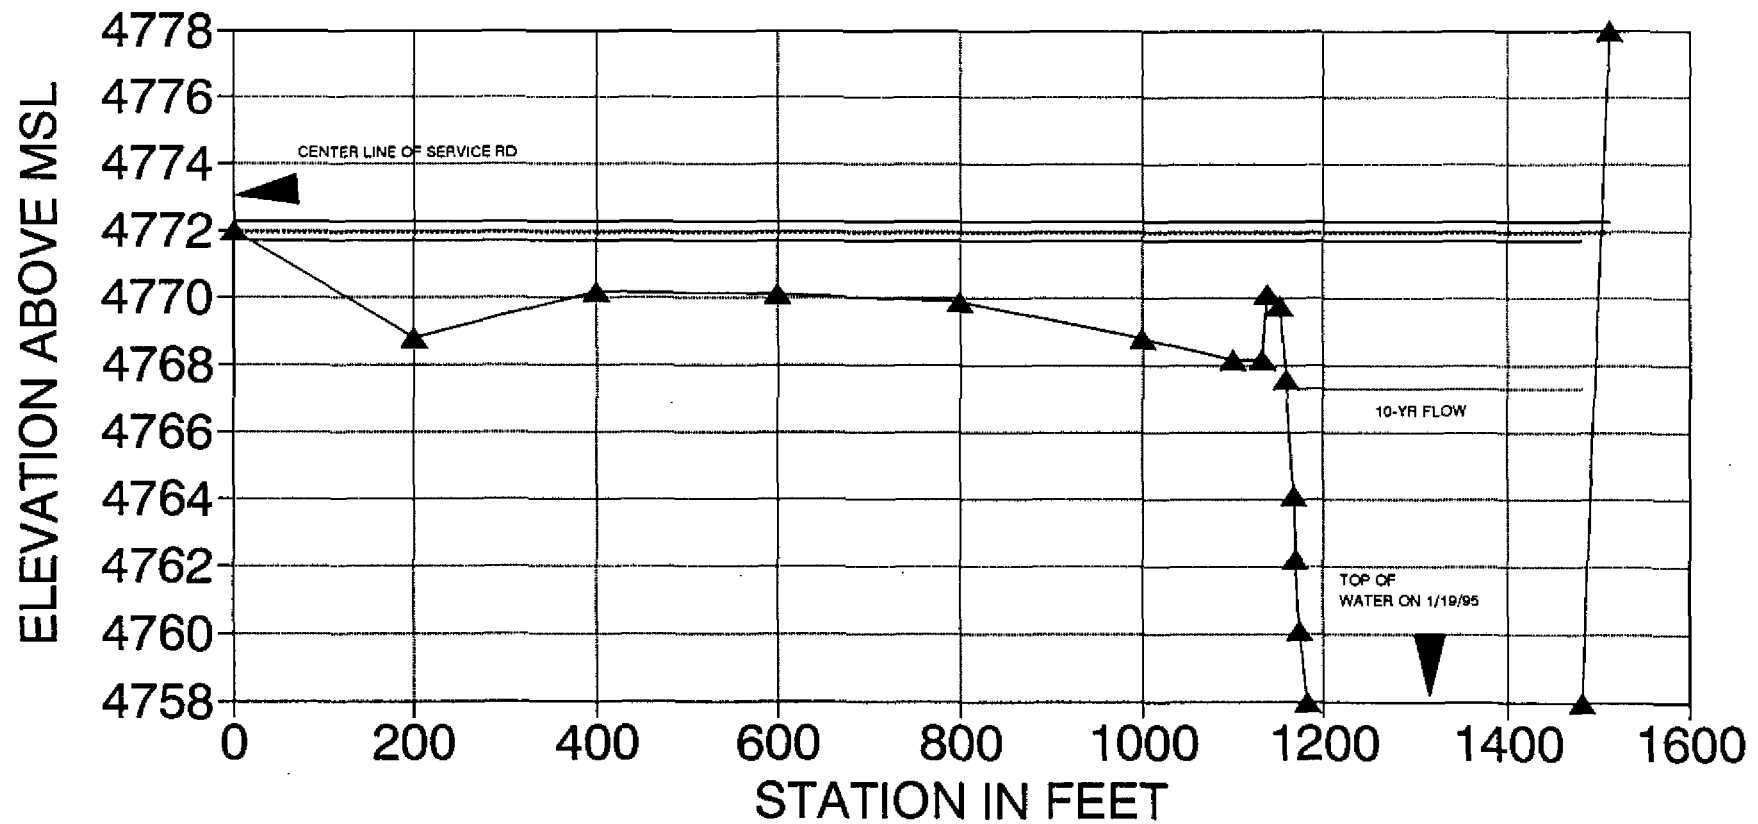
COLORADO RIVER CROSS-SECTION

During a 50-year or a 100-year flood there would be a problem at Island Acres. The 4 ponds at in the State Park, along with almost all of the park, are in the 50-year and 100-year floodplain. The levee along the southeast bank of the Colorado River does not provide 50-year protection. 50-year and 100-year floods would create a direct connection between the pond and the Colorado River. The park and its contents are subject to high flood risk. The existing levee, rebuilt with FEMA disaster recovery funds, was not designed to meet 50-year or 100-year flood protection standards and may even fail during a 10-year flood event.

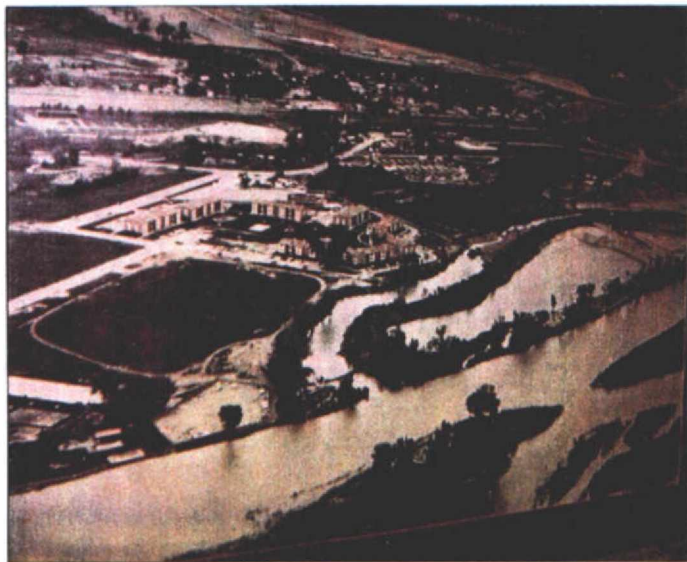
1984 Flooding

remembered that the 1984 flood on the Colorado River was approximately a 40-year event at Parachute Pond and the pond did not wash out, either from overtopping or from erosion damage. There was, however, a discharge of water from the pond into the river. That discharge was caused by a high groundwater table and by an upstream inflow. It is reasonable to assume that a 10-year flood would not inundate the pond. Based on the above description and on the profile in the Floodplain Information Report, the pond lies in a critical part of the 100-year floodplain of the Colorado River.

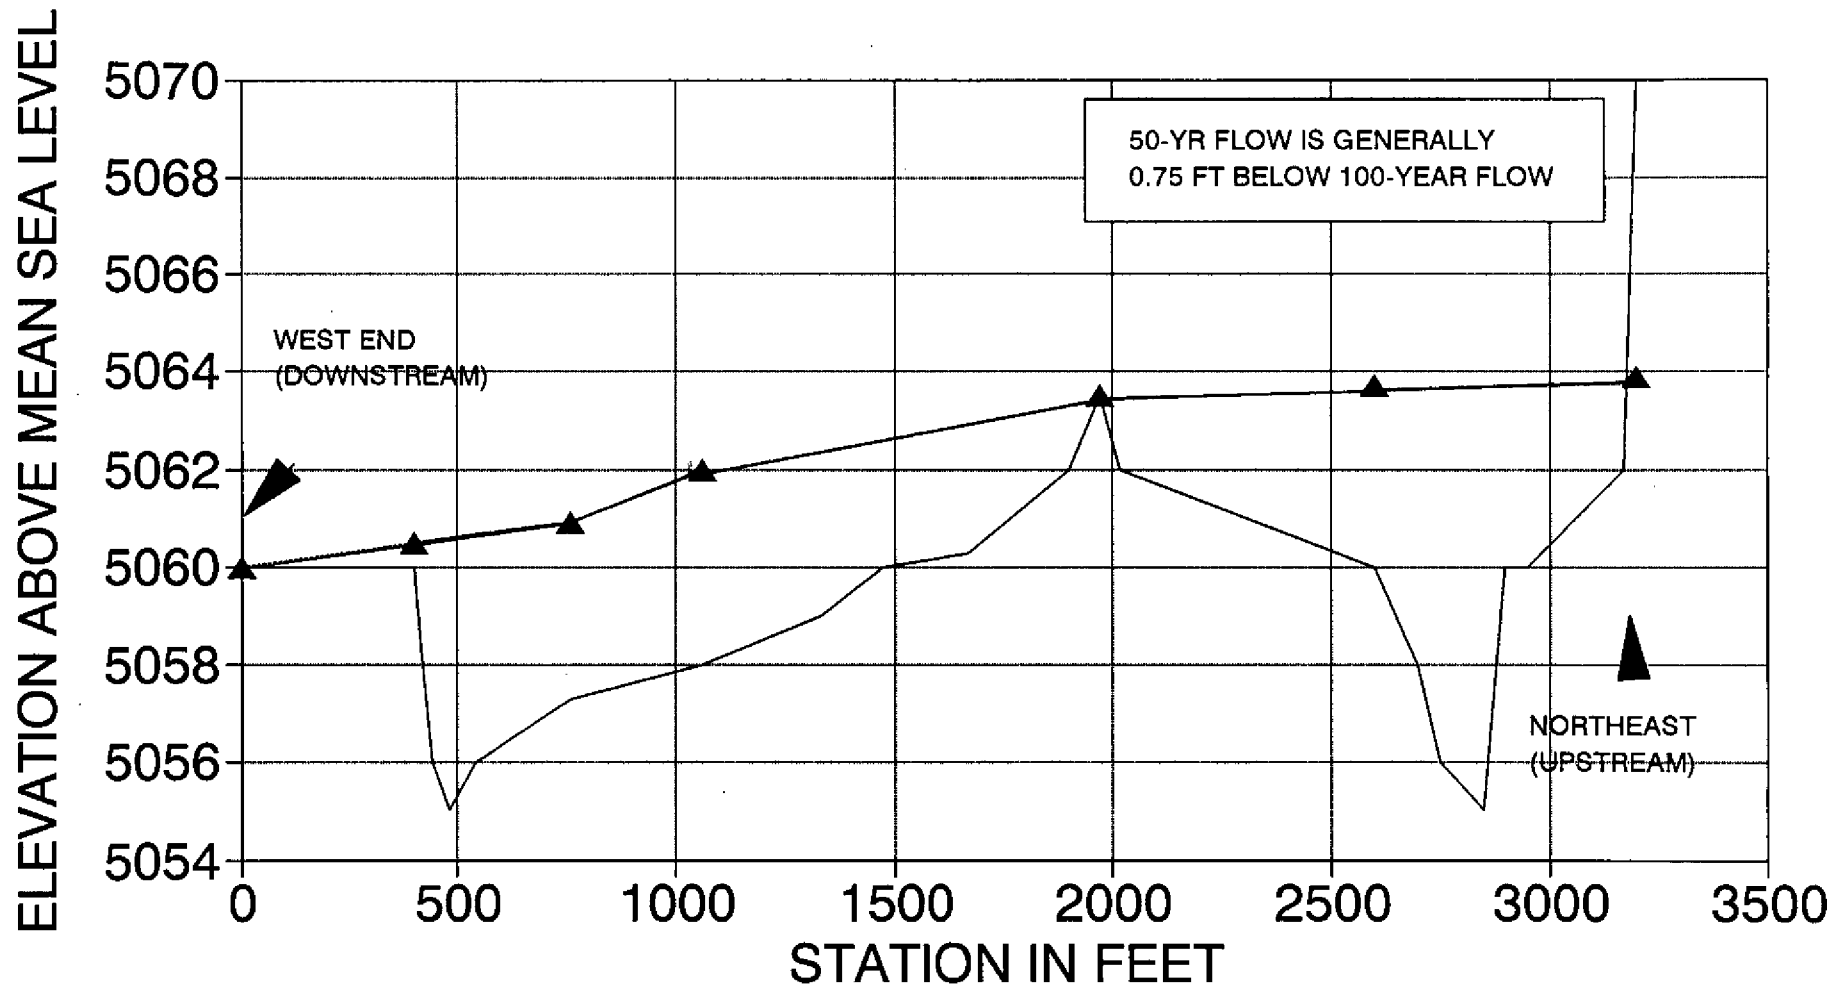
COLORADO RIVER "DIKE" PROFILE

A field survey was conducted at Parachute Pond on January 18, 1995. It included an examination of the existing condition of the riverbanks, a field survey of the elevations of the levee surrounding the pond and an examination of the outlet works for the pond and existing flood mitigation measures. The north riverbank (the one nearest the pond) has some erosion protection in the form of broken concrete and rock.
