Survey of Selected Wetlands within the  
Bureau of Land Management  
Kremmling Field Office Management Area  
(Grand County, CO)

Prepared for:  
Kremmling Field Office  
P. O. Box 68  
2103 East Park Avenue  
Kremmling, CO 80459

Prepared by:  
Jennifer Jones, Wetland Ecologist and Denise Culver, Ecologist  
May 2006

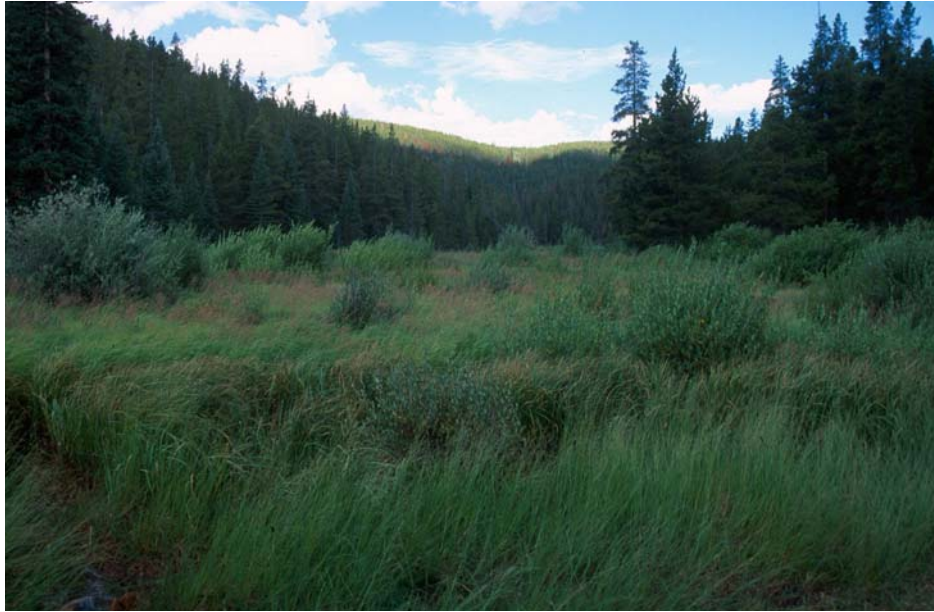
***Potential*** Wetland is functioning below its potential natural community due to road encroachment.

Photo 1. Mountain willow with bluejoint reedgrass riparian shrubland at Behler Creek.

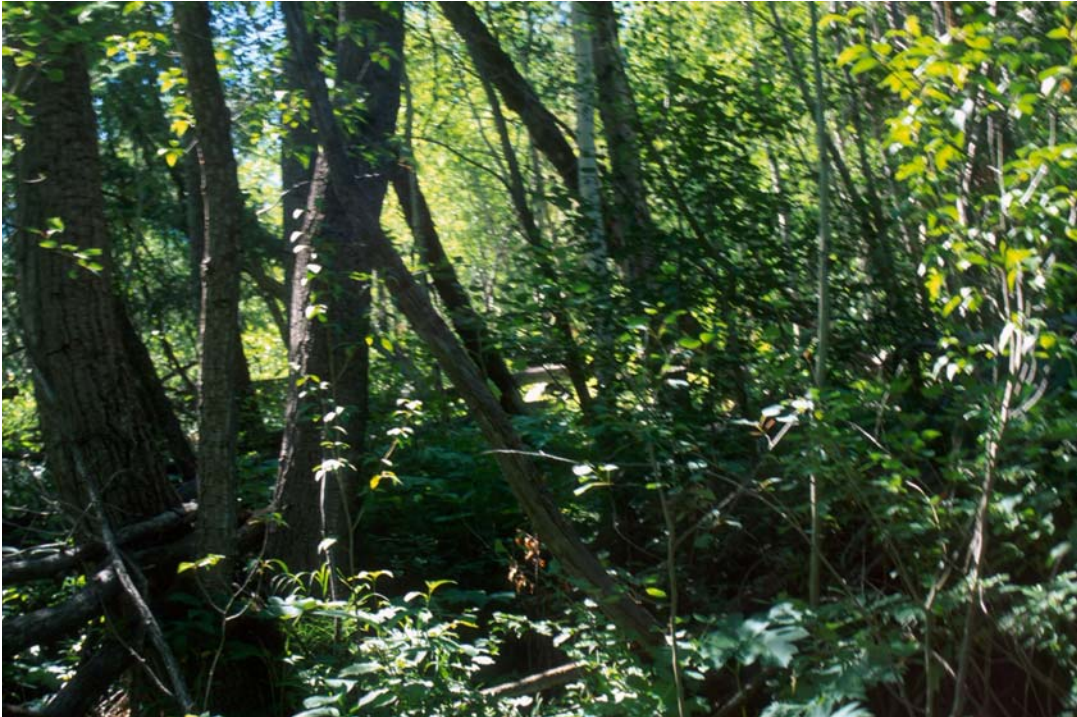
**Potential** Drainage is functioning just below its potential natural community due to logging disturbances and proximity to road.

Photo 2. Thinleaf alder / mesic forb plant community at Road End Seep at Strawberry Creek

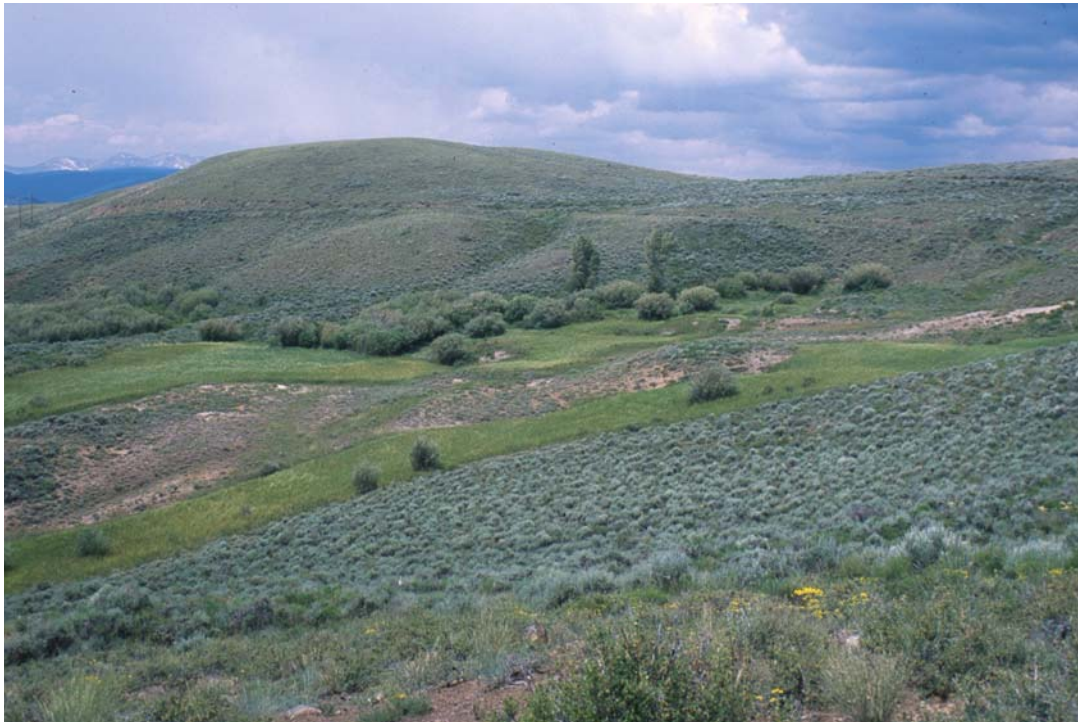
**Potential** The potential natural community for the site is difficult to estimate due to origin of wetland which has been altered due to dirt work in the area. This area is resultant from filling of past landfill and may have originally been a small, Salix dominated drainage.

Photo 3. Beaked sedge herbaceous vegetation at Landfill Seep Site.

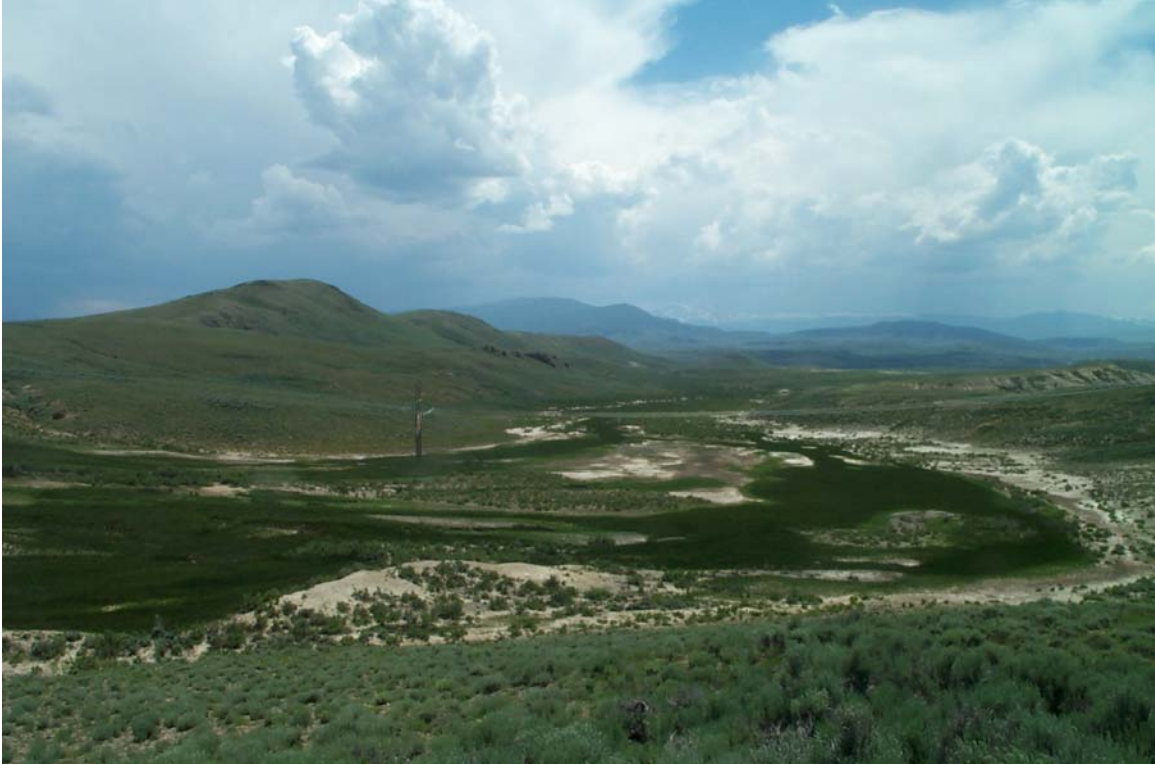
**Potential** Site is functioning just below its potential natural community due to exotic species invasion, road proximity, hydrologic alterations at lower reaches, and livestock grazing.

Photo 4. Common three-square herbaceous vegetation at Sulphur Springs.

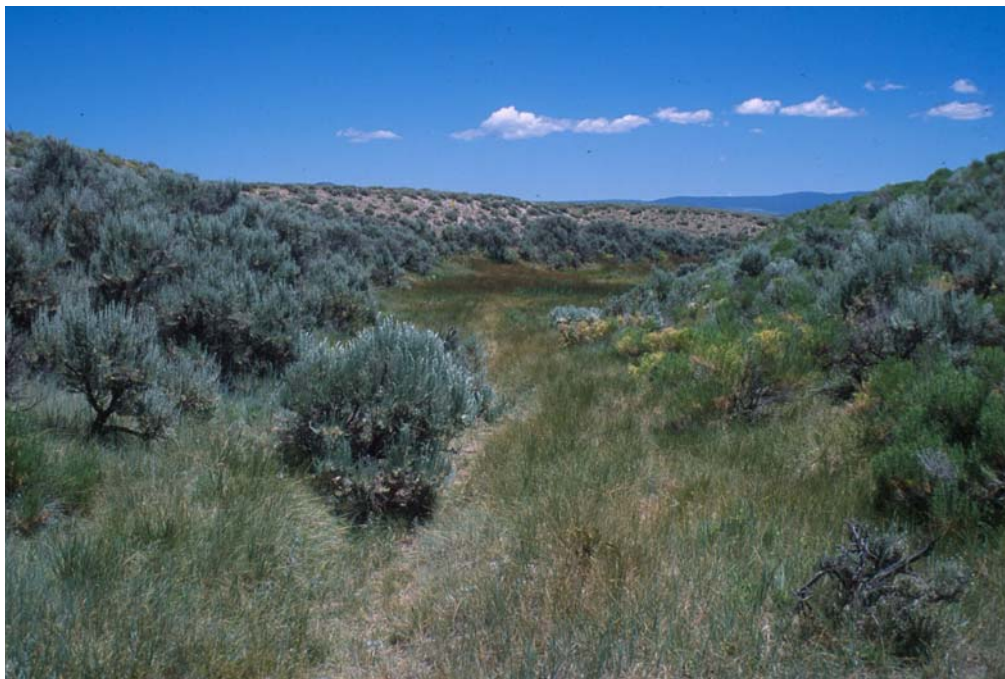
**Potential** Area is not functioning at its potential natural community due to multiple limiting factors that are not likely to be amended in the future. Adjacent road and quarry are contributing to weedy species invasion, altering microclimate conditions, and may be adding sediment to the drainage. Large trough for livestock watering is situated below the spring and before its junction with Sulphur Gulch, but it is no longer in use.

Photo 5. Beaked sedge herbaceous vegetation at Scholl Spring Site.

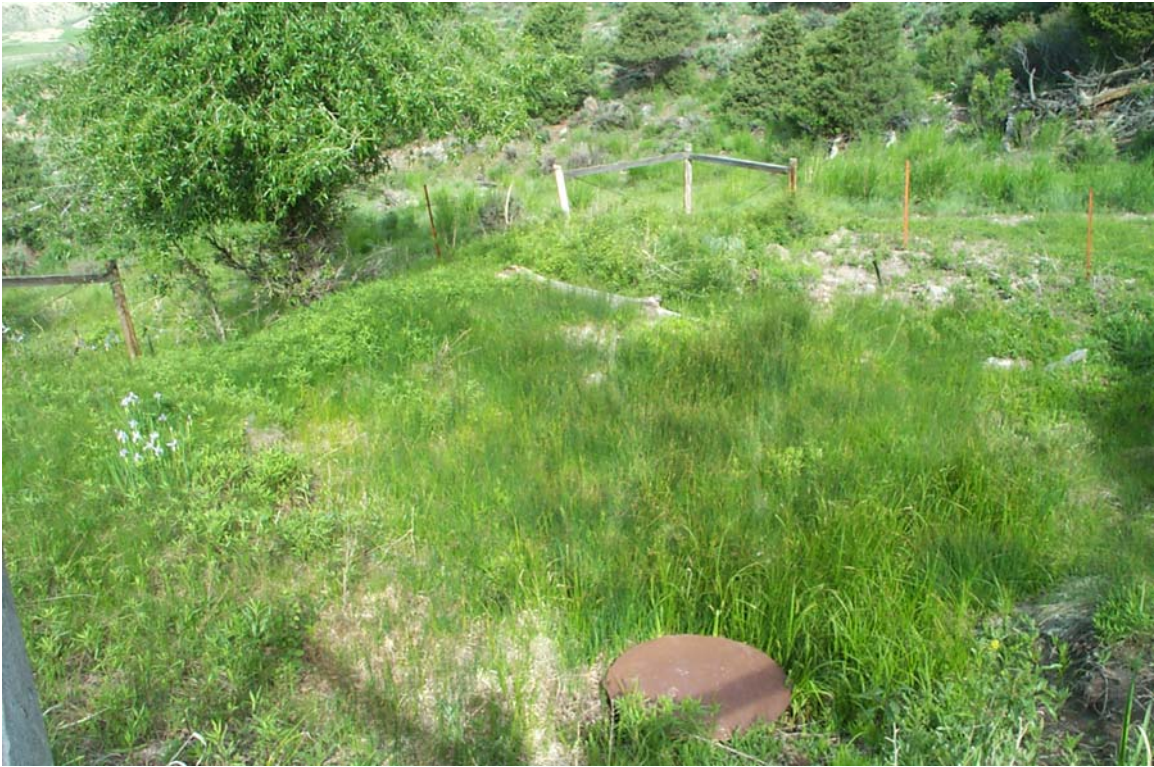
Photo 6. Wolford Mountain Springs

**Potential** Wetland is functioning below its Potential Natural Community due to alterations in hydrology and livestock grazing in area.

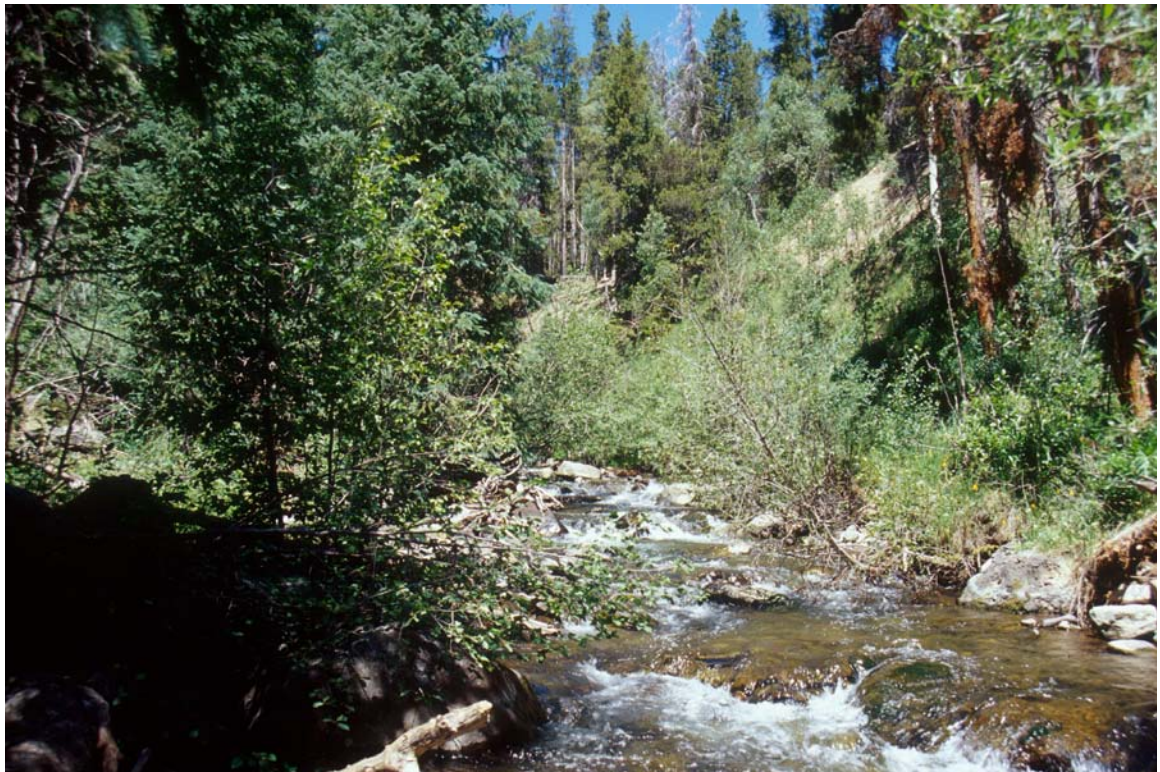
**Potential** Site is functioning below its capability due to altered hydrology and low flows created by upstream dam. Flows would need to be restored to achieve the potential natural community.

Photo 7. Thinleaf alder with Drummond willow riparian shrubland at Upper Troublesome Creek.

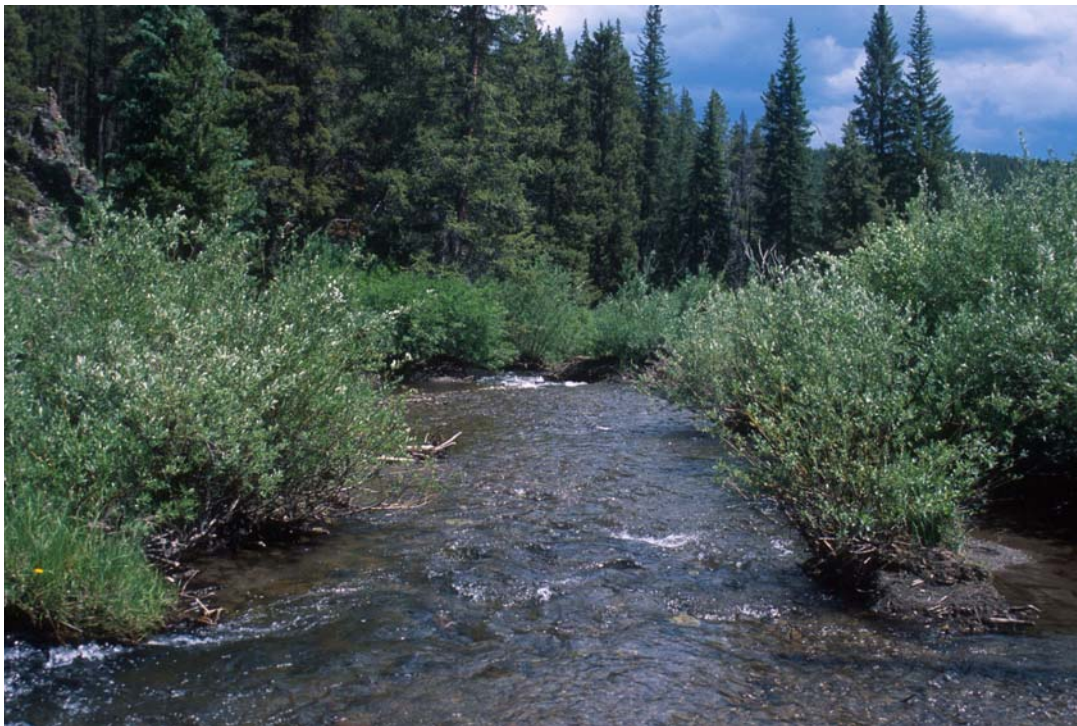
**Potential** Wetland area is functioning near its potential natural community. Although there are anthropogenic disturbances present including a ditch and road, both remain as historic disturbances and do not seem to be currently in use. There are no hydrologic alterations other than natural alterations from beaver activity and logging in the area is patchy.

Photo 8. Drummond willow with bluejoint reedgrass riparian shrubland at Rabbit Ears Creek.

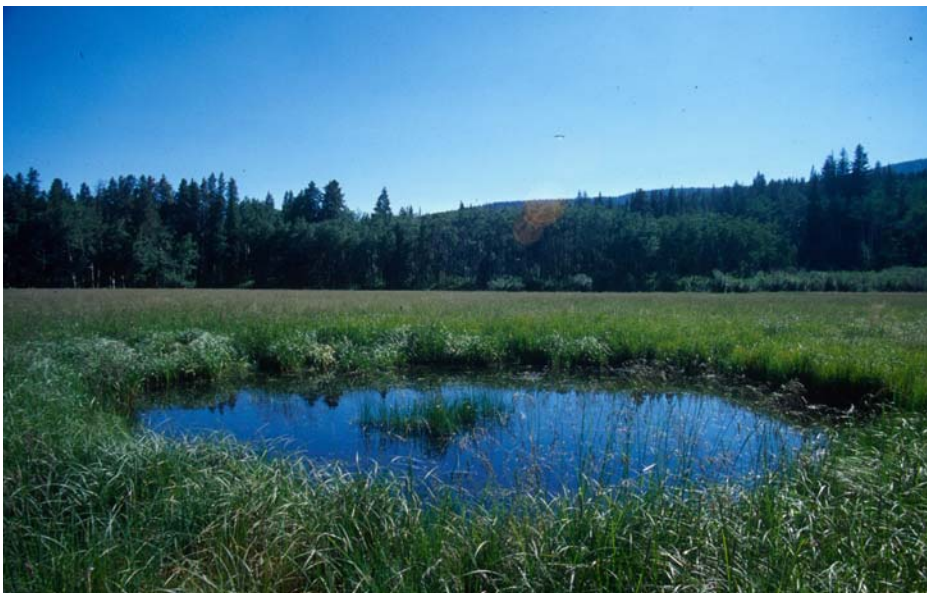
**Potential** In order for this wetland area to attain its potential natural community, the non-native species component would need to be controlled and the area maintained as a natural area in the absence of livestock grazing.

Photo 9. American mannagrass herbaceous vegetation at Charlie Creek Meadows.

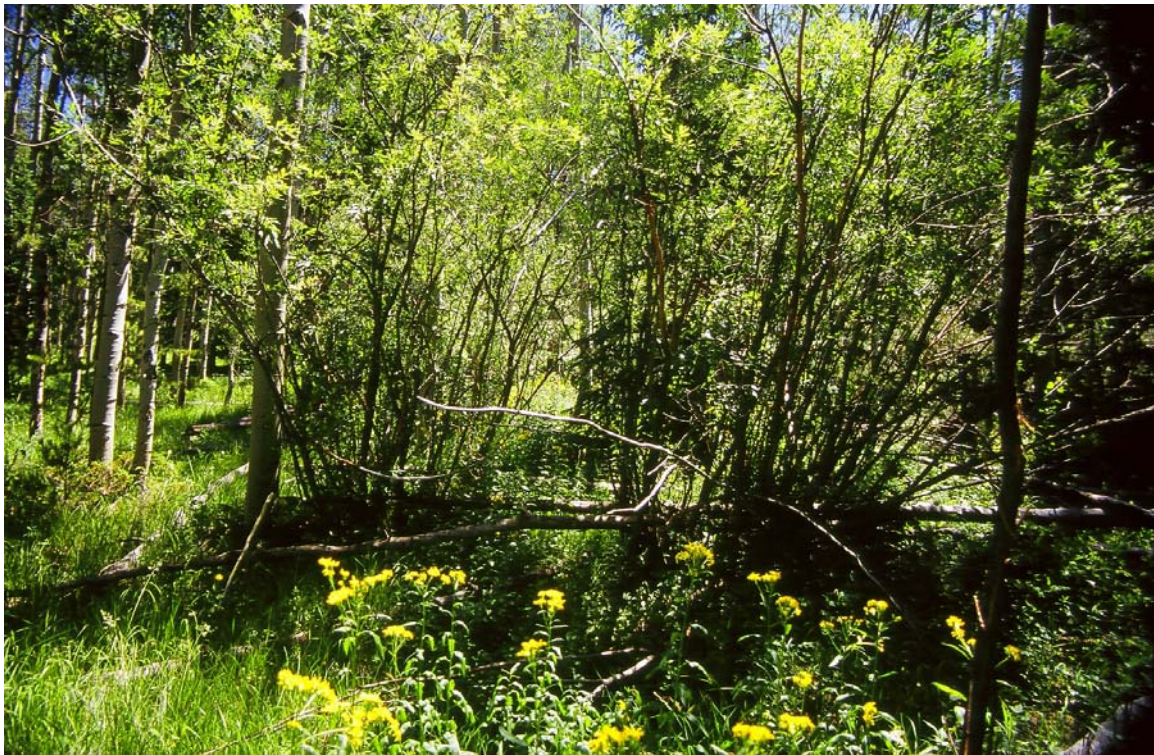
Photo 10. Charlie Creek Seep.

**Potential** Site is functioning at its potential natural community with very few alterations or disturbances.

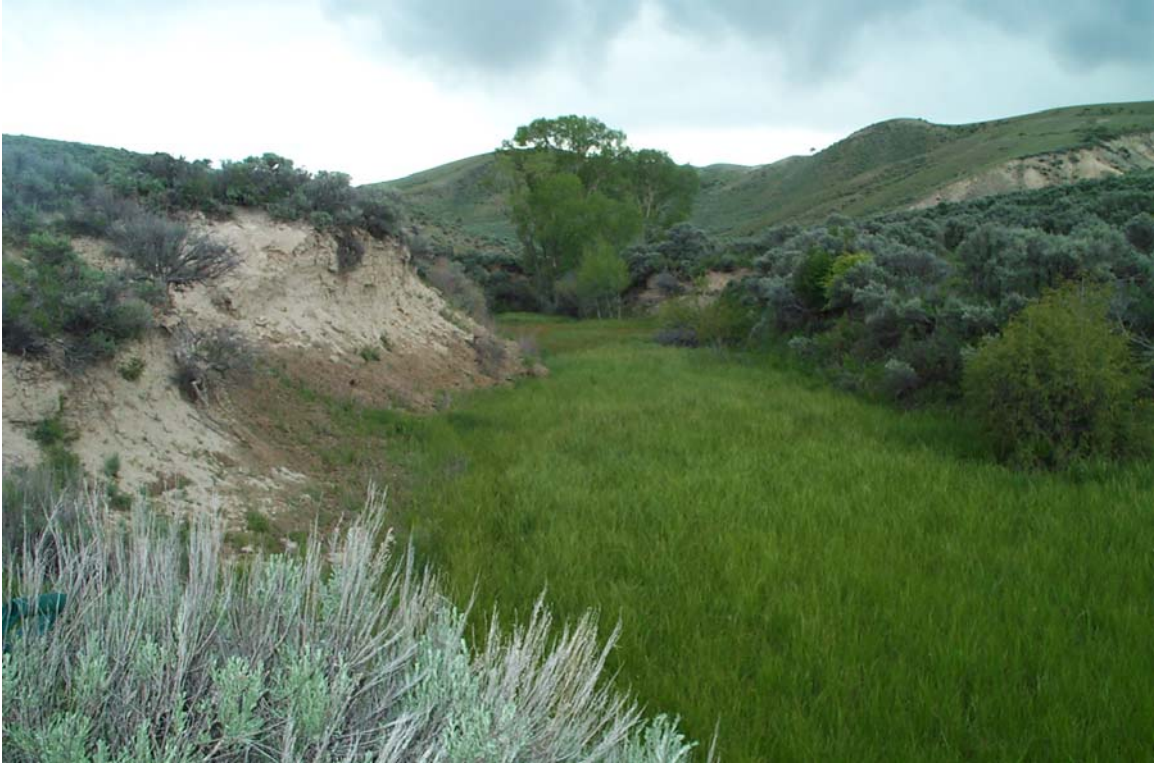
**Potential** Wetland is function just below its Potential Natural Community due to alteration of hydrology along upstream seeps and springs.

Photo 11. Woolly sedge herbaceous vegetation at Cow Gulch.

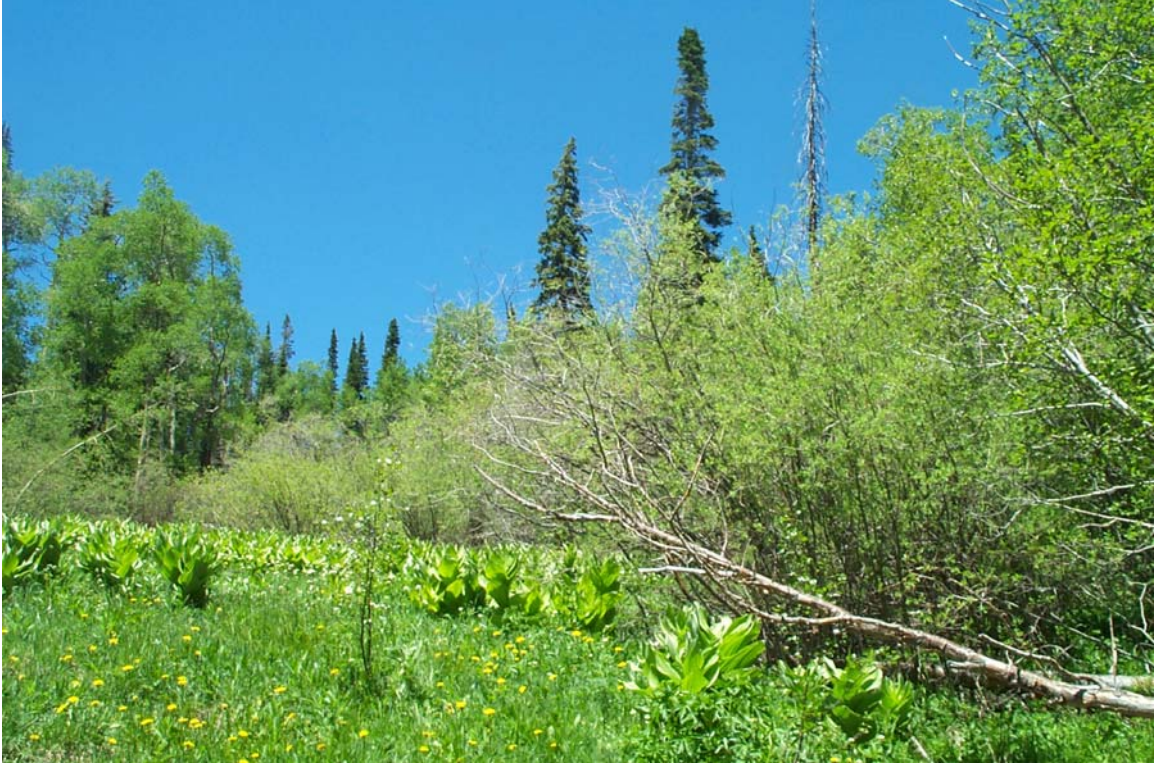
**Potential** Area is functioning near its potential natural community with the main anthropogenic disturbance being the adjacent road and recreational use of the area.

Photo 12. Alder with Drummond willow riparian shrubland at First Creek.

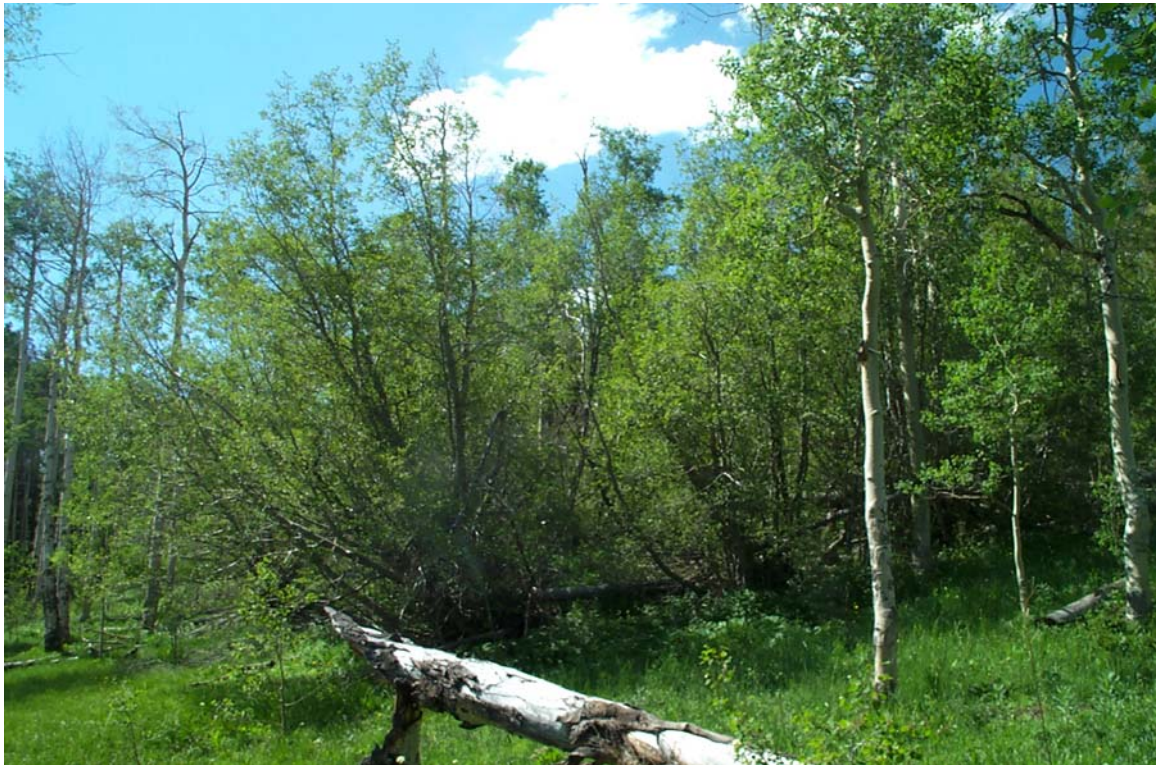
**Potential** Wetland area is functioning at its potential with all wetland functions acting to create the potential natural community

Photo 13. Alder with mesic forb shrubland at Cabin Creek Seep.

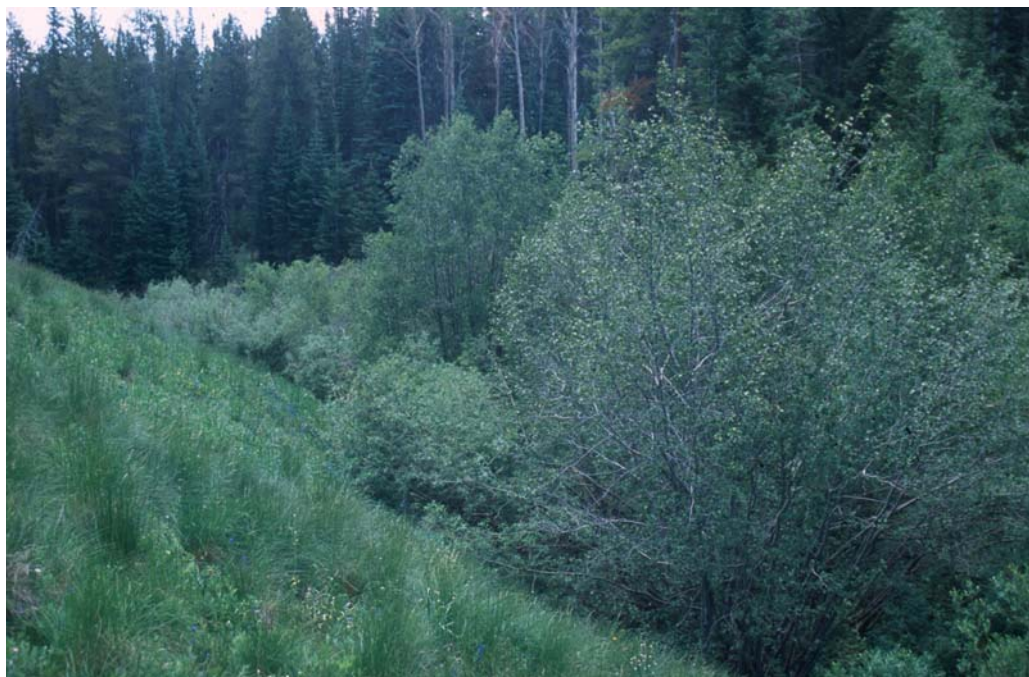
**Potential** Area is functioning at its potential. Hydrology is restricted only at the drainages upper reaches at a small culvert and road crossing. Otherwise, the only evident current disturbances are natural from seasonal flooding and wildlife use.

Photo 14. Thinlead alder with Drummond willow riparian shrubland at Black Mountain Reservoir.

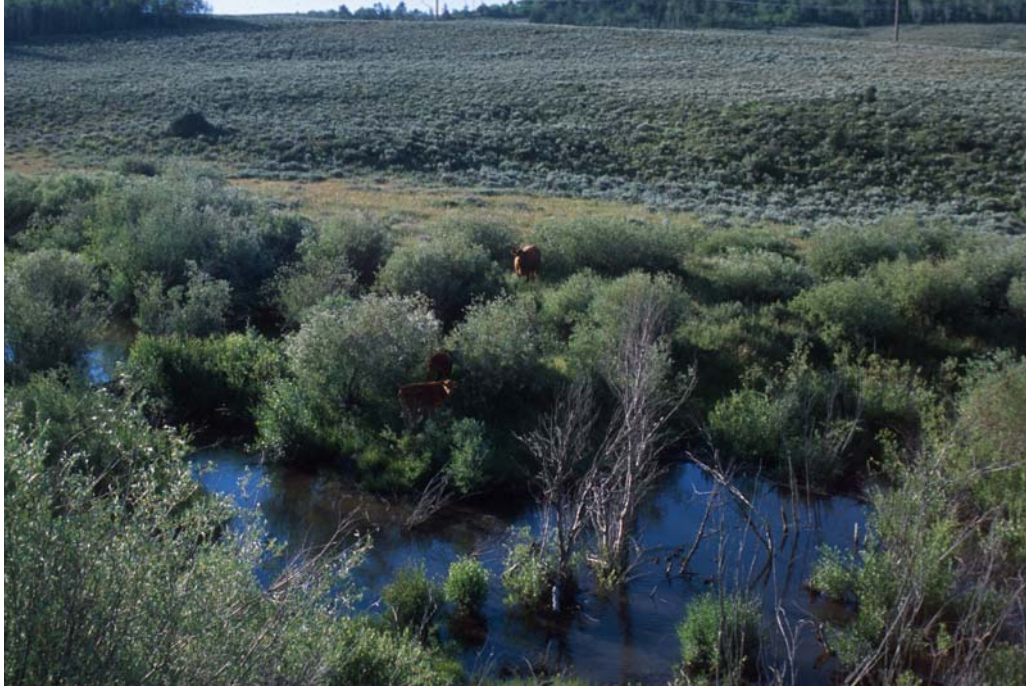
**Potential** Riparian area along Kinney Creek is not functioning at its potential due to limiting factors including hydrologic alterations from beaver activity, property ownership downstream where there is concentrated grazing and the stream has been channeled, intense grazing on BLM owned property, and road encroachment. All of these factors are contributing to the degradation of the system including non-native species invasion, bank erosion, upland species encroachment, and loss of many riparian functions that are necessary to achieve ultimate wetland values.

Photo 15. Mountain willow with mesic forb riparian shrubland at Kinney Creek.

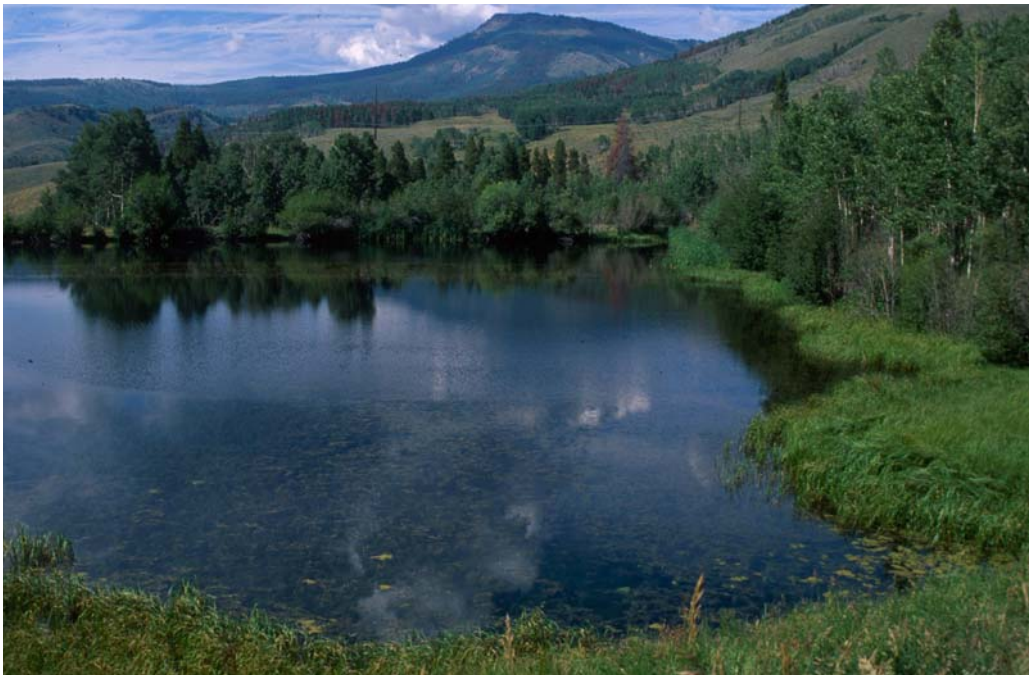
Photo 16. Ute Bill Reservoir.

**Potential** Historically, this area was part of the riparian corridor fed by a small spring-fed tributary of Ute Bill Creek. In order to achieve a potential natural community for this area flows would need to be unobstructed and past streamside vegetation reestablished.

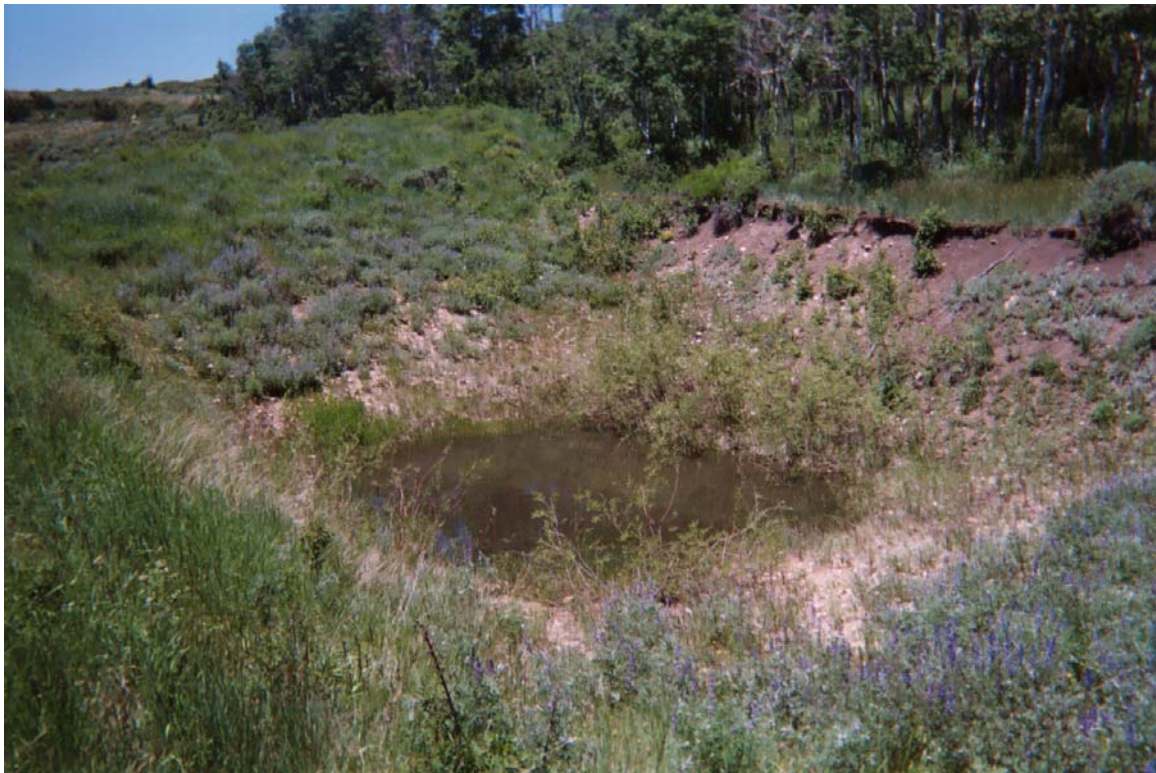
Photo 17. Rock Creek Spring.

**Potential** Wetland is functioning below its potential natural community due to past grazing, erosion, lack of back stabilizing vegetation, and possible dirt work in the area.

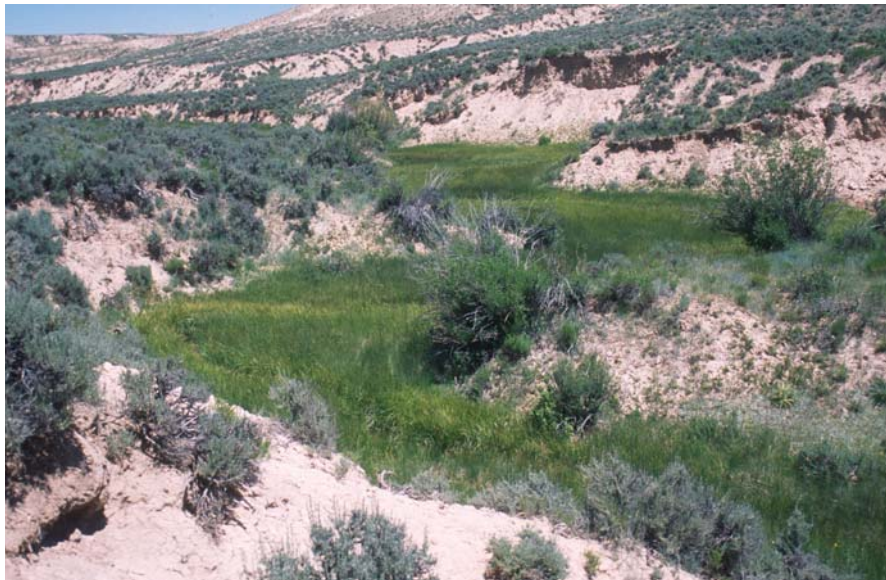
**Potential** Site is functioning near its potential and is in excellent condition despite condition of upstream watershed.

Photo 18. Beaked sedge riparian plant community at Barger Gulch.

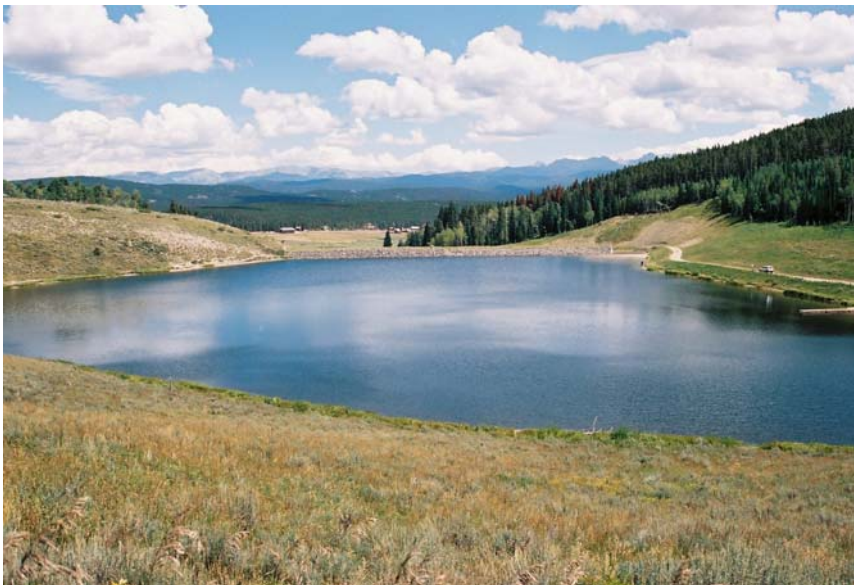
Photo 19. Gaylord Reservoir.

**Potential** There is likely no way for this site to achieve potential. Historically, this area was part of the riparian corridor of a tributary of Pole Creek. In order to achieve a potential natural community for this area flows would need to be unobstructed and past streamside vegetation reestablished.
