Report No. CDOT-DTD-R-2002-4
Final Report

Corrosion Effects of Magnesium Chloride and Sodium Chloride on Automobile Components

Prof. Yunping Xi and Zhaohui Xie

May 2002

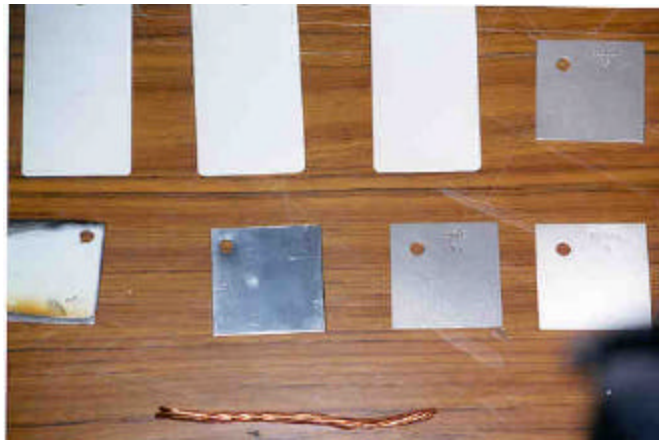
Figure 2: A photograph of the coupons.

All three ACT coupons (Type e, f, and g) have the same coating system:

Ecoat: U32AD400
Primer: G27AD258 Powder
Basecoat: R164WE936 Stone white
Clearcoat: R126CG2001

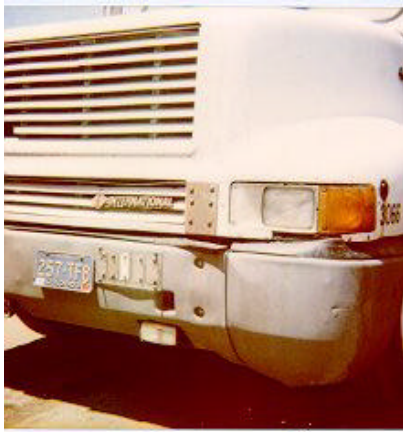
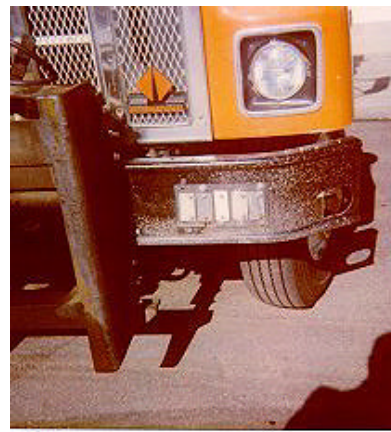
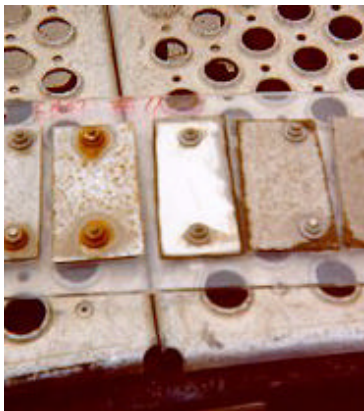
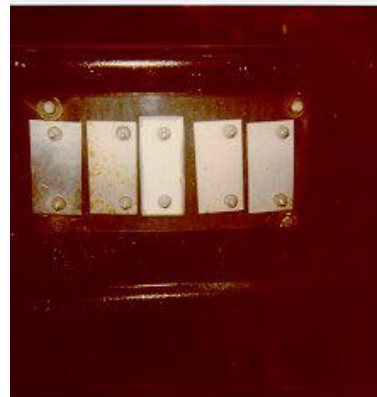
Fig.4 Coupons on the trucks

Four plates were mounted on CAST Transportation trucks; three plates were mounted on HVH Transportation trucks, and the remaining three plates were mounted on CDOT Region 6 Maintenance trucks. While both CAST and HVH have interstate operations, the participating carriers were asked to mount the plates on trucks that ran miles only in Colorado to guard against exposure to other state's deicing chemicals.

The in-service exposure test was carried out on Colorado highways during the winter of 1999 to verify the results from the laboratory experiments. Five metal coupons, identical to those used in the laboratory tests, were bolted to a Plexiglas sheet approximately the size of a license plate. Ten of these Plexiglas plates were mounted on trucks for exposure on the highway starting the first week of November 1999. The plates were removed from the various trucks and returned to CU-Boulder for analysis in May 2000.

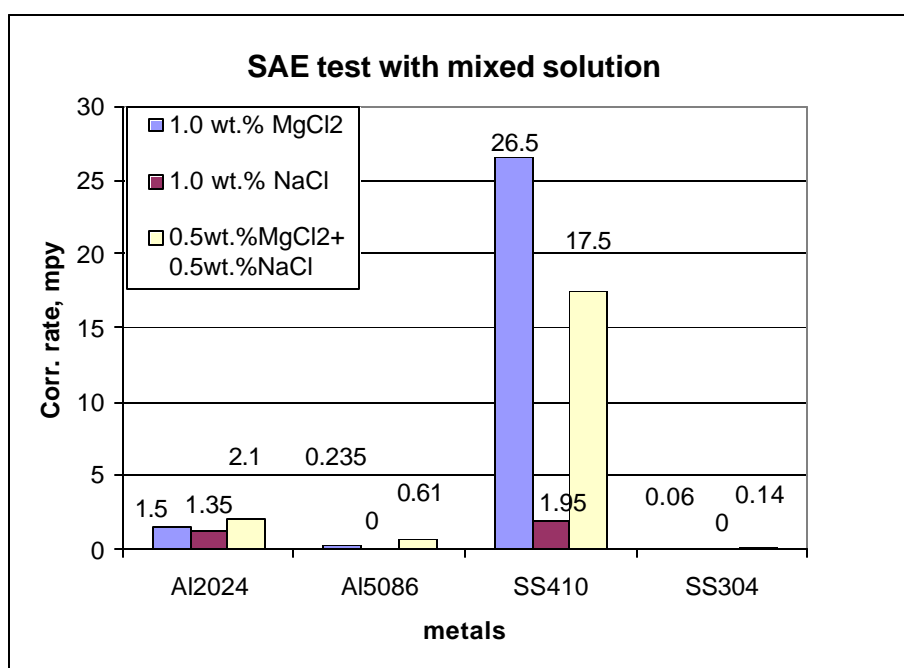
Fig.7 SAE tests with mixed solution

The experimental results of the cyclic test Run 5 with mixture of NaCl and MgCl₂ (practical salts) are given in Table 8 (Appendix 1) and shown in Fig.7. Mixed solution was used to compare with single salt, in order to assess the possibility of a possible coupling effect between MgCl₂ and NaCl. Intuitively, the mixed solution of NaCl and MgCl₂ should be less

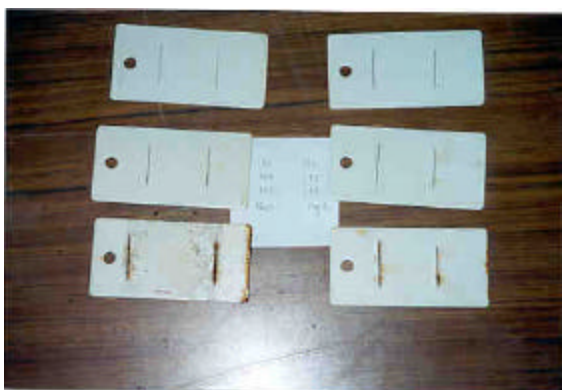
Figure 8: Coupons Corroded by a mixture of NaCl and MgCl_2 (practical salts)

For ACT coupons (i.e. ACT cold roll sheets, ACT Zn/Fe A45, and ACT E60 EZG), different chlorides used in the cyclic tests did not lead to any significant difference in the corrosion damage, as shown in Figure 8. The cold roll sheet was corroded by both NaCl and MgCl_2 to the same extent. However, no corrosion occurred to the other two ACT sheet materials, (ACT Zn/Fe A45 and ACT E60 EZG) even after the cyclic tests were extended from two months to four months. One should notice that a scratch which penetrated the coating layer was made on every ACT coupon. Previous research showed that the scratches help accelerate the corrosion of the metals. The tests indicate that the treatments of electroplating or the hot-dip alloying during the manufacturing of the coupons enable the two ACT coupons to withstand cyclic chloride corrosion.

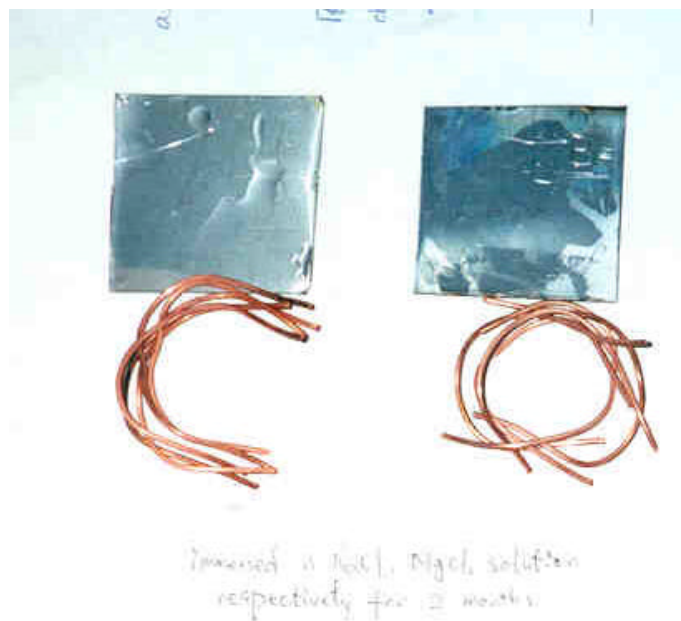
Figure 13: Immersion tests of SS410 and copper wires.

In order to confirm the role of oxygen in the electrochemical corrosion process, another experiment was performed, in which SS410 and copper wires were immersed in 30 wt.% NaCl solution and 30 wt. % MgCl_2 solutions for two months, respectively. Although the two materials suffered severe corrosion under other test environments, hardly any corrosion occurred in the immersion test (Figure13). This indicates the importance of oxygen in the corrosion process.

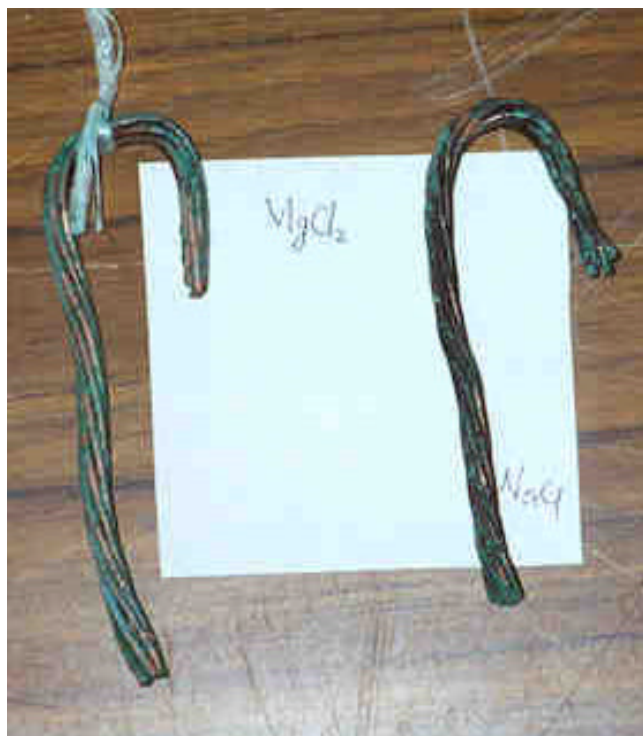
Figure 14: Corroded copper wires after SAE J2334 testing

The corrosion tests for copper tubes by both SAE J2334, In the test, two different chloride solutions were used with the same concentration (3.0 wt.%). Different corrosion damages were observed. The corroded coupons are shown in Figures 14. The photo indicate that MgCl_2 causes more severe corrosion to the copper specimens than NaCl . The coupons subjected to MgCl_2 solution had more green rust (CuO) on the corroded surface than that subjected to NaCl solution.

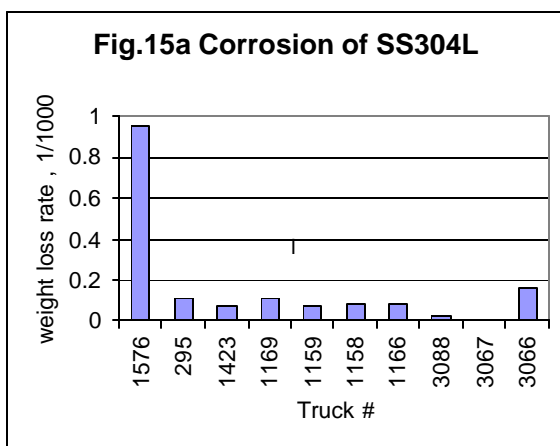
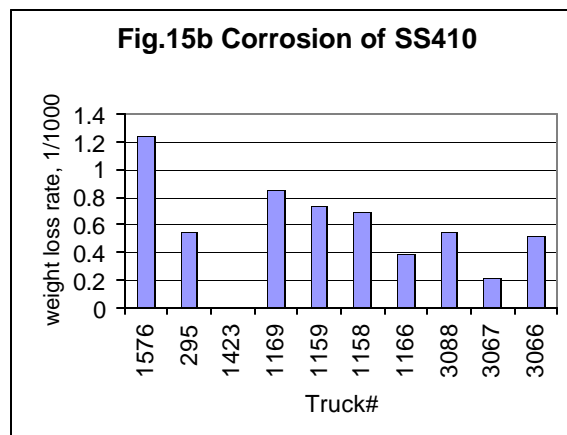
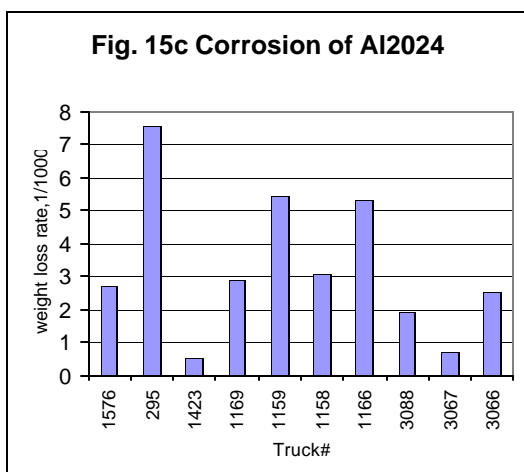
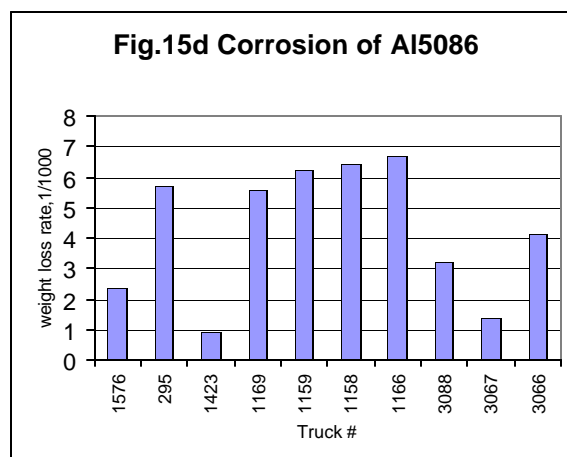
Figure 15 Corrosion rates of the coupons mounted on the trucks

Since the records of the salt application on these roads were not available. This in-service experiment did not lead to further conclusion.

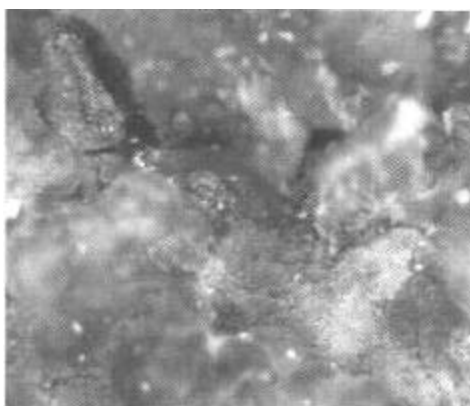
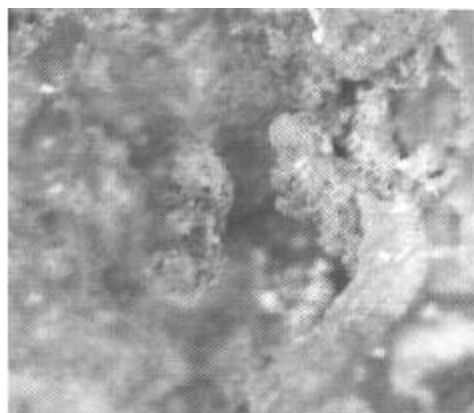
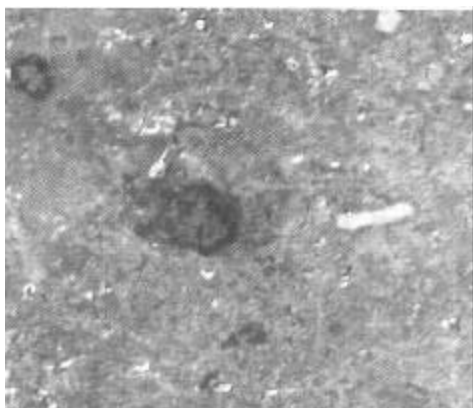
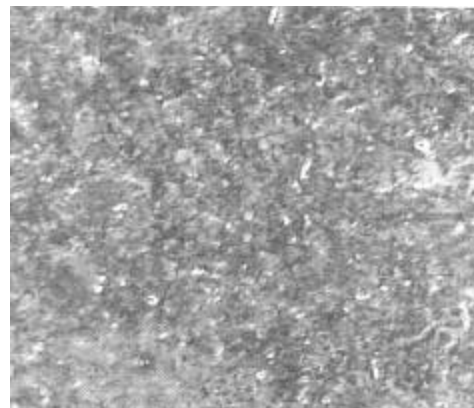
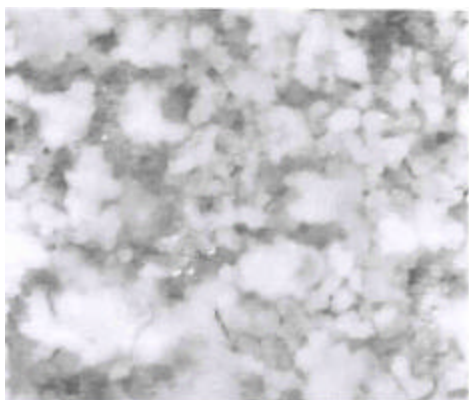
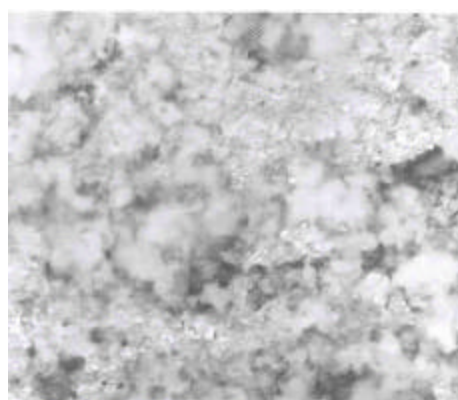
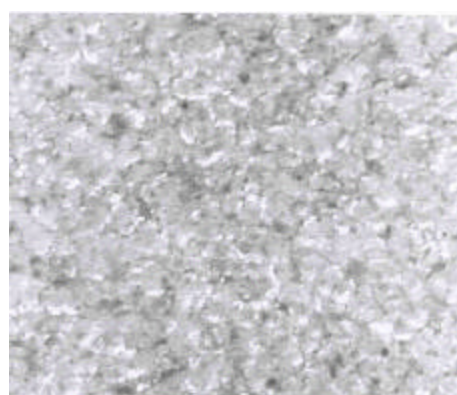
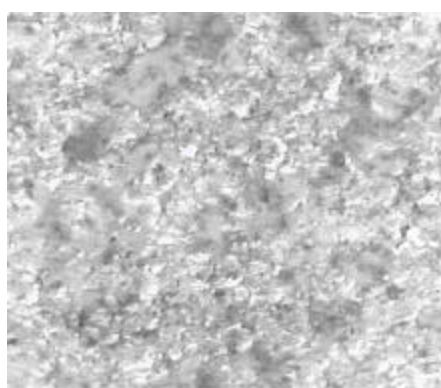
Figures 16: Microscope photographs of the corroded coupons subjected to the cyclic exposure corrosion test

In order to understand and further explain some of the test results, chemical and microscopic analyses were performed. Figure 16a through Figure 16h are the microscope photographs of the corroded coupons subjected to the cyclic exposure corrosion test. It can be seen that regardless of the corrosion medium used, the same morphological feature of the corrosion products is observed for the same metal. Different amounts of the corrosion products can be seen for different metals under attacks by different chlorides. All corrosion products are in amorphous or glass states.

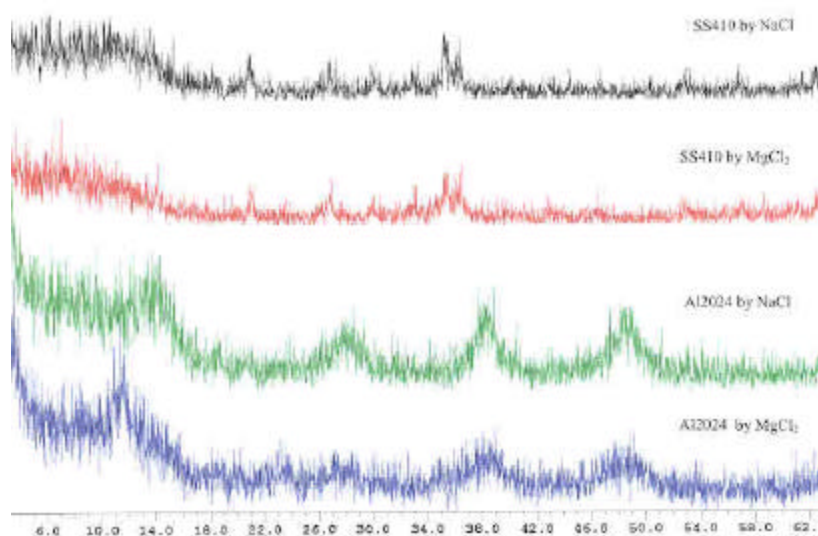
Figure 17: Corrosion products from SAE J2334 test, analyzed by XRD

The corrosion products collected from those coupons in SAE J2334 test were analyzed by X-ray diffraction (XRD) (see Figure 17). The XRD results show these corrosion products are aluminum oxide hydroxide (bohmite) for the aluminum, and a mixture of iron oxide (magnetite) and iron oxide hydroxide (lepidocrocite) for the steel. These corrosion products are in low crystallinity, without incorporation of chloride. Our results agree with the study by Kajiyama and his colleague (1995), who studied the chemical composition of the corrosion products of steel on vehicles used in North America, as well as the growth mechanism of the corrosion products. Quantitative analyses of the crystalline compositions were performed on the rust formed on the outer panel surface and in the crevice of the lapped portion on the vehicles. Characteristic regions of the rust compositions were found in the α -FeOOH/(Fe₃O₄ + γ -FeOOH)/(β -FeOOH + amorphous rust) ternary diagram. The rust from the crevice in the lapped portion contained more (γ -FeOOH + Fe₃O₄) than that from the outer steel panel.

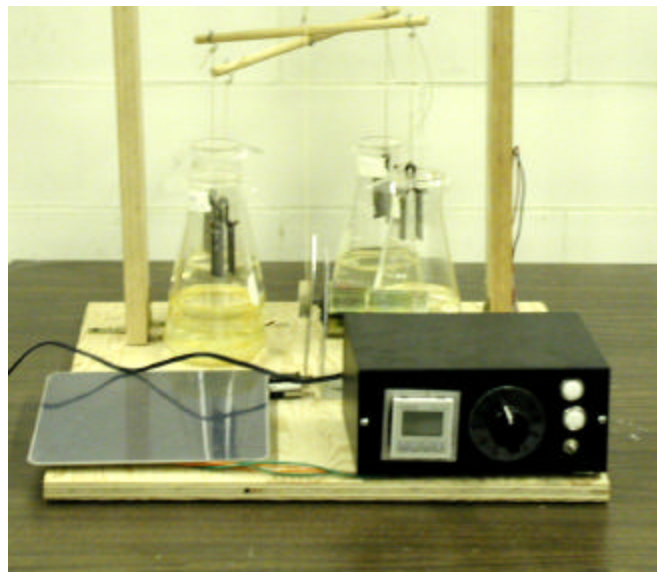
Fig.2-1 Experimental setup for the NACE TM-01-69 test

The corroded coupons were removed from the solution after 72 hours. They were placed in a beaker containing the cleaning acid, concentrated hydrochloric acid containing 50 g/l SnCl_2 and 20 g/l SbCl_3 . After 15 min. of cleaning the coupons were removed from the acid, rinsed with tap water and then distilled water, and wiped with paper tissue. The dried coupons were weighed for weight loss to 0.001g.

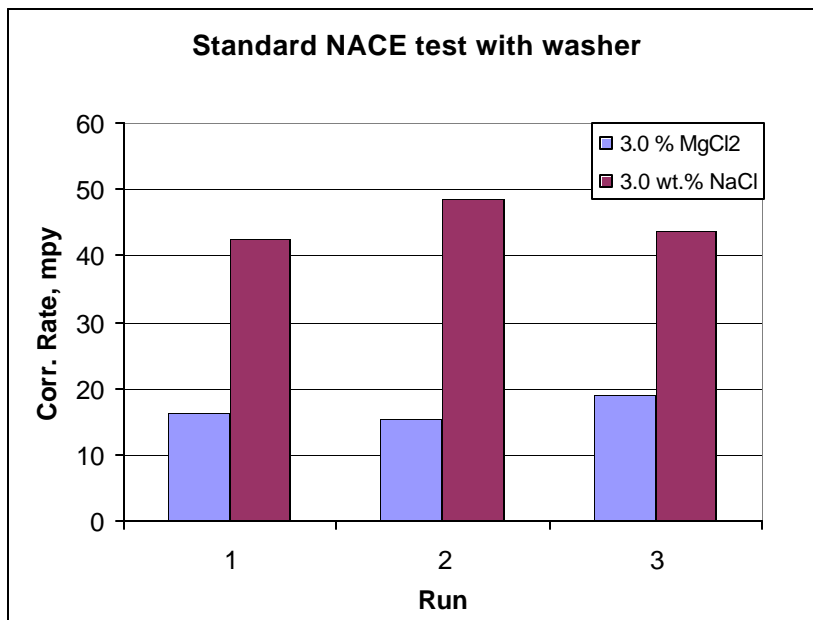
Fig. 2-2 Standard NACE test with washer as coupons

The results of three NACE tests were given in Table 2-1 (Appendix II) and diagrammatically shown in Fig. 2-2. The room temperatures of the testing laboratory were $26 \pm 1.0^\circ\text{C}$ ($79 \pm 1.7^\circ\text{F}$). One can see that MgCl_2 with inhibitor is less corrosive than NaCl , but not 70% less.

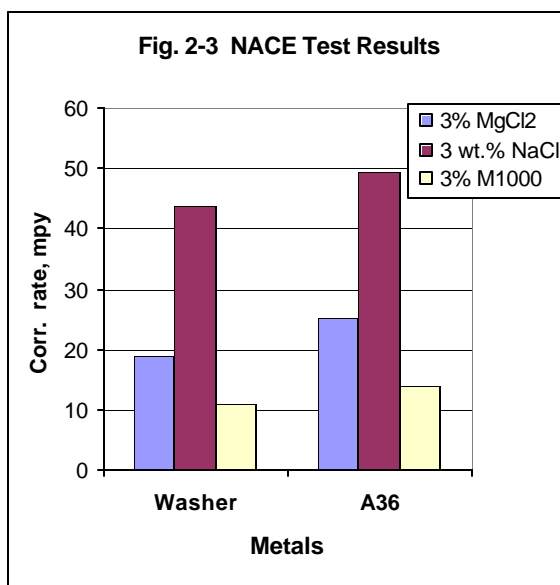
Fig.2-3 NACE test Results with washers and A36

In addition to the standard NACE test as shown above, modified NACE tests were carried out in the Phase II study. The modifications included the use of A36 steel coupons, and the use of various concentrations of MgCl_2 solutions. The test results are given in Figs. 2-3 and 2-4. Detailed test data can be found in Table 2-2 (Appendix II). From Fig. 2-3, one can see that NaCl caused the highest level of corrosion among the three deicing chemicals, and M1000 the least. The changes in the concentration of MgCl_2 solution in the range of 3% to 12% (or 0.84 wt.% to 3.36 wt.%) do not increase the corrosion rates of A36 and washer. To the contrary, a decreased tendency is observed (Fig.2-4). This may be due to the effect of inhibitor in the MgCl_2 solution, which has an increased concentration in the solution of 12% MgCl_2 . It is now very clear that using the NACE test, NaCl is more corrosive than MgCl_2 , even MgCl_2 solution is increased to the same level of the 3.0 wt. % as NaCl solution.

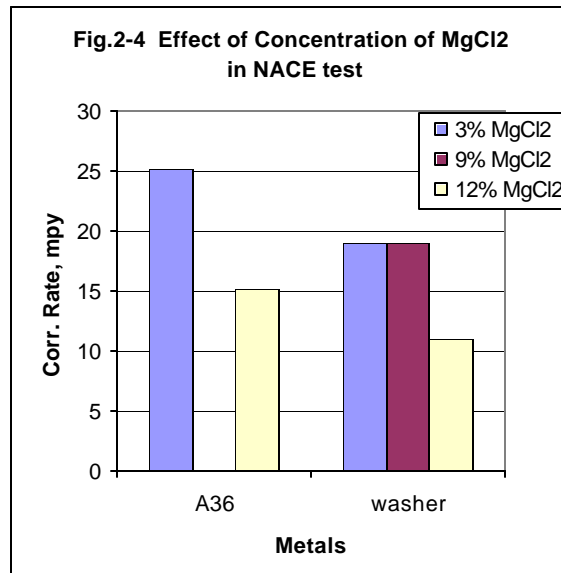
Fig. 2-4 Effect of concentration of MgCl_2 in the NACE test

Other metal coupons, i.e., SS410, SS304, Al2024 and Al5086, were also tested by the NACE method. However, the NACE test cannot create any significant corrosion on these metals, because the testing time of 72 hours is apparently too short to generate any detectable corrosion on the metals.

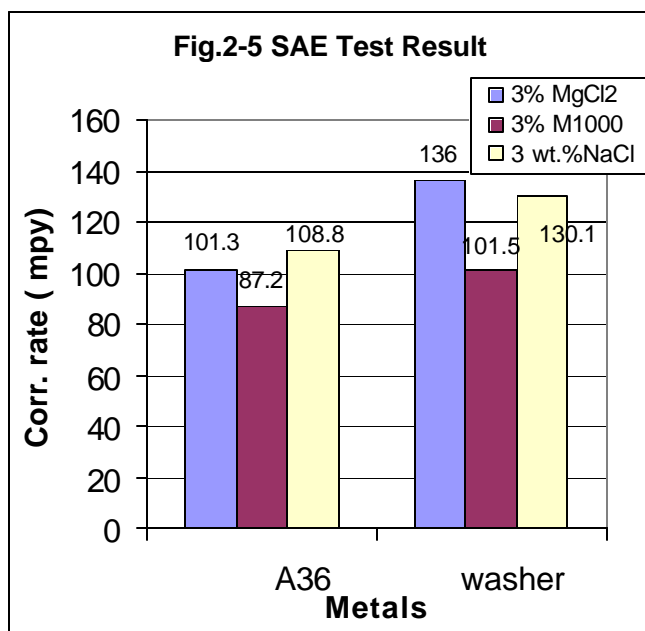
Fig. 2-5 SAE test results

These SAE tests continued for 58 days before stopped. The A36 and NACE washer coupons were cleaned by the same procedure as described early in the NACE test. It is very important to see that with A36 and washer as coupons, the corrosion rates resulted from NaCl and MgCl_2 solutions became comparable (see Fig.2-5), which is different from the results of the Phase I with other metals.

Another deicing solution, Caliber M1000 was also evaluated by the SAE test to compare with NaCl. The result indicated that when using NACE washer and A36 as testing coupons, 3.0% M1000 was less corrosive than 3.0 wt. % NaCl, or 3.0% $MgCl_2$ (Fig.2-5).

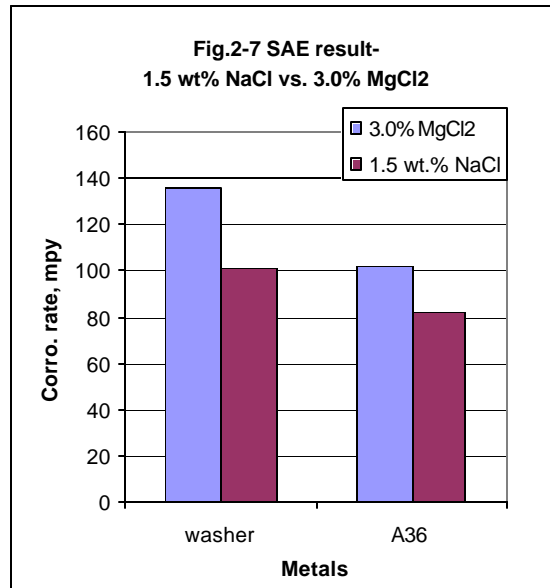
Fig. 2-7 SAE result- 1.5 wt. % NaCl vs. 3.0% MgCl₂

When the results from 1.5 wt. % NaCl solutions and 3.0 % $MgCl_2$ (or 0.84 wt. %) are compared, as shown by Fig. 2-7, $MgCl_2$ has a higher corrosion rate than NaCl. Therefore, the SAE test leads to a conclusion that $MgCl_2$ is more corrosive than NaCl for all three concentrations used in the tests (1.5 wt.%, 3.0 wt.%, and 6.0 wt.%). This conclusion, different from the NACE test, was further confirmed later by long term SAE tests of 81 days (see Fig. 2-14).

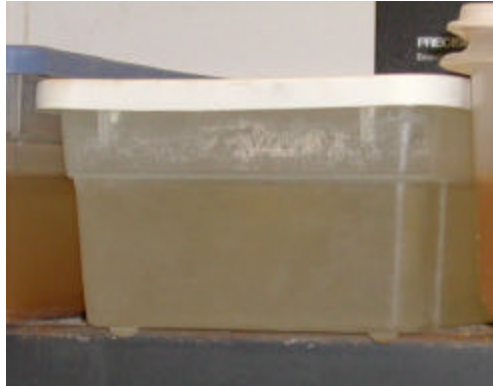
Fig. 2-8 Distilled water tank after 81 days

The SAE test with distilled water was started from August 18, 2001. After 81 days of testing, a very thin layer of rust appeared on the surfaces of A36 coupons and NACE washers. There was almost no visible rust on the surface of SS410 and Al2024 coupons. The water used as corrosion medium was clear without significant rust accumulation (Fig.2-8), which is an indication of the absence of rust accumulation.

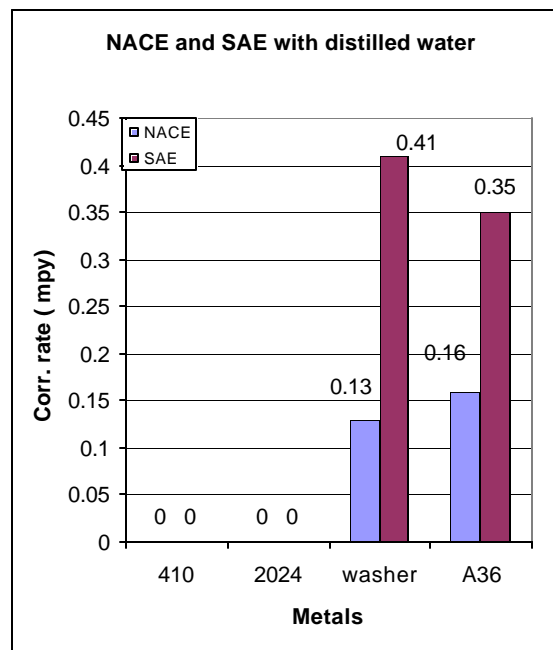
Fig. 2-9 Comparison of the NACE and SAE tests with distilled water

For the purpose of comparing the relative corrosiveness of the testing environments of the NACE method and the SAE method, distilled water was used as a corrosive solution in the two tests.

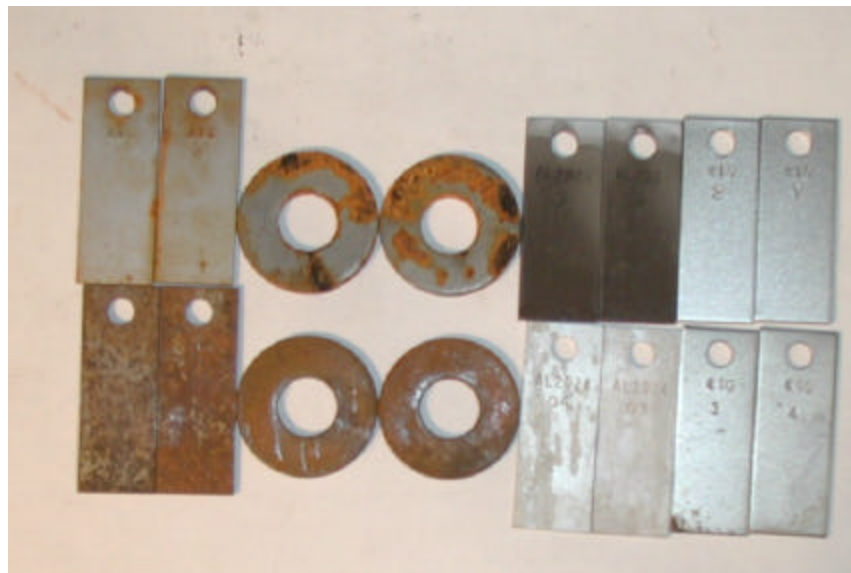
Fig. 2-10 Coupons exposed to distilled water
(Upper: from the NACE test of 109 days, lower: from the SAE test of 81 days)

The NACE test with distilled water was started from July 22, 2001. The testing period of the NACE test was extended significantly to compare with the testing period of the SAE test. After 109 days, the NACE test was stopped and the corrosion rate was measured. The calculated corrosion rates for the two tests are shown in Fig. 2-9. Comparing the SAE test to the NACE test with distilled water, it is evidenced that the SAE test had resulted in one to two times higher degrees of corrosion to the washers and A36 coupons. This suggests that the SAE test provides a much more aggressive testing environment than the NACE method, which may be due to the elevated temperature or high humidity, or the combination of the two. The appearance of the coupons before cleaning is shown in Fig. 2-10.

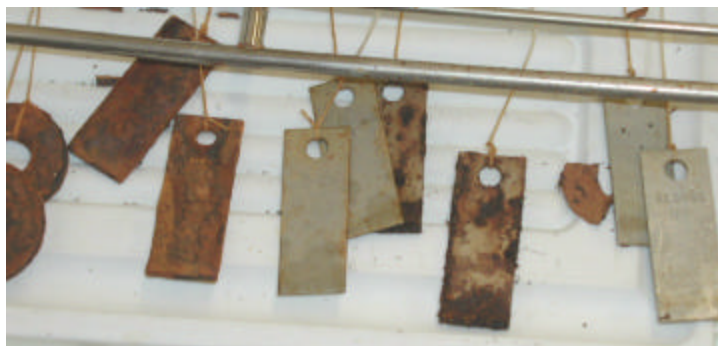
Fig. 2-12 The coupons of the SAE test at 20 days

The SAE tests with NaCl and $MgCl_2$ solutions were started from August 18, 2001 and stopped after 81 days. This test served as a confirmation test for the SAE tests conducted in the Phase I. In this test, both of the solution concentration of NaCl and $MgCl_2$ were increased to 3.0 wt.%, instead of 1.0 wt.% in the Phase I. Fig. 2-12 shows the appearance of the coupons after 20 days of test. Since the coupons of the same type of metals exhibit similar extent of corrosion when exposed to different solutions, a simple visual inspection of surface appearance cannot tell the difference (e.g. a thick layer of rust covers the surface of the coupons of mild steel). The exact level of corrosion must be evaluated by weight loss analysis. However, an approximate assessment can be made by observing the colors of the solutions used in the test, as shown in Fig. 2-13a Fig. 2-13b. From the figure, it is apparent that $MgCl_2$ is more corrosive than NaCl, which is consistent to the results obtained in the Phase I. This confirms the conclusion achieved in the Phase I that $MgCl_2$ is more corrosive than NaCl by the SAE test.

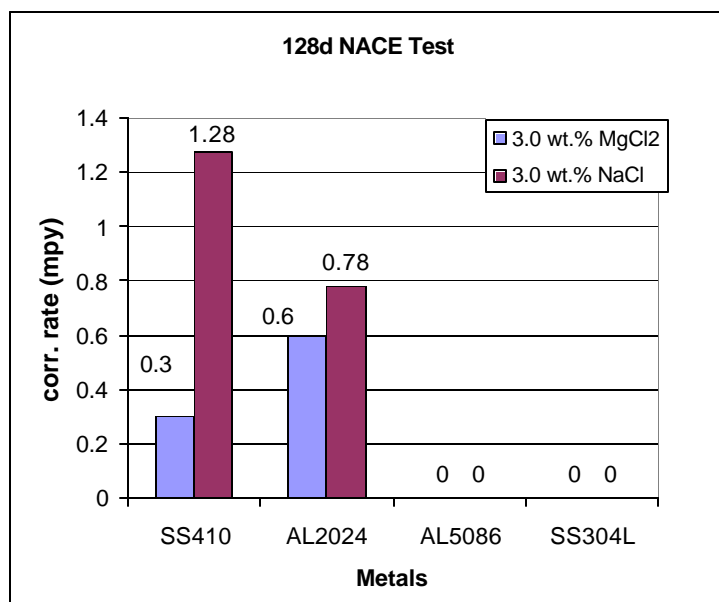
Fig. 2-15 128 days NACE test

From the NACE test, the MgCl₂ with inhibitors is much less corrosive than the NaCl (Fig. 2-15), regardless of the concentration of the solution and the testing duration used in the test. From the SAE test, however, the MgCl₂ with inhibitors is more corrosive than the NaCl (Fig. 2-14); the same results as obtained in the Phase I study.

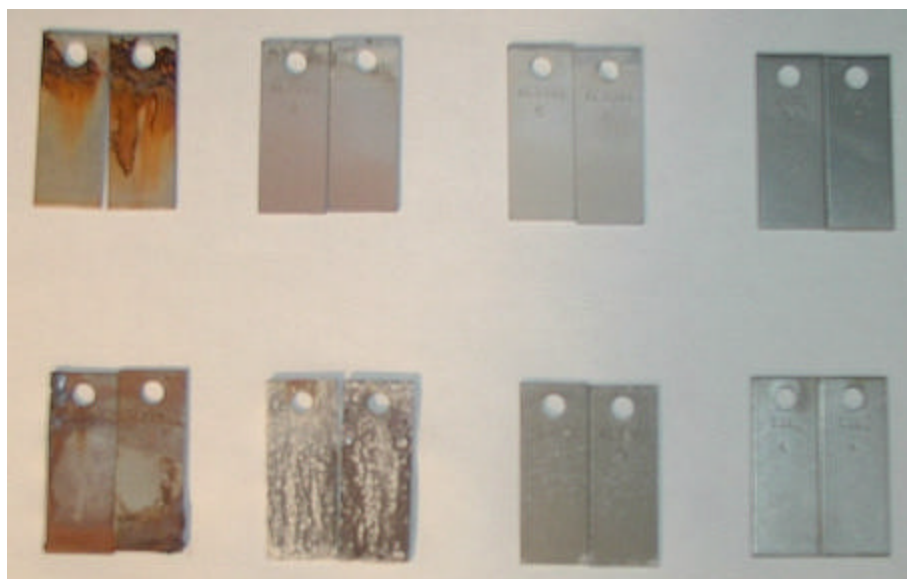
Fig. 2-16 Coupons after the NACE test

(Upper: exposed to the MgCl₂ solution, lower: exposed to the NaCl solution)

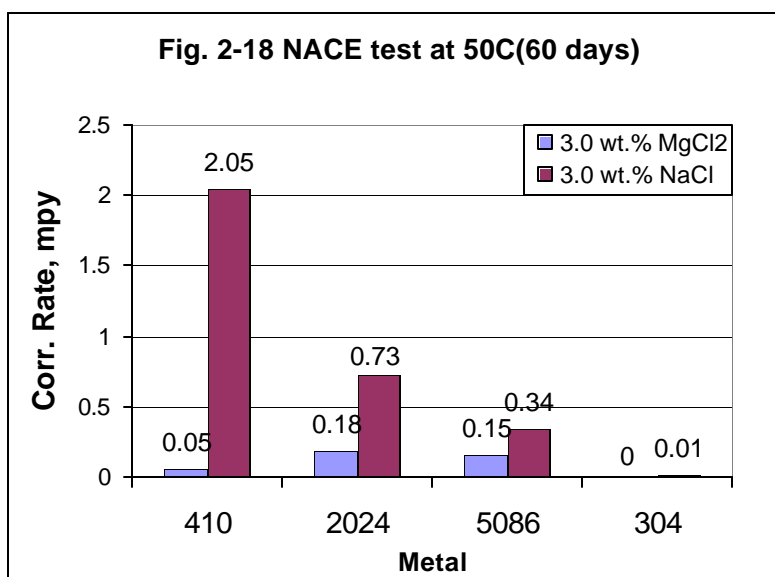
Fig.2-18 NACE test at 50°C (60 days)

Another major difference in the NACE test and the SAE test is the testing temperature. The NACE test is conducted under ambient temperature, while the SAE test is conducted under two elevated temperatures for the dry stage (60 °C) and the humidity stage (50 °C). In general, a higher temperature leads to a higher reaction rate. In order to assess the effect of temperature on the corrosion result, the NACE test was modified to have the testing temperature as 50°C (122 °F). At the same time, the immersion time of coupons in the solution was also modified. Instead of 10 min. in the solution and 50 min. in the air, the NACE test was modified to have coupons 30 min. in the solution and 30 min. in the air for each one-hour cycle. In this way, the contact time with chloride solutions is increased.

When the environmental temperature is increased to 50 °C, as in the modified NACE test, the surface of coupons becomes dried much faster. The contribution of the dry stage to the final corrosion result becomes even less. So, this modification can not alter the characteristic of the NACE test.

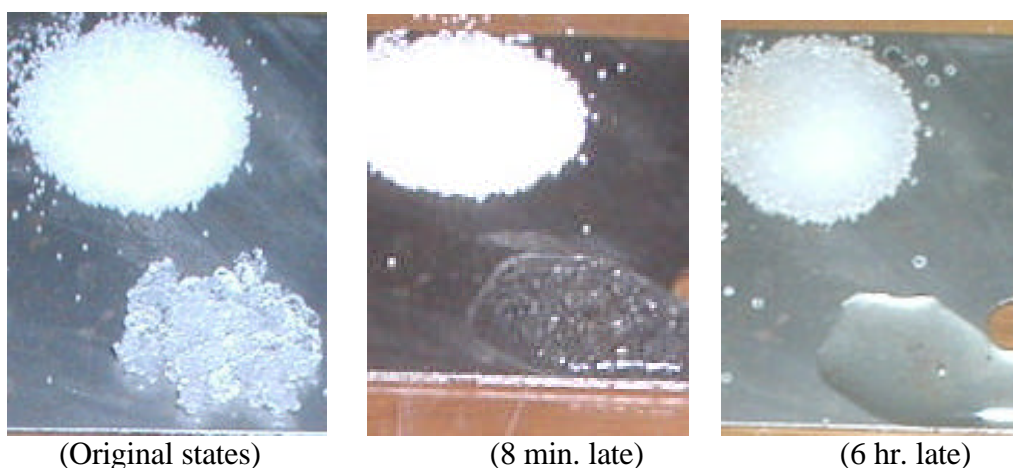
Fig. 2-20 Comparison of hydrophilicities between MgCl_2 and NaCl

A simple experiment demonstrates the difference in hydrophilic behaviors of the two chlorides and physical changes experienced by them during the dry-wet process: both sodium and magnesium chlorides are placed in a chamber of 50°C and 100% relative humidity. It is observed that MgCl_2 solid dissolves into solution by absorbing moisture within a few minutes, while NaCl remains in solid state even after six hours, as shown in Fig.2-20.

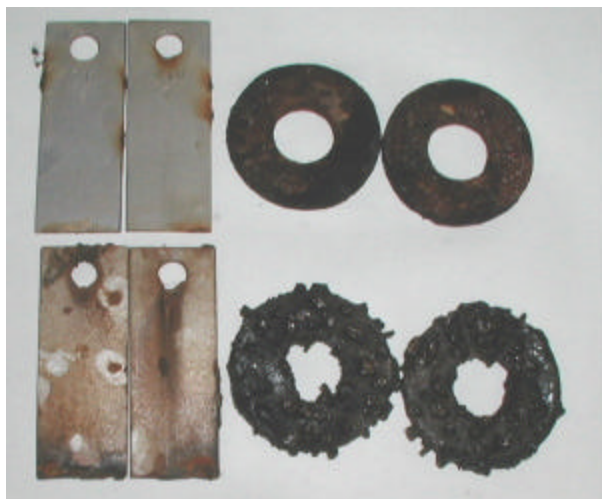
Fig. 2-22a Coupons in the NACE test at 50°C and 100% RH after 7 days
(upper: by $MgCl_2$; lower: by NaCl)

In this test, the coupons were placed in a chamber of 50°C and 100% relative humidity. The other testing conditions are the same as a standard NACE test, i.e. 10 min. dip in solution and 50 min. in air. The coupons in this test are either immersed in the solutions or stayed in saturated air. In both cases, the surface of the coupons was continuously covered by a liquid film. Therefore, this test is similar to a continuous immersion test. As expected, NaCl behaves more aggressively in this type of environment. The coupons tested by the modified NACE test after seven days are shown in Fig. 2-22a, which shows that NaCl solution indeed has higher corroding ability than $MgCl_2$. The corresponding corrosion rates are given in Fig. 2-22b.

This test consists of two stages in every 24-hour cycle: 15 min. dip in 25°C solutions, followed by a wet chamber stage (50°C, 100%RH) of 23hr. and 45 min., i.e., the SAE J2334 test without the dry stage. Compared to the modified NACE test at 50°C and 100% RH (Section 13.1), this test has shorter dip period and at lower temperature: only a 15 min. dip period every 24 hours under 25°C. It can be seen from Figs. 2-24a and 2-24b that the results obtained by this test are different from those present in Section 13.1. The difference reflects the importance of immersion stage and its condition to the corrosion results. In the NACE test, the coupons are immersed in hot solutions of 50°C and have a total immersion time of $10 \times 24 = 240$ min. every 24 hours. As result, NaCl resulted in severe corrosion, as observed from Fig. 2-22a. In the case of the SAE test without the dry stage, the coupons have only a 15 min. dip period in 25°C solutions every 24 hours, as a result, the corresponding corrosion is much less severe than the NACE test (compare Fig. 2-22a and Fig. 2-24a).

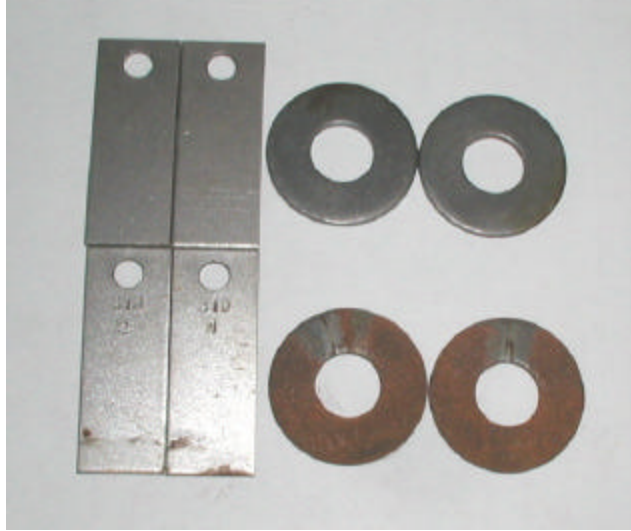
Fig. 2-23a Coupons by the SAE test without the wet stage after 7 days
(Upper: by MgCl_2 ; lower: by NaCl)

This test consists of two stages in each 24-hour cycle: 15 min. dip in 25°C solution, followed by a dry stage of 23 hr. and 45 min. (60°C, 50% RH), i.e., a SAE J2334 test without the wet stage. As mentioned before, the coupons will become dry soon after placed in the dry chamber. It is very difficult for the corrosion to take place in the dry stage. Therefore, the corrosion during this modified SAE test takes place almost solely within the 15 min. dip stage in every 24 hours cycle. So, it is an intermittent immersion test, similar to the standard NACE test. The coupons tested for seven days are shown in Fig. 2-23a and the corrosion rates are given in Fig. 23b. It is very clear that minor corrosion was developed on the washer subjected to NaCl, consistent with the standard NACE test data, and all other coupons remained intact.
