# **SHORT-TERM CRACK SEALANT PERFORMANCE AND REDUCING BUMPS AND TRANSVERSE CRACKING IN NEW HOT MIX ASPHALT OVERLAYS OVER CRACK SEALANTS**

**Scott Shuler**

**November 2009**

**COLORADO DEPARTMENT OF TRANSPORTATION  
DTD APPLIED RESEARCH AND INNOVATION BRANCH**

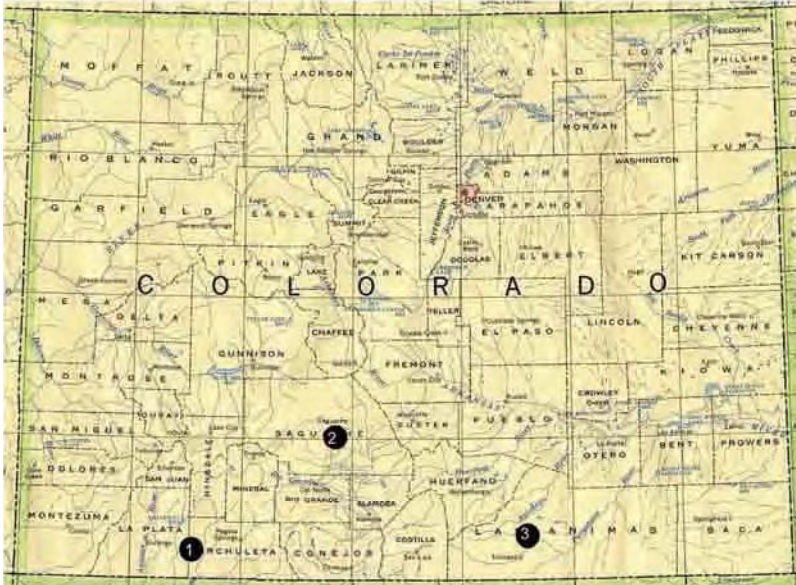
**Figure 2. Experiment Site Locations**

(location 1) from the intersection of US 160 south from milepost 30.02 to 32.70, on US 285 south of Saguache, CO from milepost 82.98 to 85.08 (location 2) and on US 350 northeast of Trinidad, CO from milepost 20.51 to 23.20 (location 3) as shown in Figure 2.
