COLORADO RIVER FLOOD RISK ANALYSES

**Connected Lakes
Duke Lake
30 Road Pond
Corn Lake
Island Acres Ponds
Parachute Pond
Rifle Rest Area Pond**

the Colorado Water Conservation Board

January 1995

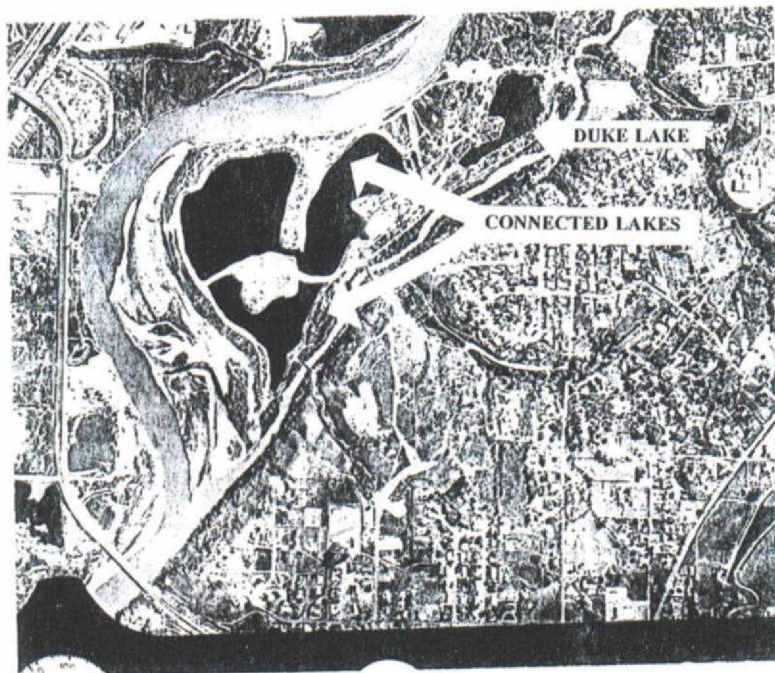
1994 Condition

Aerial photographs of flooding at Connected Lakes in 1984 and 1993 and a photograph of present conditions at the state park are included on the preceding two pages.

Connected Lakes and Duke Lake were entirely inundated in 1983 and 1984. Due to the protection provided by the levee system constructed for Connected Lakes in 1991 and by the Pepsi-Cola Plant levee system and due to smaller flows, no flood inundation occurred during the 1993 flood event. That levee construction led to higher stream velocities. This reach of the Colorado River was already subject to severe bank erosion and channel migration before the levee construction. During the 1983 and 1984 floods part of the river was flowing through the site. The constriction caused by the levee work has made those problems more severe because of the higher flood stages and velocities. The entire area lies within the 100-year floodplain.

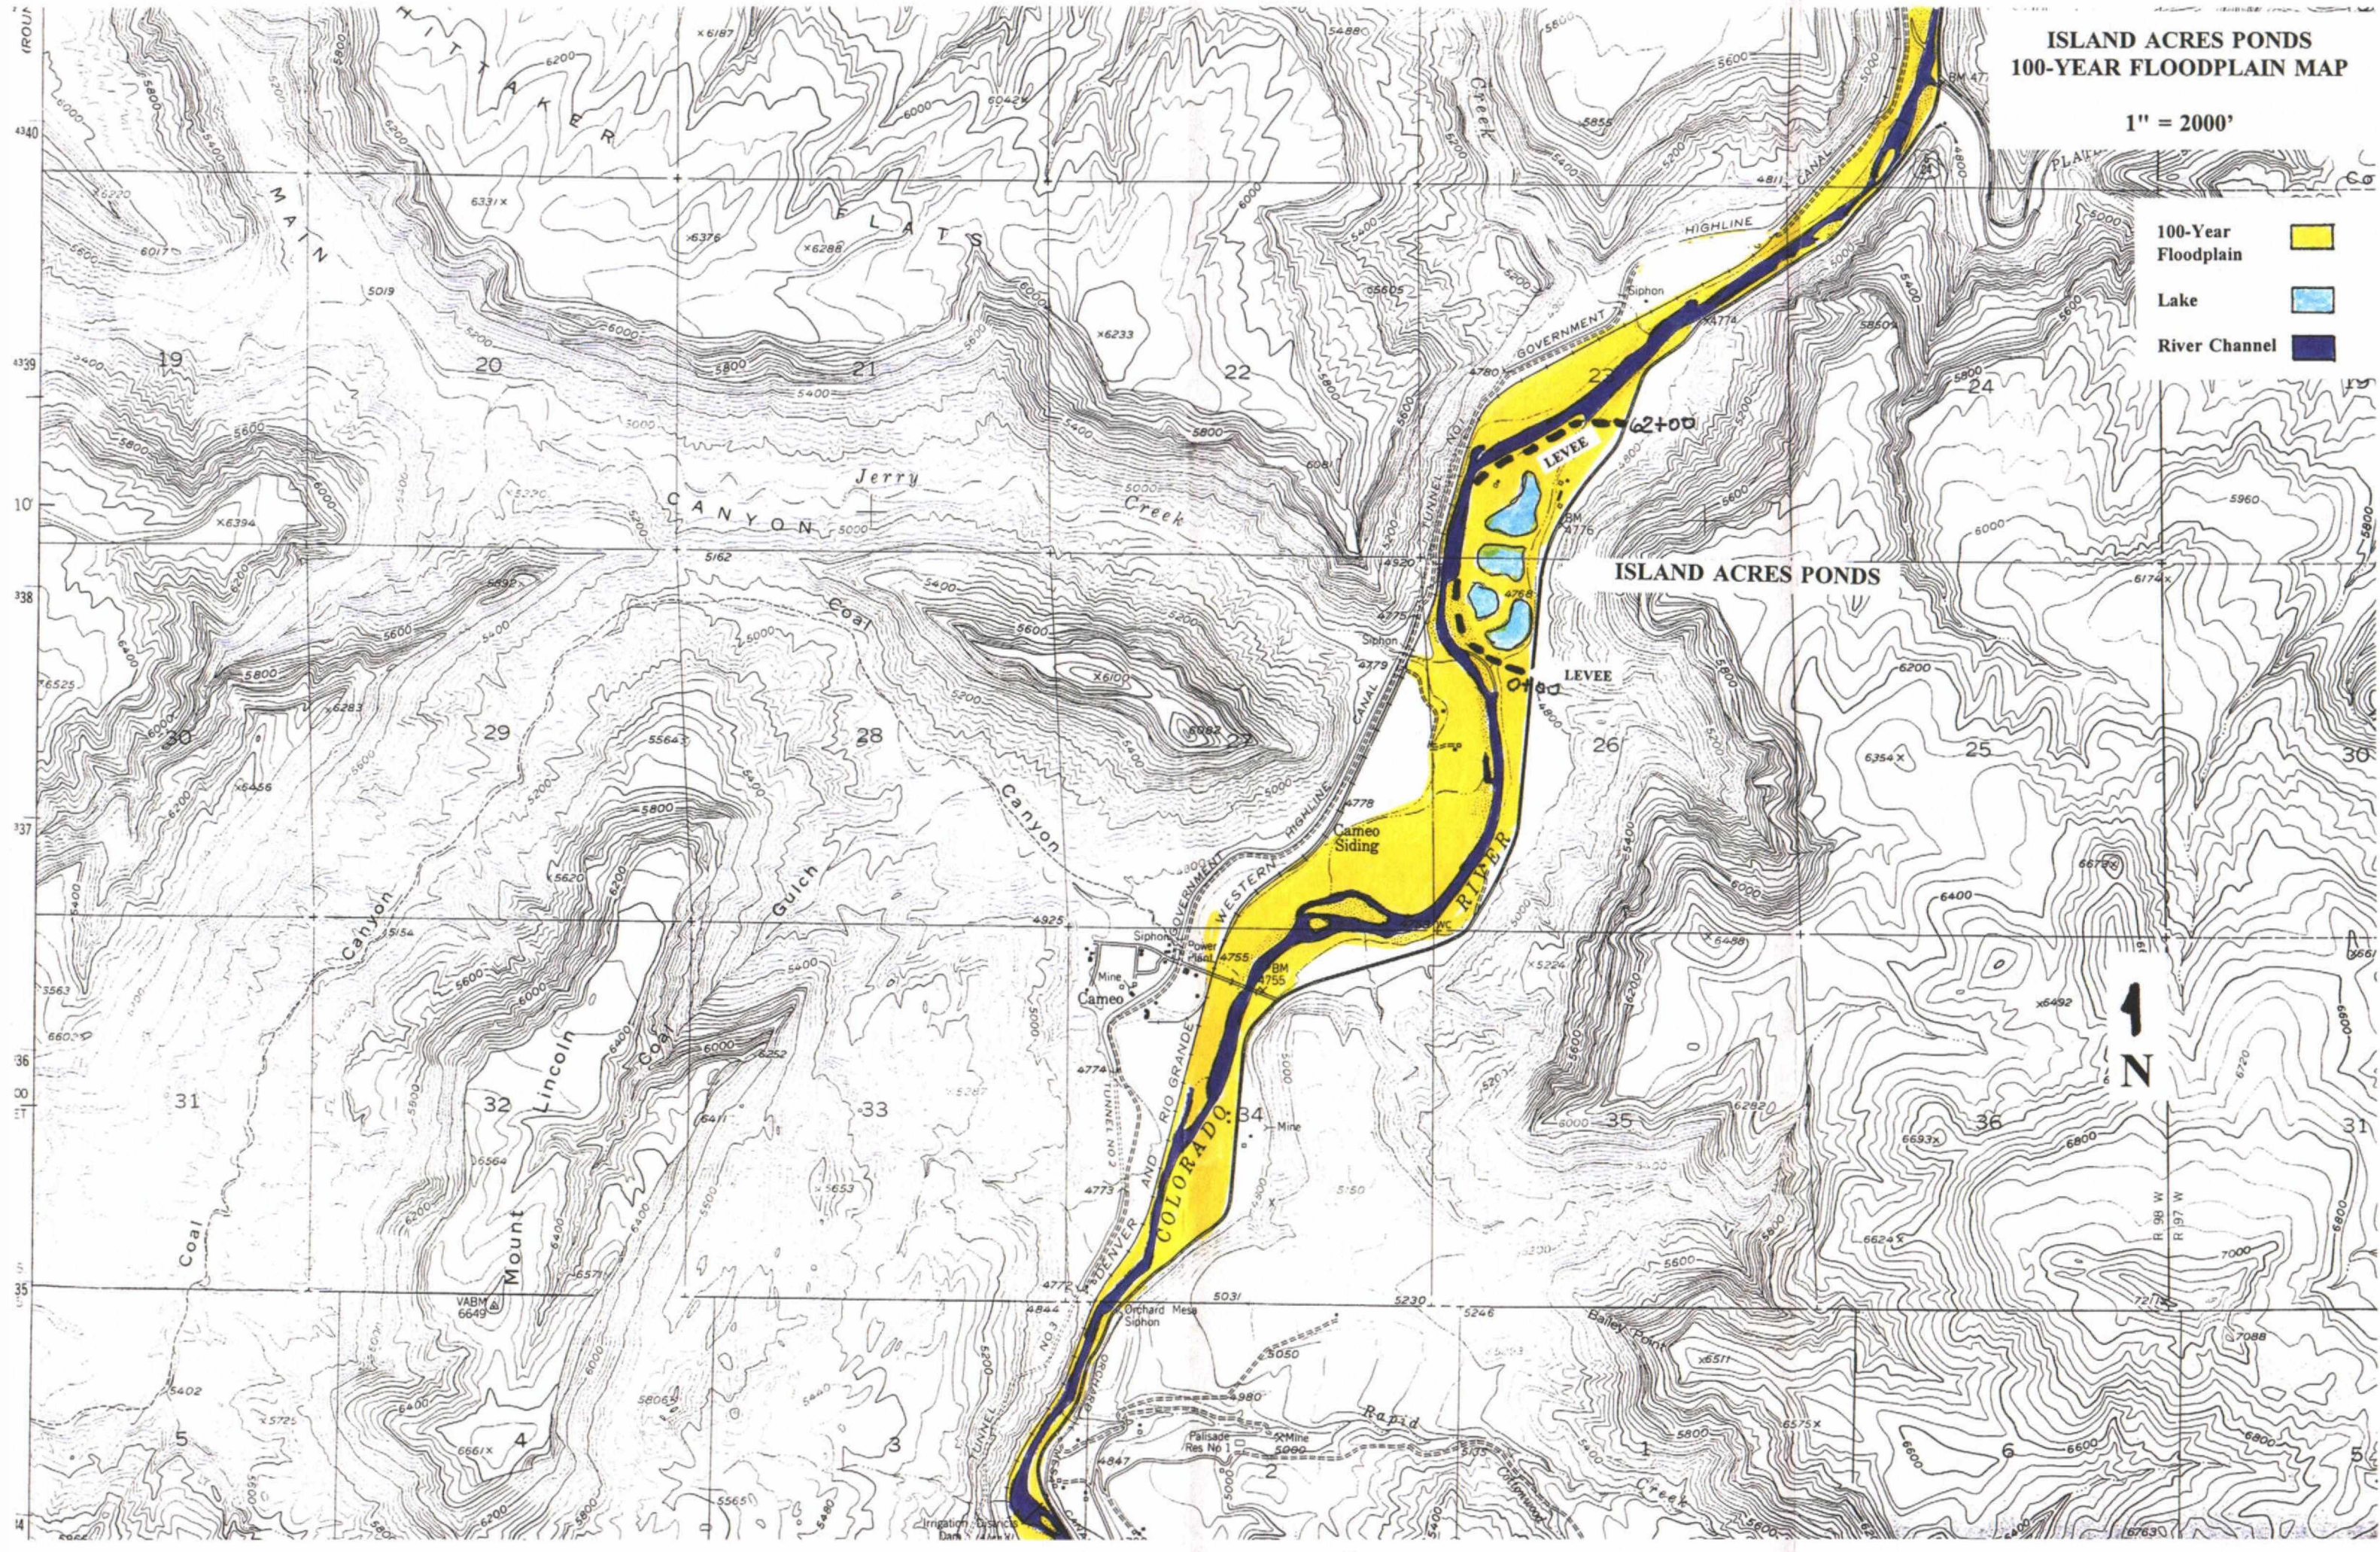
An aerial photo of flooding at Island Acres State Park in 1993 is included on the preceding page. Unfortunately no photos of flooding in 1983 or 1984 were available. There was some anecdotal information about the flooding there, however. In both years the site was inundated. In 1984 the flood damage was severe enough to warrant emergency recovery assistance from FEMA as part of the Presidential Disaster Declaration. The one pond that was in the park at that time was inundated. (The other ponds were excavated after the 1984 flood.) The pre-existing levee that had been destroyed was rebuilt through that project. In 1993 floodwaters came within 2 or 3 feet of overtopping the levee which was constructed along the riverbank in 1985. In the 1993 photo it appears that the southernmost pond (the pond that is the furthest downstream) experienced seepage from the river, indicating a need for greater protection above ground and below ground.

During a 50-year or a 100-year flood there would be a problem at Island Acres. The 4 ponds at in the State Park, along with almost all of the park, are in the 50-year and 100-year floodplain. The levee along the southeast bank of the Colorado River does not provide 50-year protection. 50-year and 100-year floods would create a direct connection between the pond and the Colorado River. The park and its contents are subject to high flood risk. The existing levee, rebuilt with FEMA disaster recovery funds, was not designed to meet 50-year or 100-year flood protection standards and may even fail during a 10-year flood event.
