PROCEEDINGS of the 33rd ANNUAL HIGHWAY GEOLOGY SYMPOSIUM

ENGINEERING GEOLOGY and ENVIRONMENTAL CONSTRAINTS

PROCEEDINGS OF THE 33RD ANNUAL
HIGHWAY GEOLOGY SYMPOSIUM

Engineering Geology
and
Environmental Constraints
in
Vail, Colorado
1982

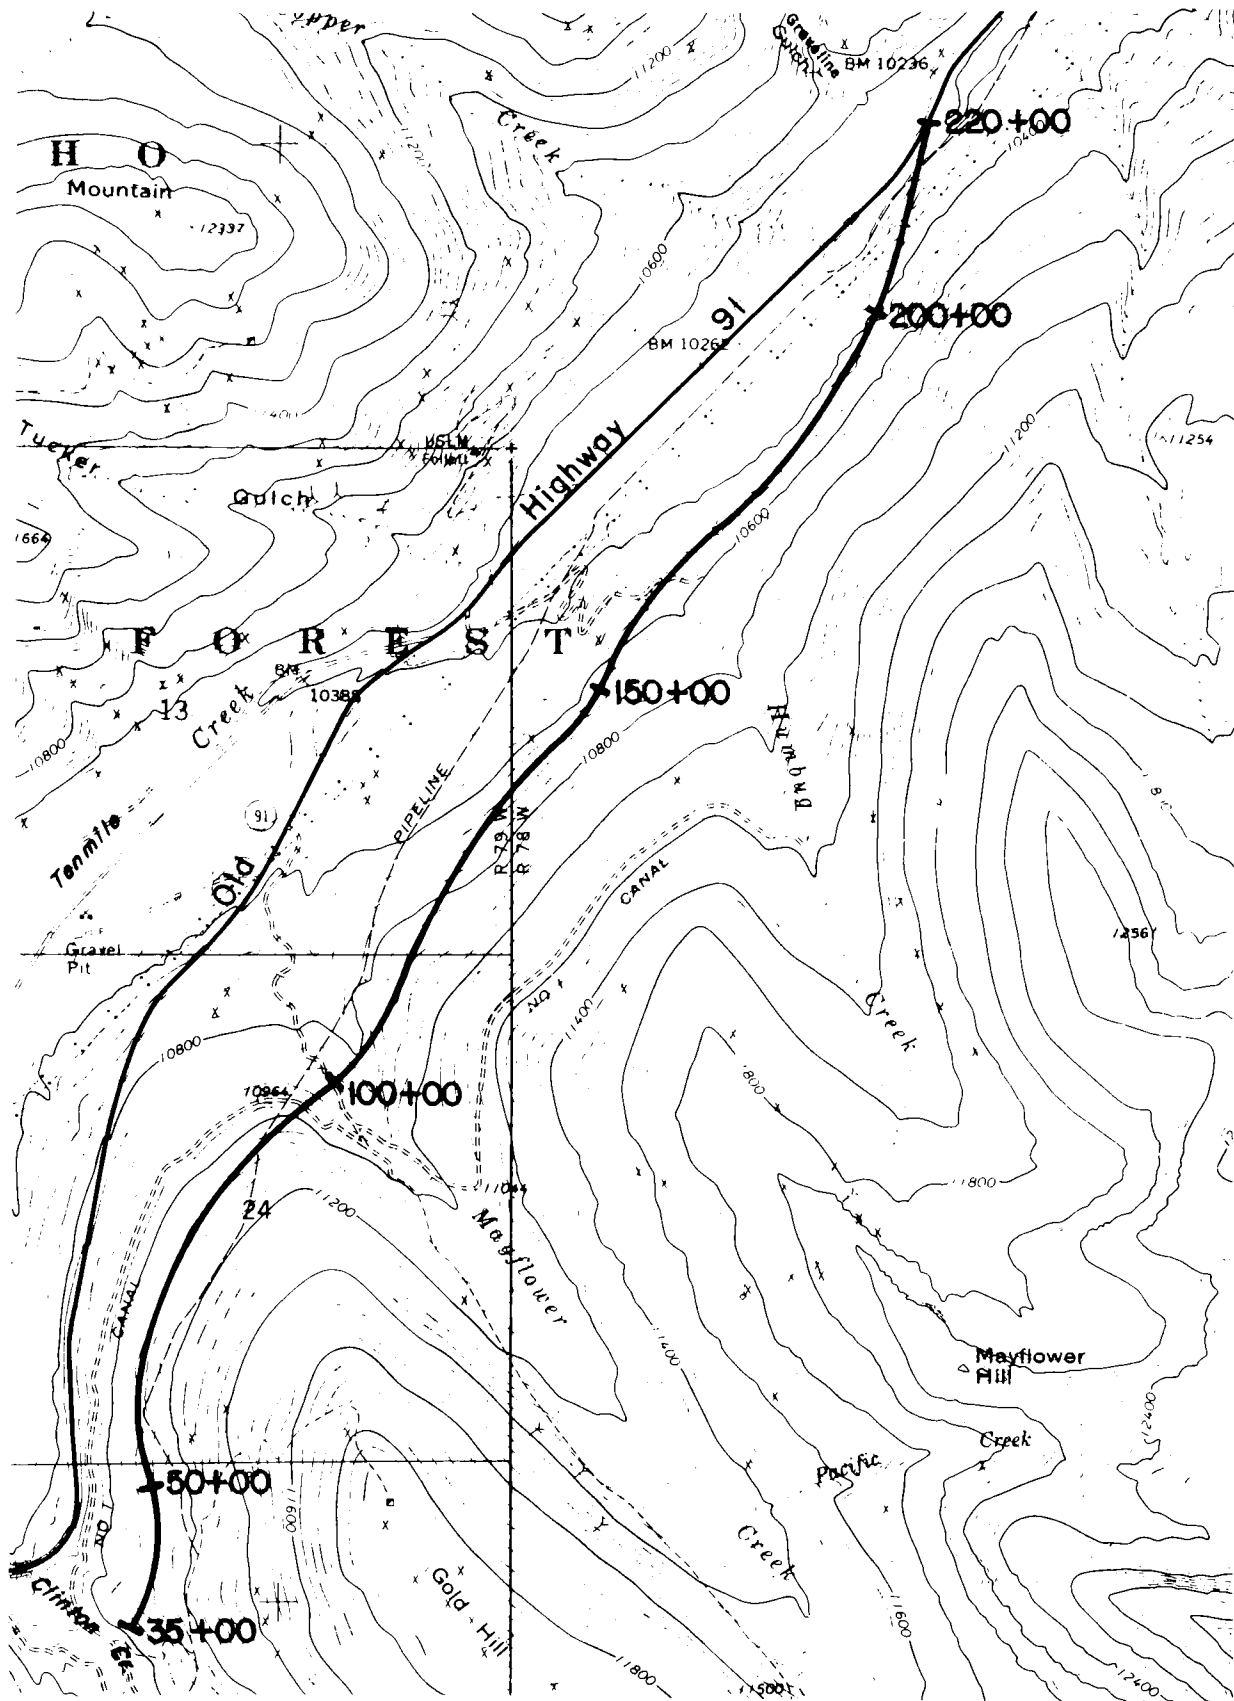
Figure 1. Highway 91
Relocation

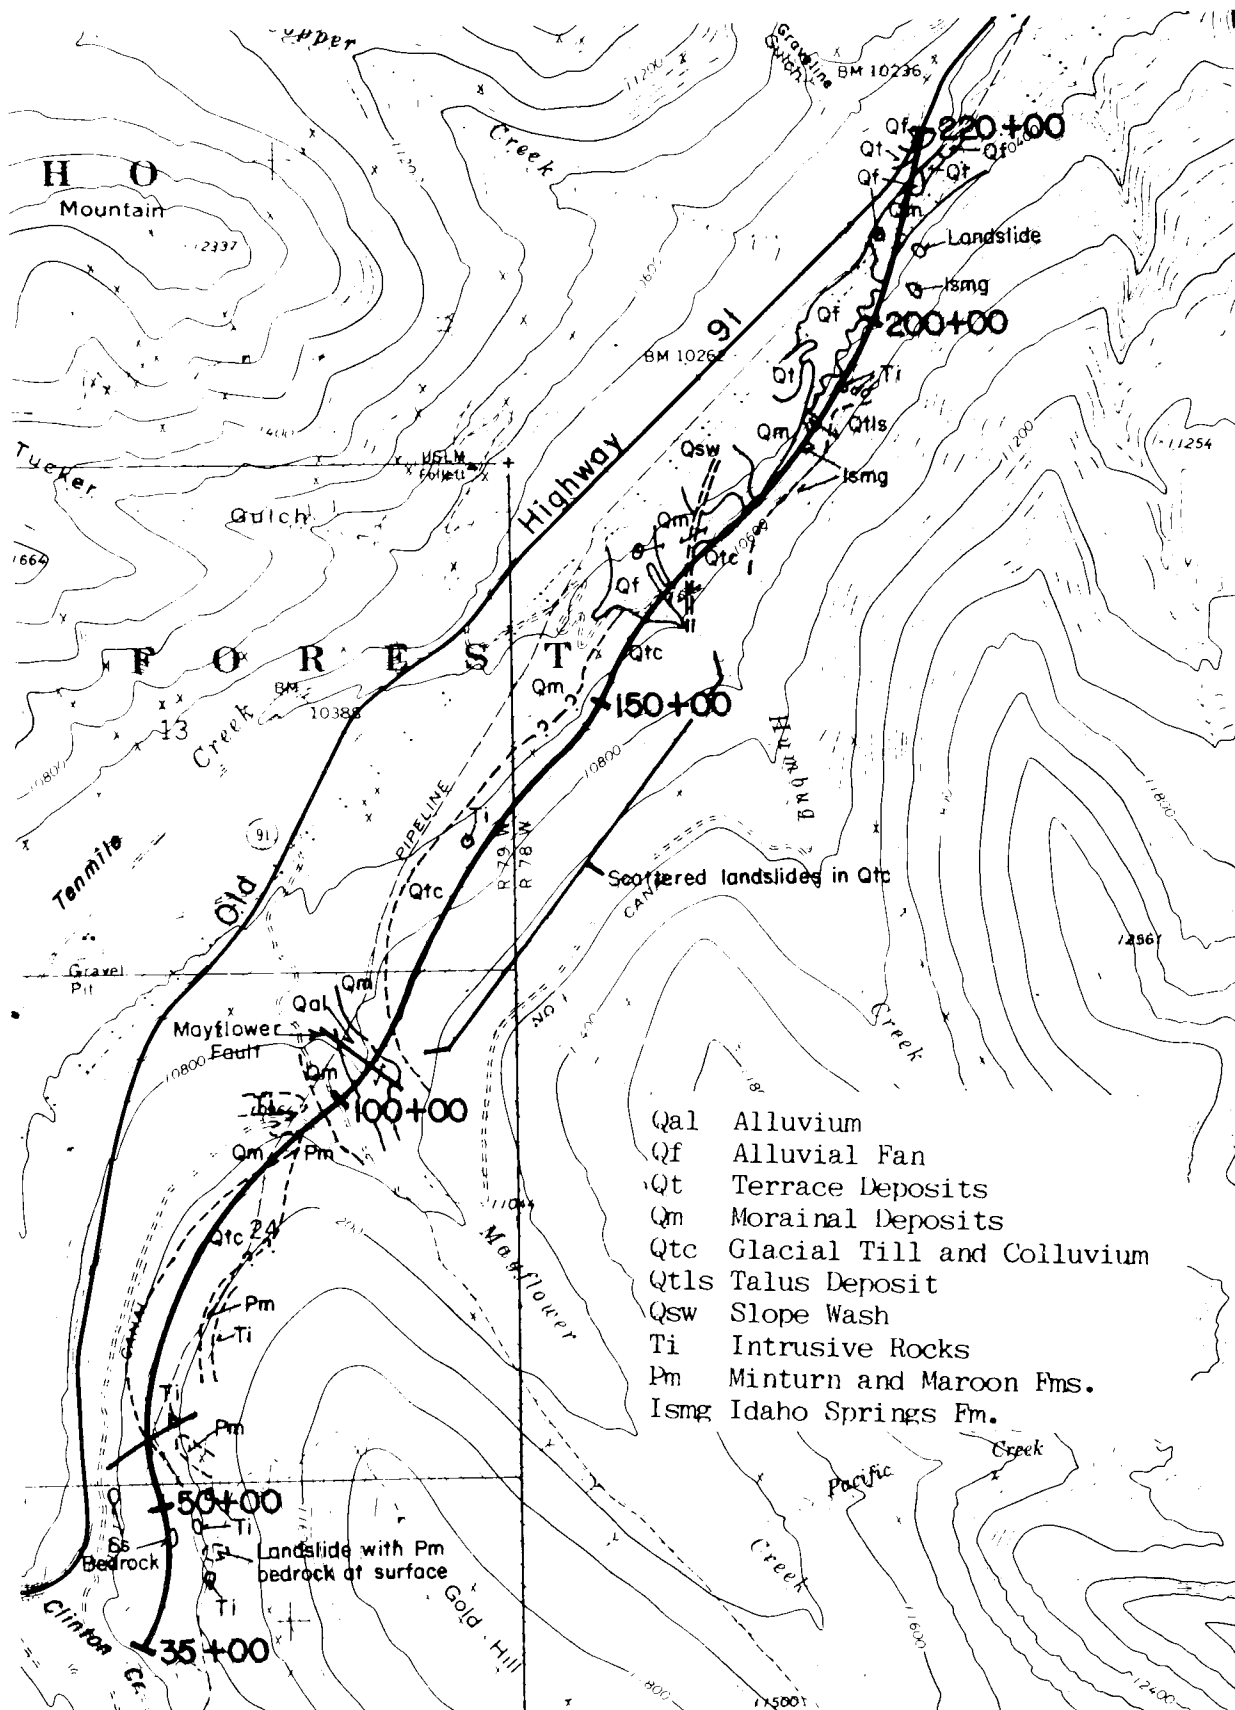
Figure 2. General Geology

The trace of the unnamed southernmost fault is shown in Figure 2. Downhill from where it crosses the alignment the fault is marked by numerous seeps and springs, hummocky ground, and small-scale failures in cuts, fills and natural slopes. This area is apparently part of an old landslide. If this fault is exposed in bedrock cuts, it could be a source of water and an engineered drainage plan may be needed to correct any adverse water problems.

The Mayflower fault intersects the alignment as shown in Figure 2. A zone 300 feet wide on the northeast side of the fault includes a large area of spongy, hummocky ground with many seeps, leaning and "pistol-butted" trees and signs of surface instability. A series of pronounced

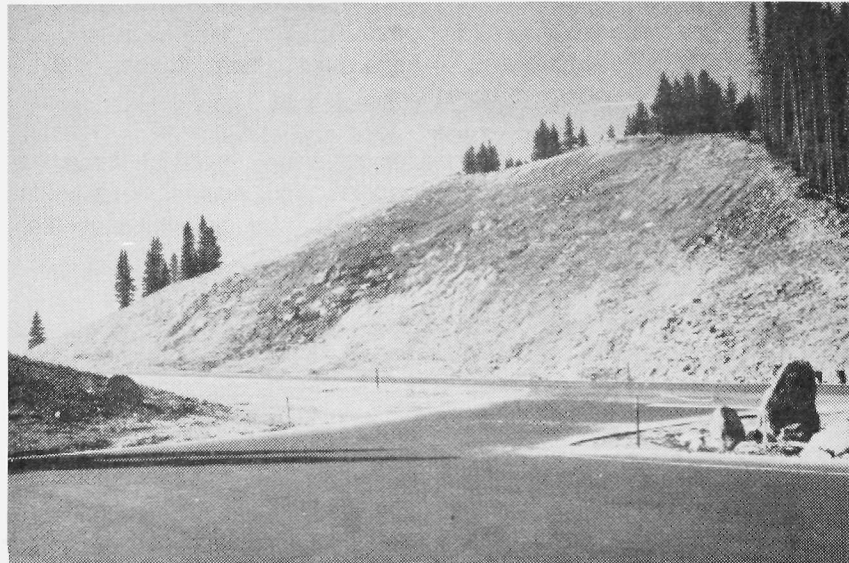
Figure 3. Exposure of Minturn-Maroon Formations in west side of road cut on south side of Clinton Dam.

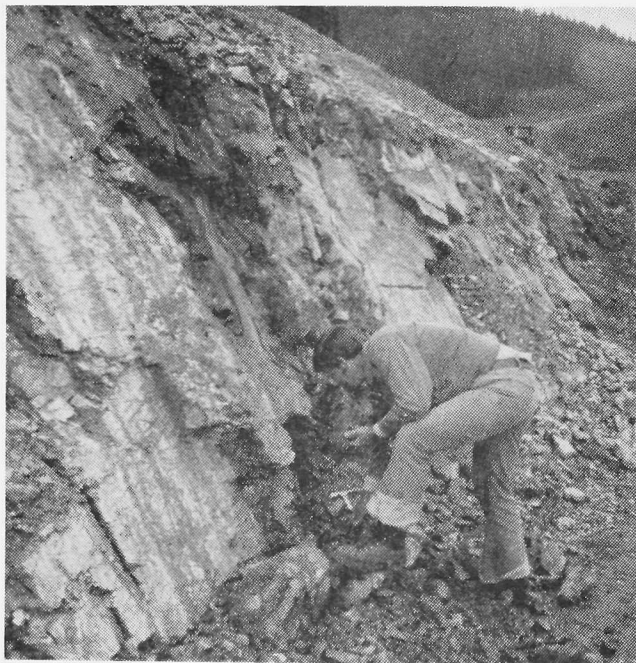
Figure 4. Exposure of Tertiary intrusive rock in trench dug on south side of Mayflower gulch.

The igneous intrusives of Tertiary age in the study area are quartz monzonite porphyries which should be relatively sound and stable in their unaltered state (see Fig. 4). If these rocks are encountered in a weathered and(or) fractured condition at grade along the alignment they could cause stability problems.

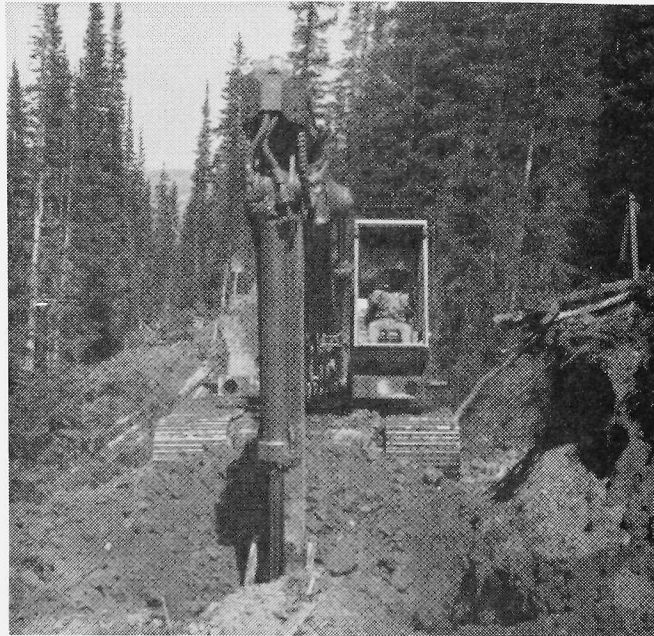
Figure 5. Backhoe in operation on pioneer road in "tenderloin" area.

Exposures of intrusive rocks in outcrops or test pits along the alignment were dug easily with a backhoe because they were weathered and well jointed (see Figs. 5 and 6). These rocks should prove to be rippable close to the surface where frost action and weathering have weakened them.

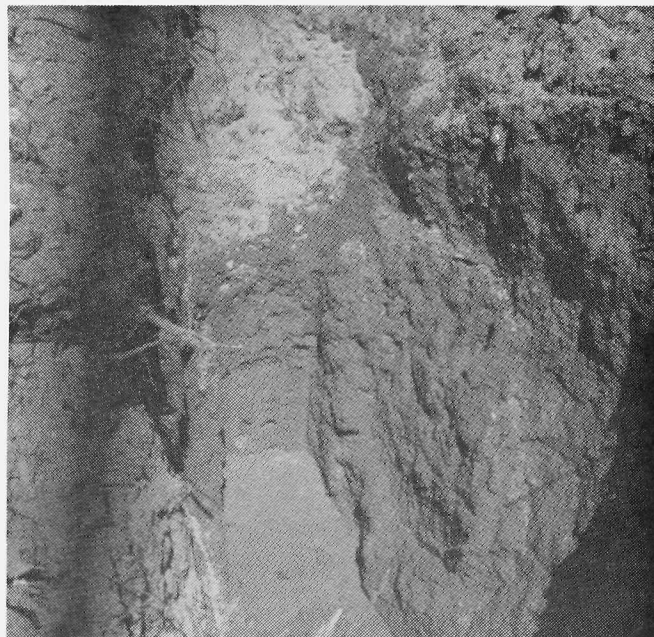
Figure 6. Backhoe pit in jointed and weathered Tertiary intrusive rock, "tenderloin" area.

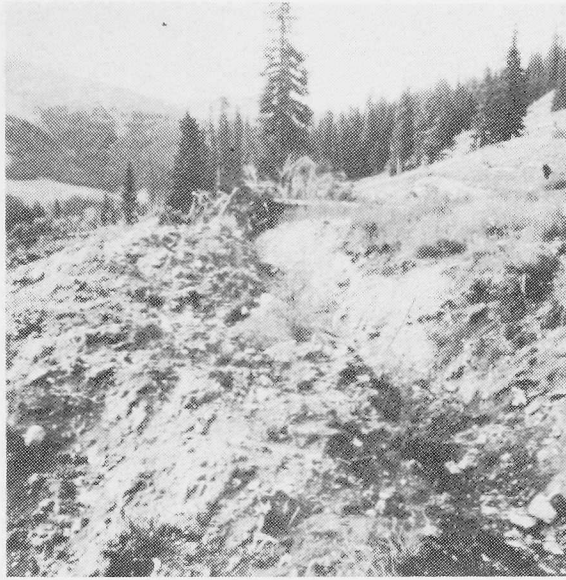
Figure 7. Glacial till exposed above Borrow Area B. Material on left (west) has slumped; note light-colored scar marking uphill limit of slump.

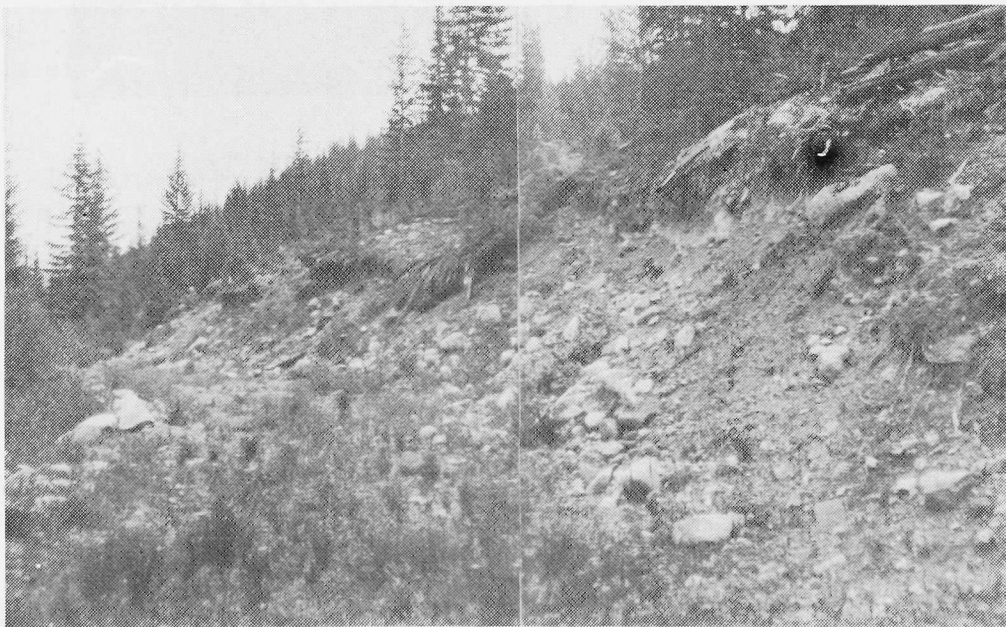
Figure 8. Glacial till exposed in old drill site road at about Sta. 164+50.

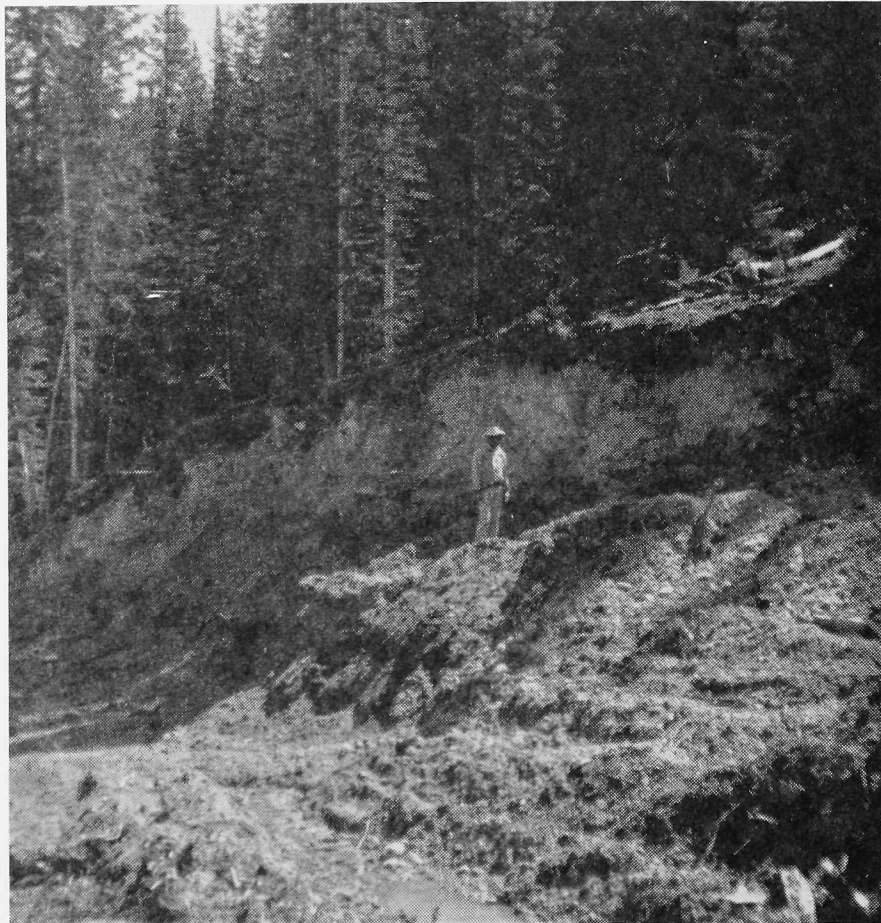
Figure 9. Slump in cut for drill road at about Sta. 124+50. After cut was made slumping apparently occurred in several episodes.

In moist, poorly drained areas, such as the "tenderloin" (Stas. 115+00 to 157+00), which exist along the alignment, disruption of the surface material in any way is likely to cause failure (see Fig. 9). Engineered drainage and slopes appear to be the most readily applied corrective measures in this situation. Additional engineering design (i.e. retaining walls and armored slopes) may be needed in specific locations. Removal and replacement of some of this material is suggested as a remedial measure if zones of high clay content or organic matter are encountered during construction.

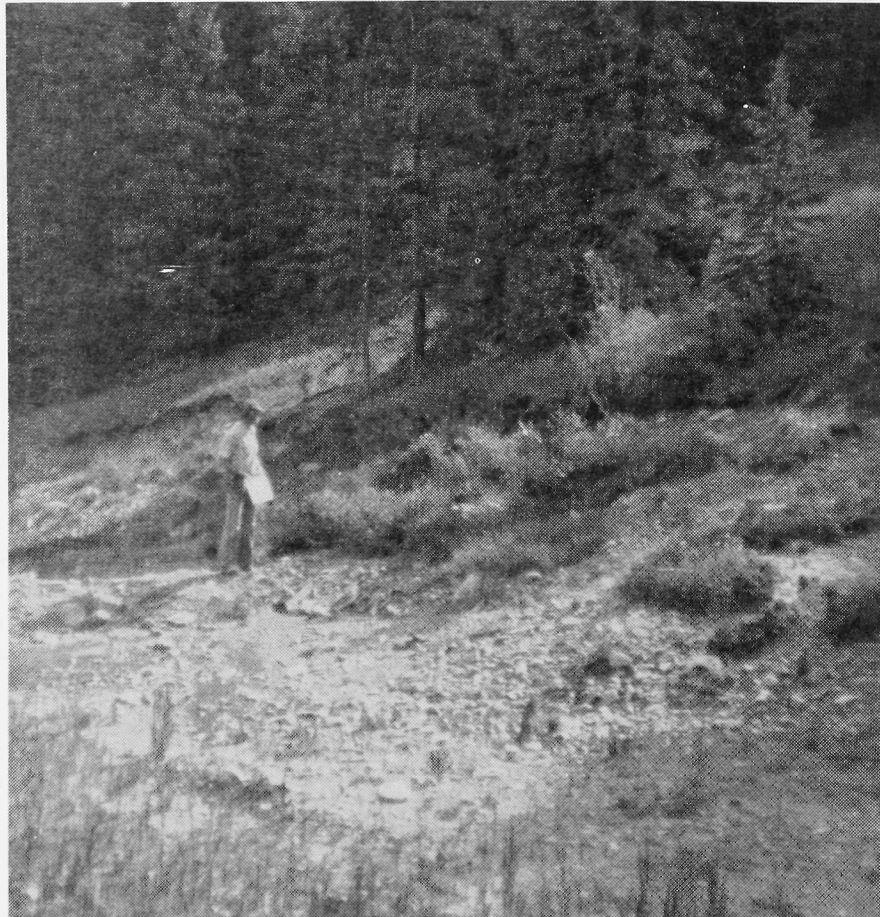
Figure 10. Small landslide or slump that occurred between August 6 and 10, 1976 in morainal material at about Sta. 110 on the north side of Mayflower Creek.

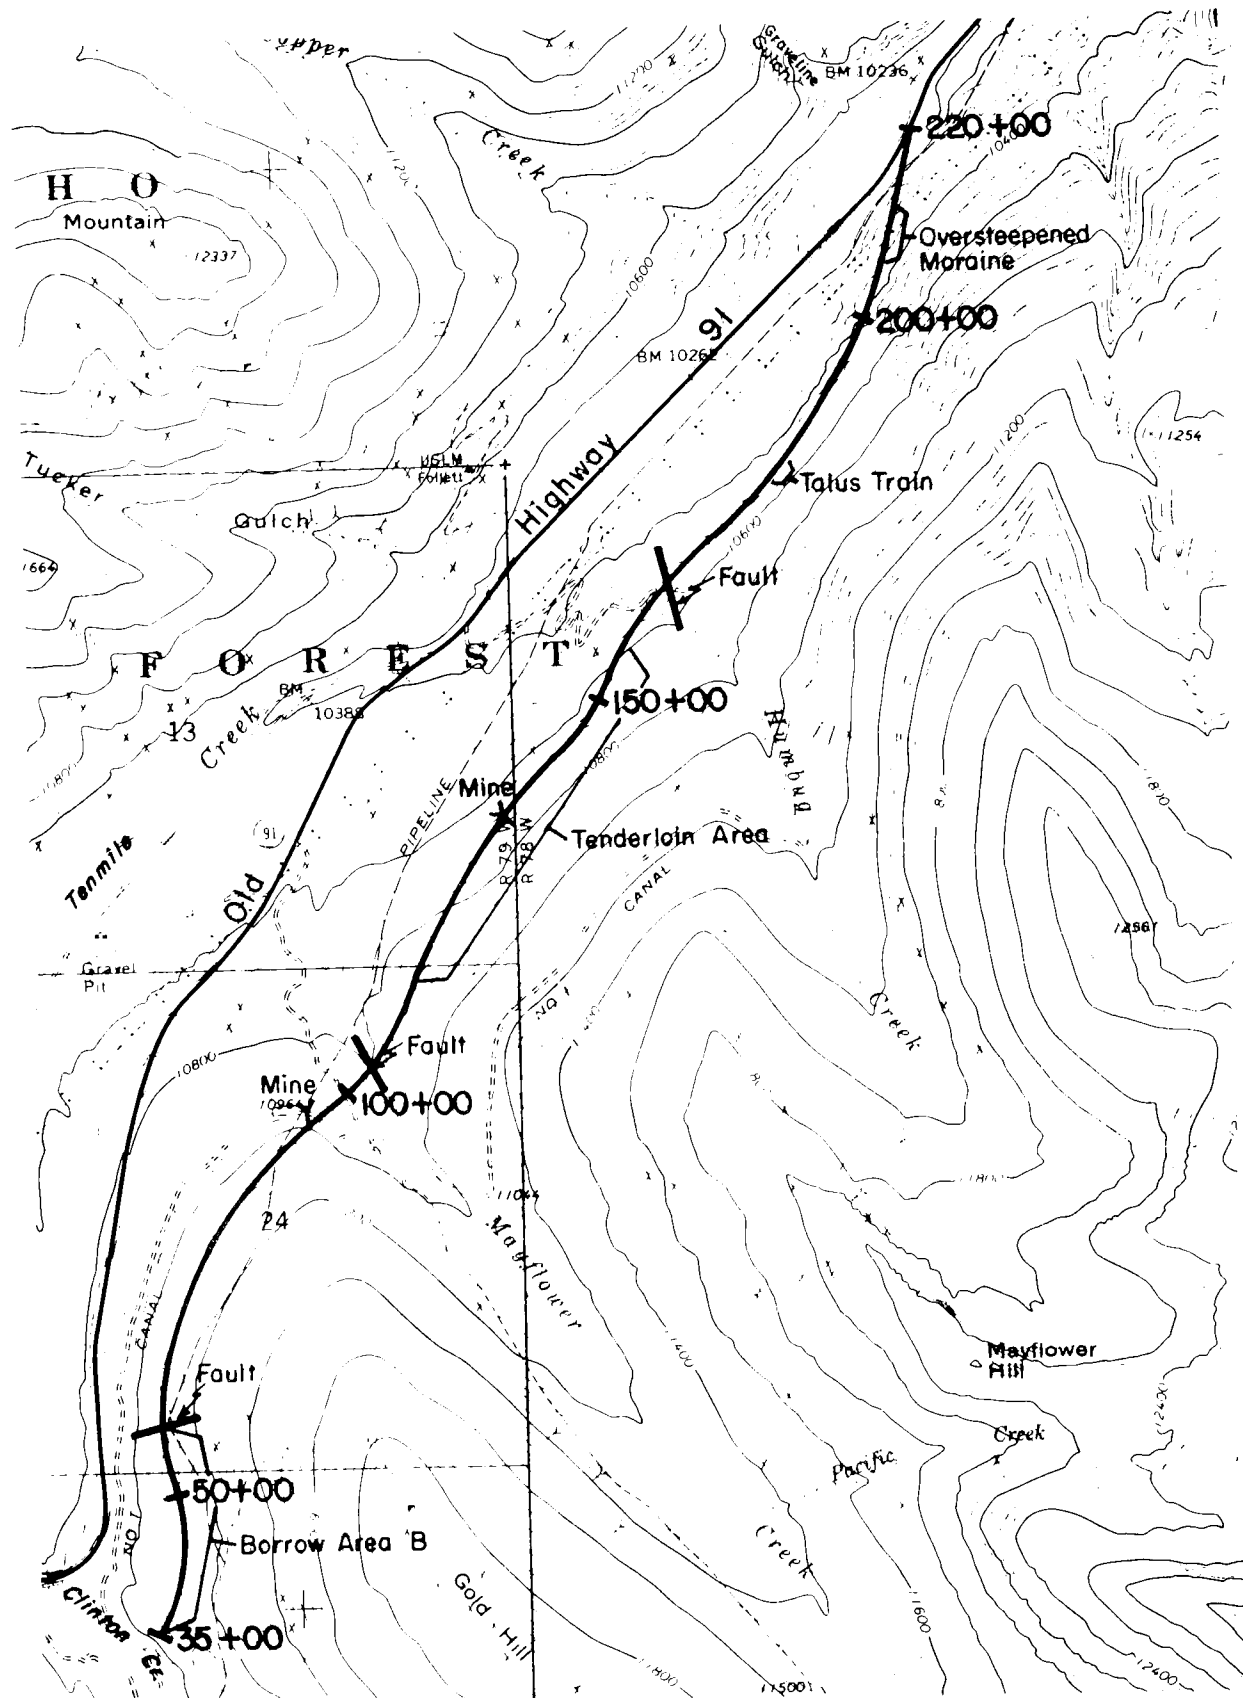
Figure 11. Problem Areas

Problem areas are identified in order to define conditions which should be mitigated in design (Fig. 11). It should be noted that even slight changes in the alignment may alter the relative effect of these problems on the roadway, eliminating certain site-specific problems and introducing others not noted in this study.

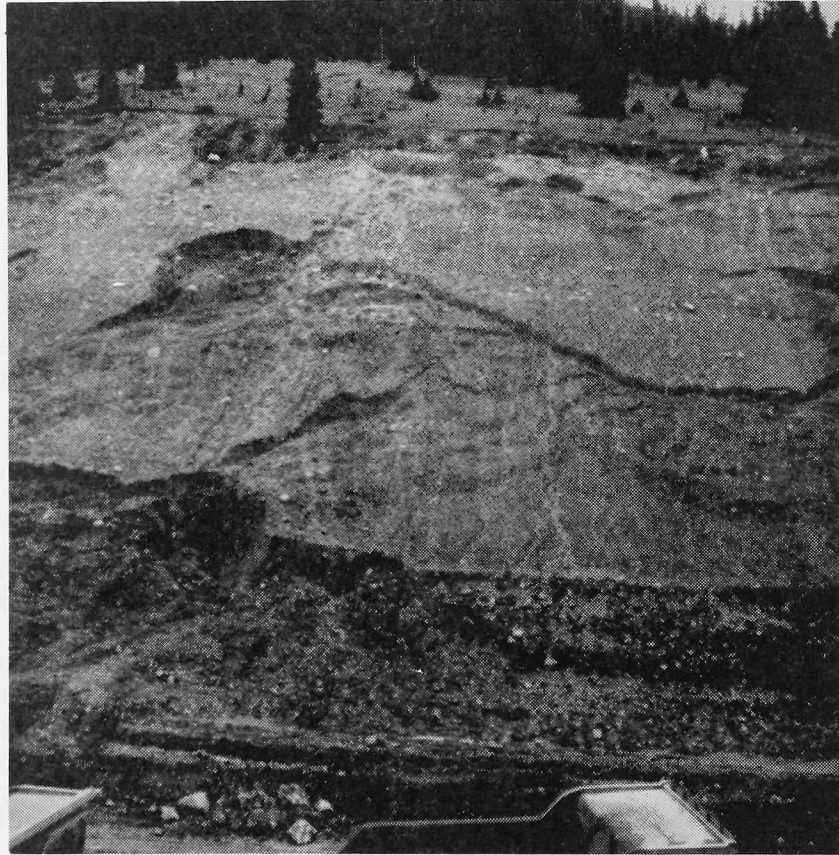
Figure 12. Right cut slope at about Sta. 39+00 in Borrow Area B, September 1976. Note failures indicated by multiple scarps. This picture is typical of conditions in the cut slope between Stas. 36+50 and 41+00.

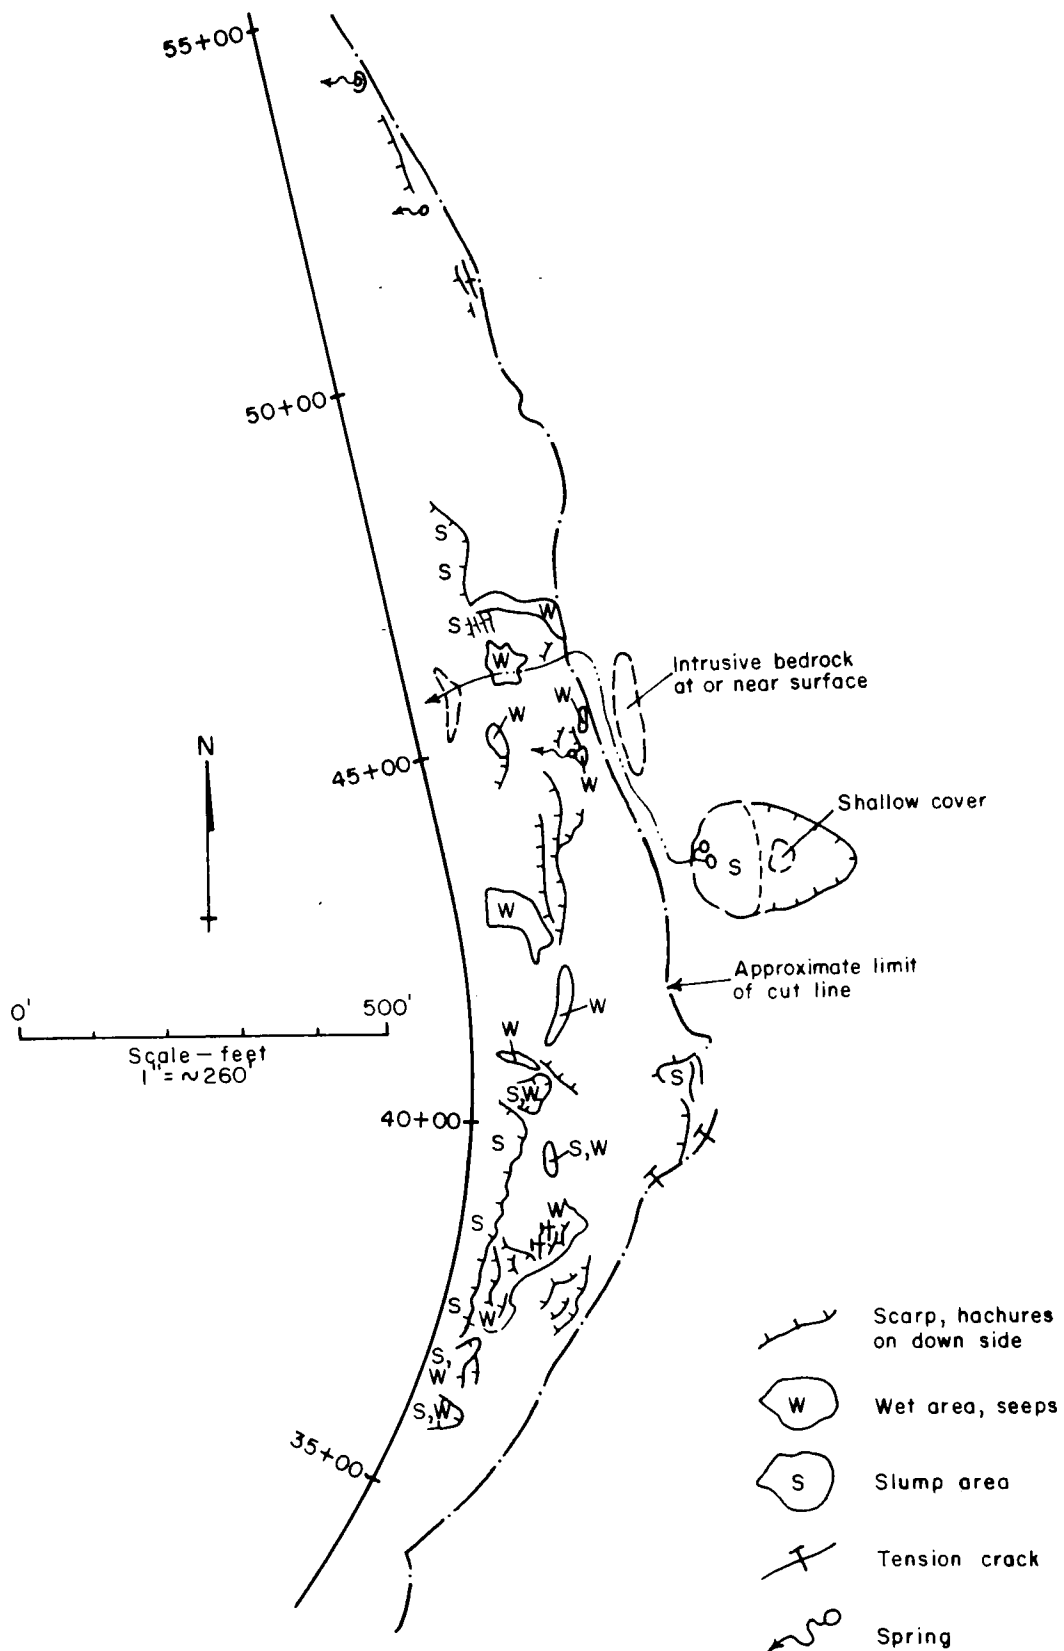
Figure 13. Generalized Map of Borrow Area B
early September, 1976.

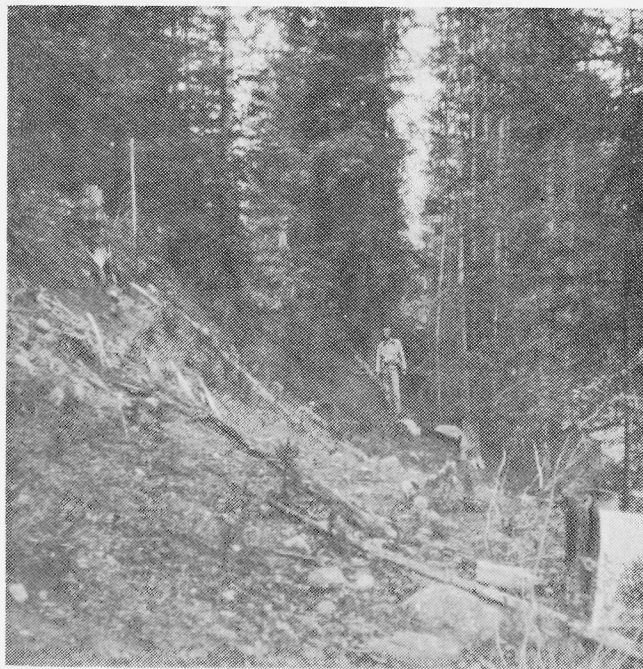
Figure 15. Unstable slope in morainal deposits, "tenderloin" area.

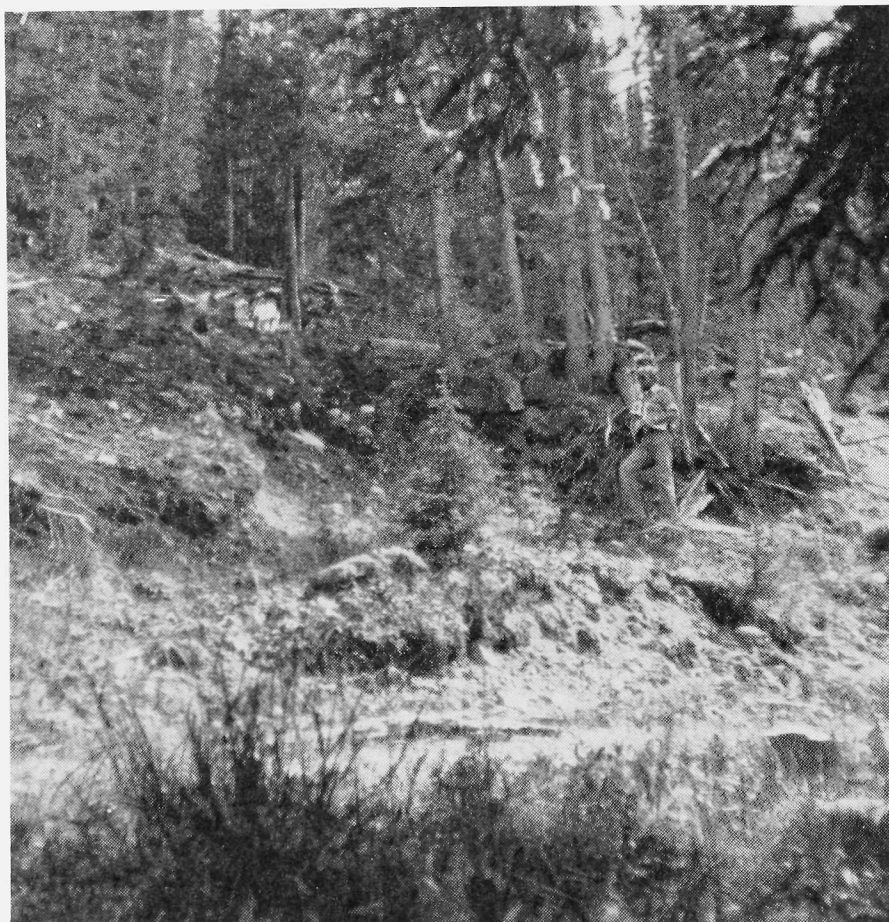
Figure 16. Multiple scarps above an old drill location access road at about Sta. 145+00 in the "tenderloin" area.

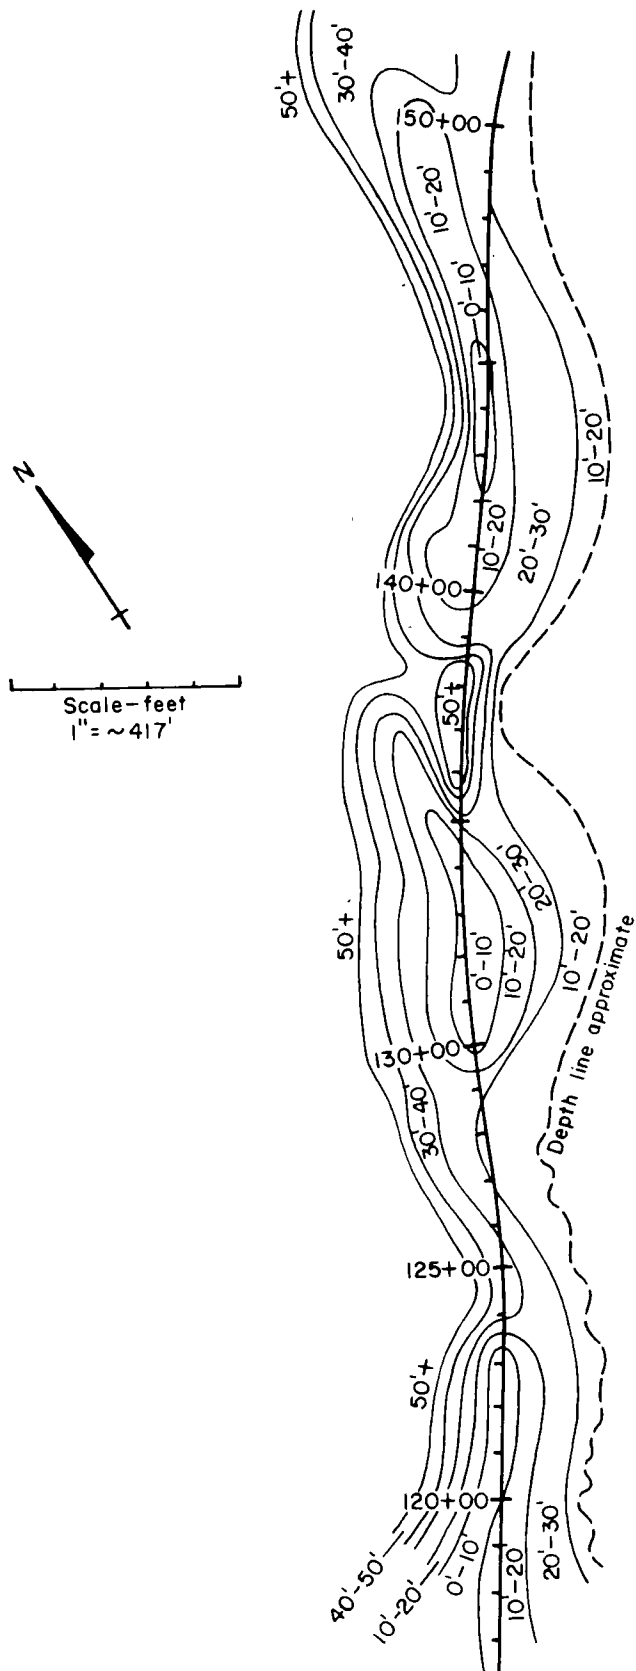
Figure 17. Depth-to-Bedrock Map
Tenderloin Area

Depth to bedrock was of greater concern in the "tenderloin" than in any other part of the alignment. In order to make an estimate of this depth, geophysical and test pit programs were conducted to supplement information acquired from surface geologic mapping and from a few exploration test holes. Figure 17 shows the results of this effort.

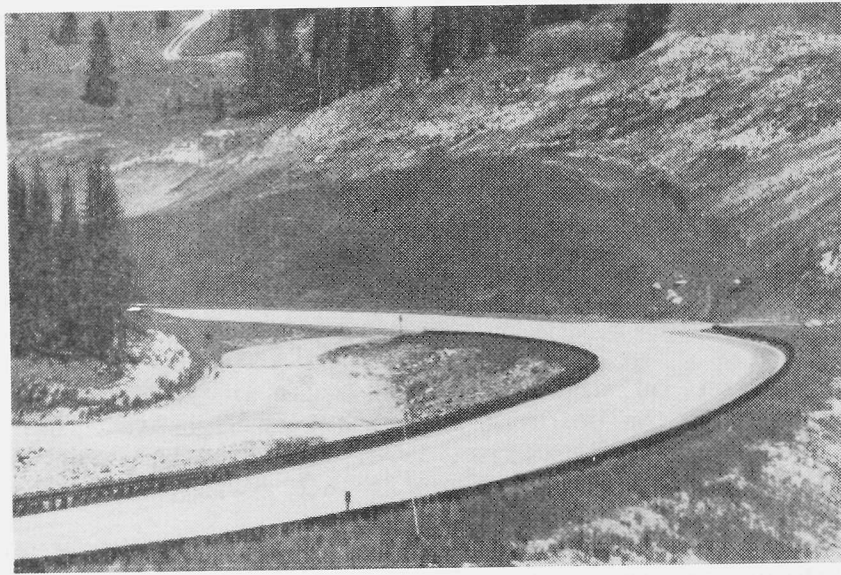
Figure 18. Borrow Area B. Berm (dark arcuate area) in lower part of cut has been an effective barrier to major failure.

Figure 18 shows Borrow Area B and the stabilizing berm which was emplaced to load the base of the cut. The crest drain (see Fig. 19) along the top of the cut was performing as intended although some material had sloughed down into the permeable drain. Some slumping (see Fig. 20) had occurred in the vicinity of Sta. 45+00 and this appeared to be due to excess water in a clayey environment.

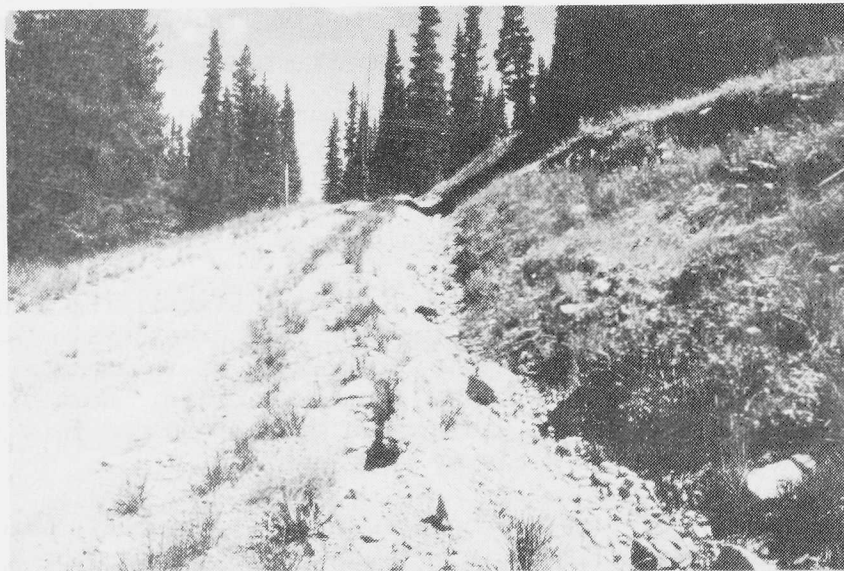
Figure 19. Crest drain on right above Borrow Area B. cut. Drain is effectively transmitting water through porous blanket although some sloughing has occurred.

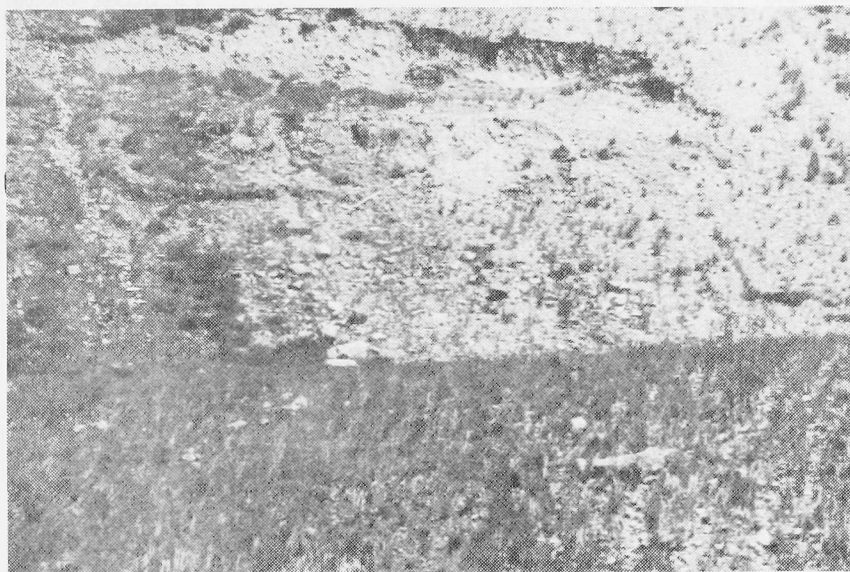
Figure 20. Minor sloughing of morainal material in Borrow Area B above berm surface (lower third of picture).

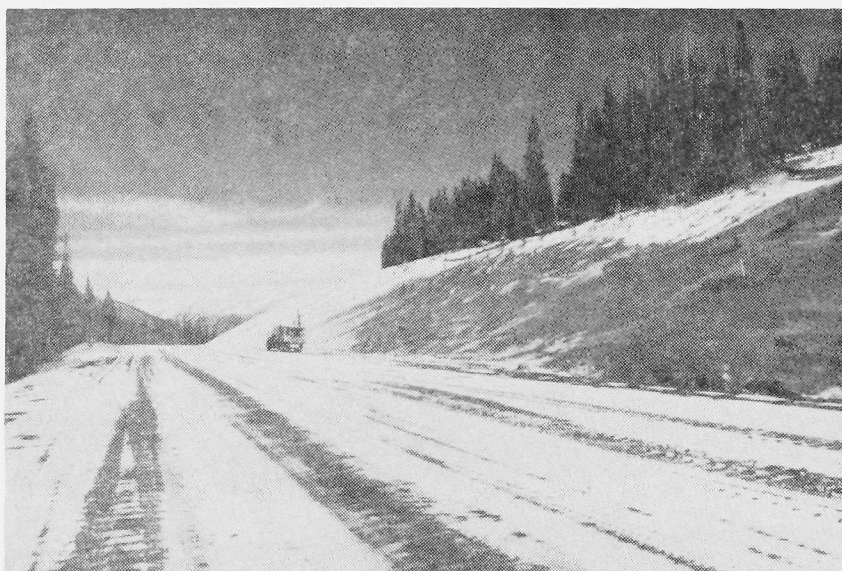
Figure 21. Hydromulching, November 1977.

As evidence of the concern with the environment, Climax planted several thousand seedlings in various cuts along the alignment in addition to hydromulching all cuts. Figure 21 shows hydromulching under way during November, 1977, with snow on the ground. Although the evergreen seedlings grow slowly, the hydromulching has been effective as witnessed throughout all of the alignment where bare rock is not exposed.

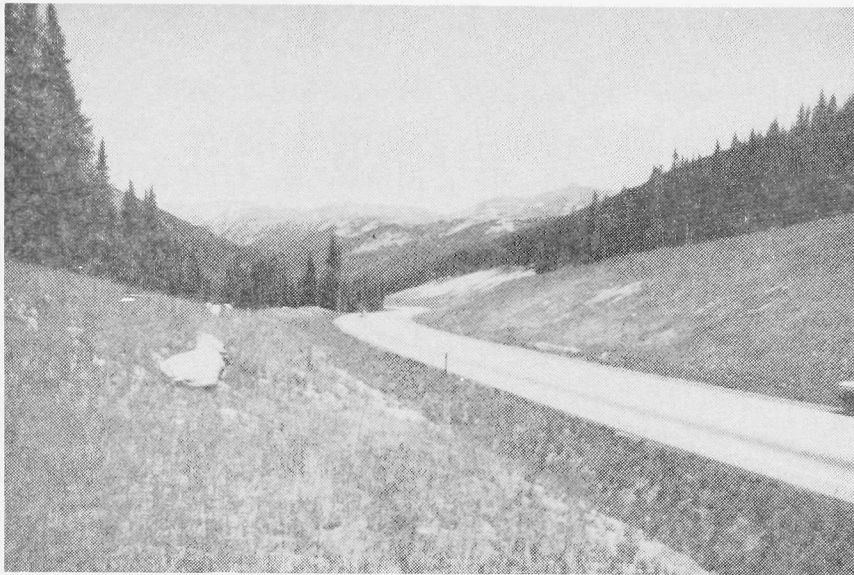
Figure 22. Panoramic view of "tenderloin" area. Note the well established stand of grass in the foreground. Rocks such as the large boulder to the left were placed at random along some of the slopes as a matter of aesthetics.

The system of subdrains placed in the "tenderloin" area was of particular interest. Figure 22 is a panoramic view of the "tenderloin" in which it can be seen that no major failures have occurred. Minor slump features such as the one shown in Fig. 23 are uncommon through this reach of the alignment.

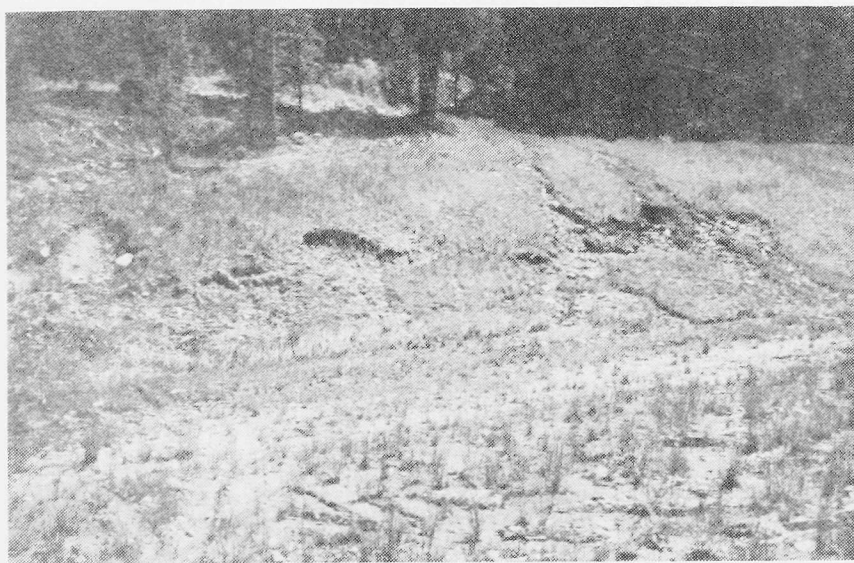
Figure 23. Minor slump features in the "tenderloin" area just south of Humbug Creek.

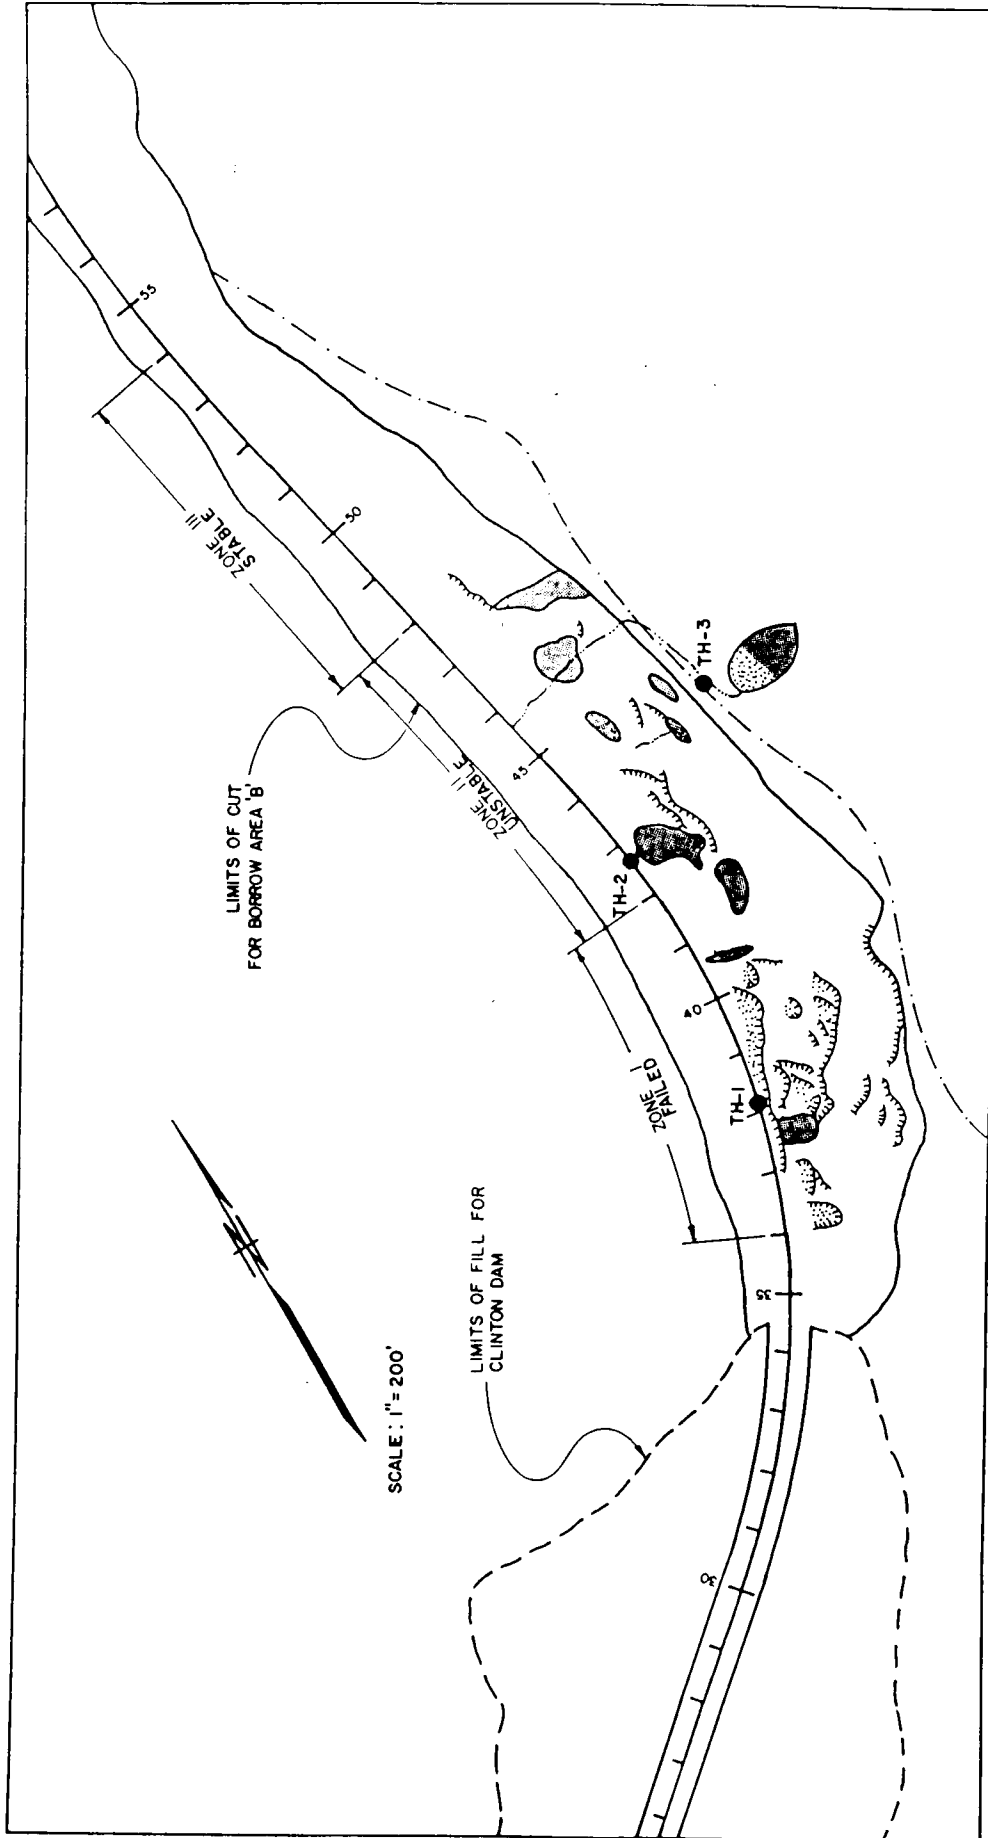
BORROW AREA 'B' — SURFACE FEATURES AND TEST HOLE LOCATIONS
