PROCEEDINGS of the 33rd ANNUAL HIGHWAY GEOLOGY SYMPOSIUM

ENGINEERING GEOLOGY and ENVIRONMENTAL CONSTRAINTS

PROCEEDINGS OF THE 33RD ANNUAL
HIGHWAY GEOLOGY SYMPOSIUM

Engineering Geology
and
Environmental Constraints
in
Vail, Colorado
1982

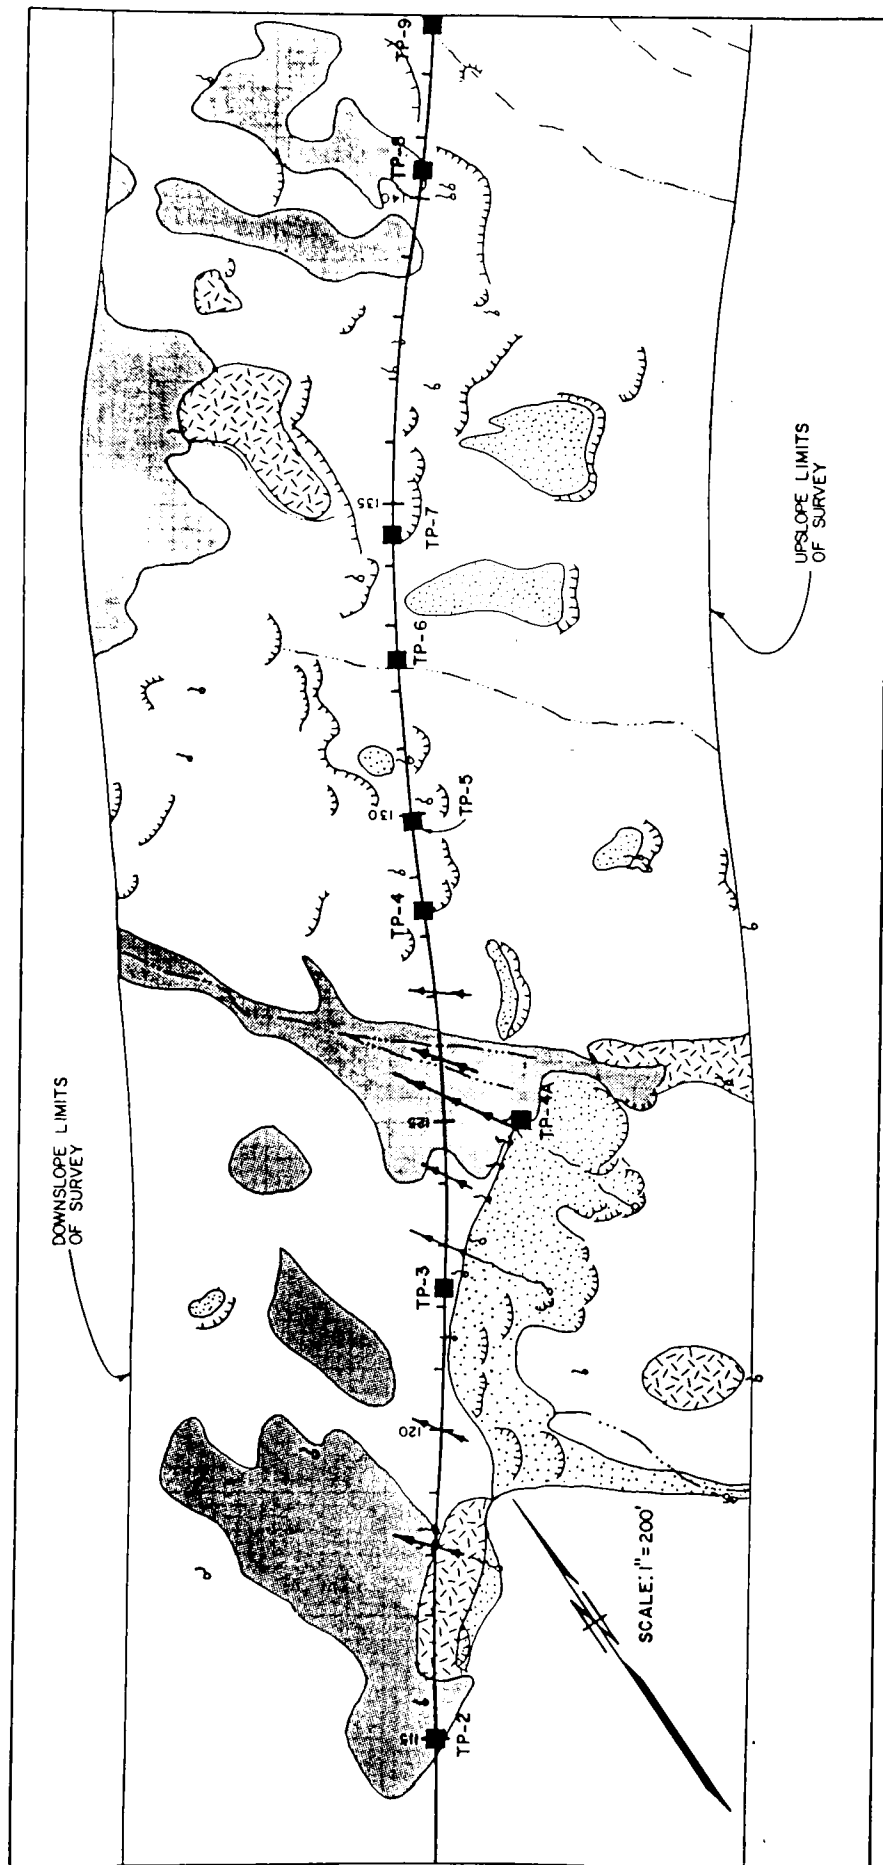
TENDERLOIN AREA (STATIONS 115 THROUGH 143) SURFACE FEATURES AND TEST PIT LOCATIONS

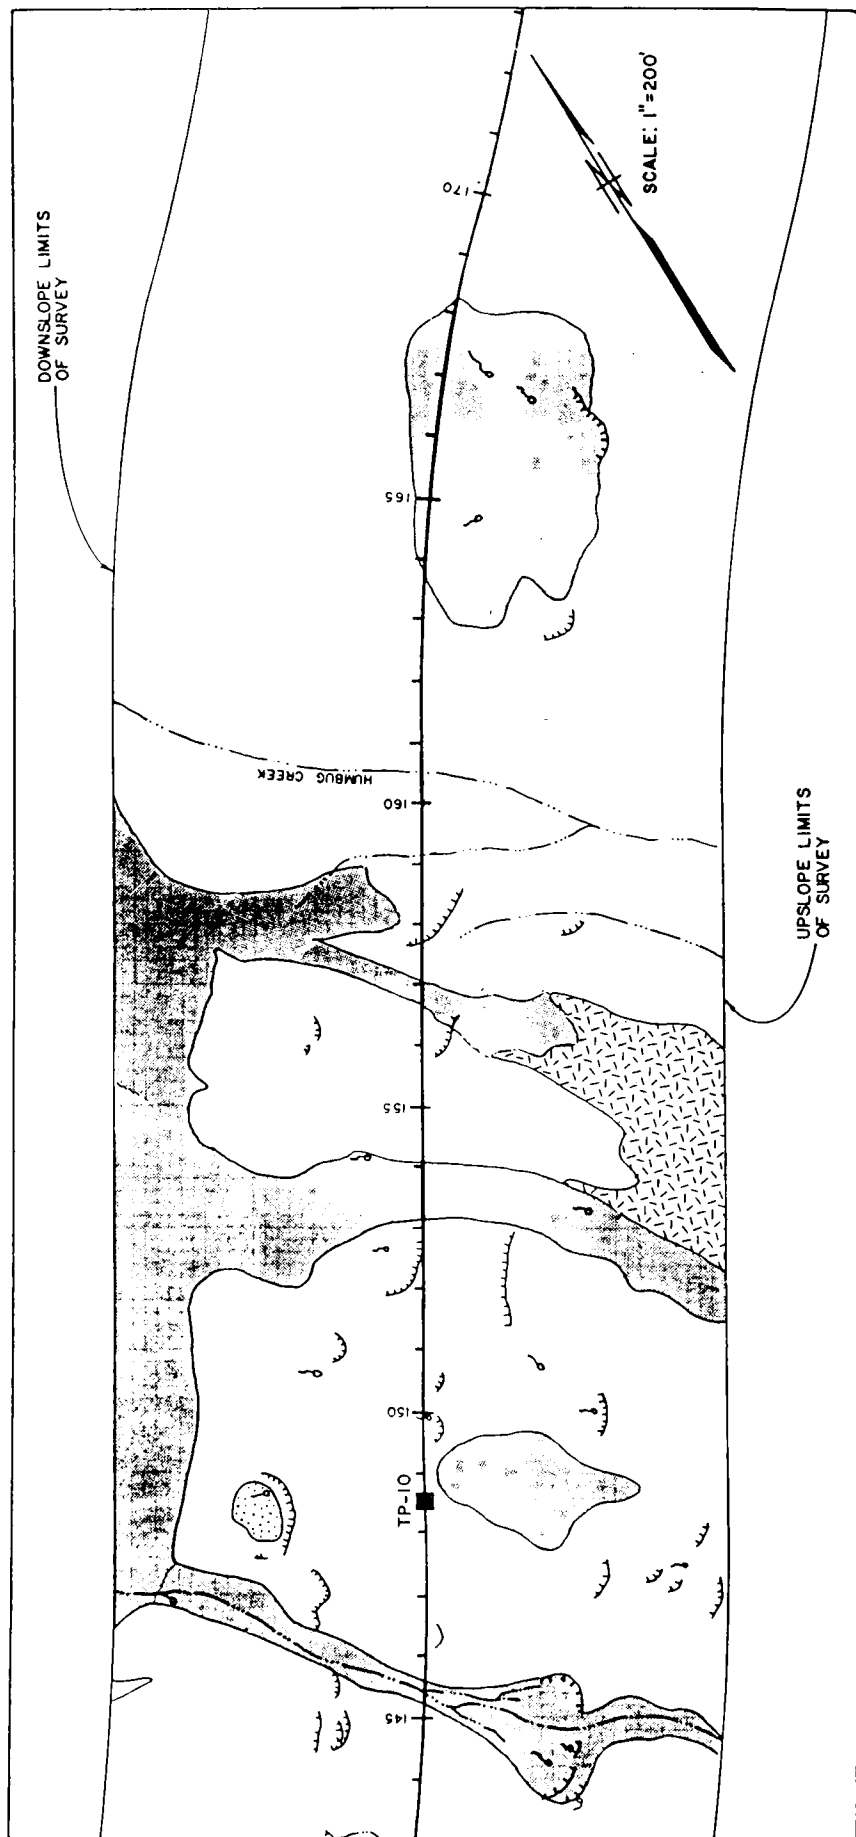
TENDERLOIN AREA (STATIONS 143 THROUGH 160 +) SURFACE FEATURES AND TEST PIT LOCATIONS

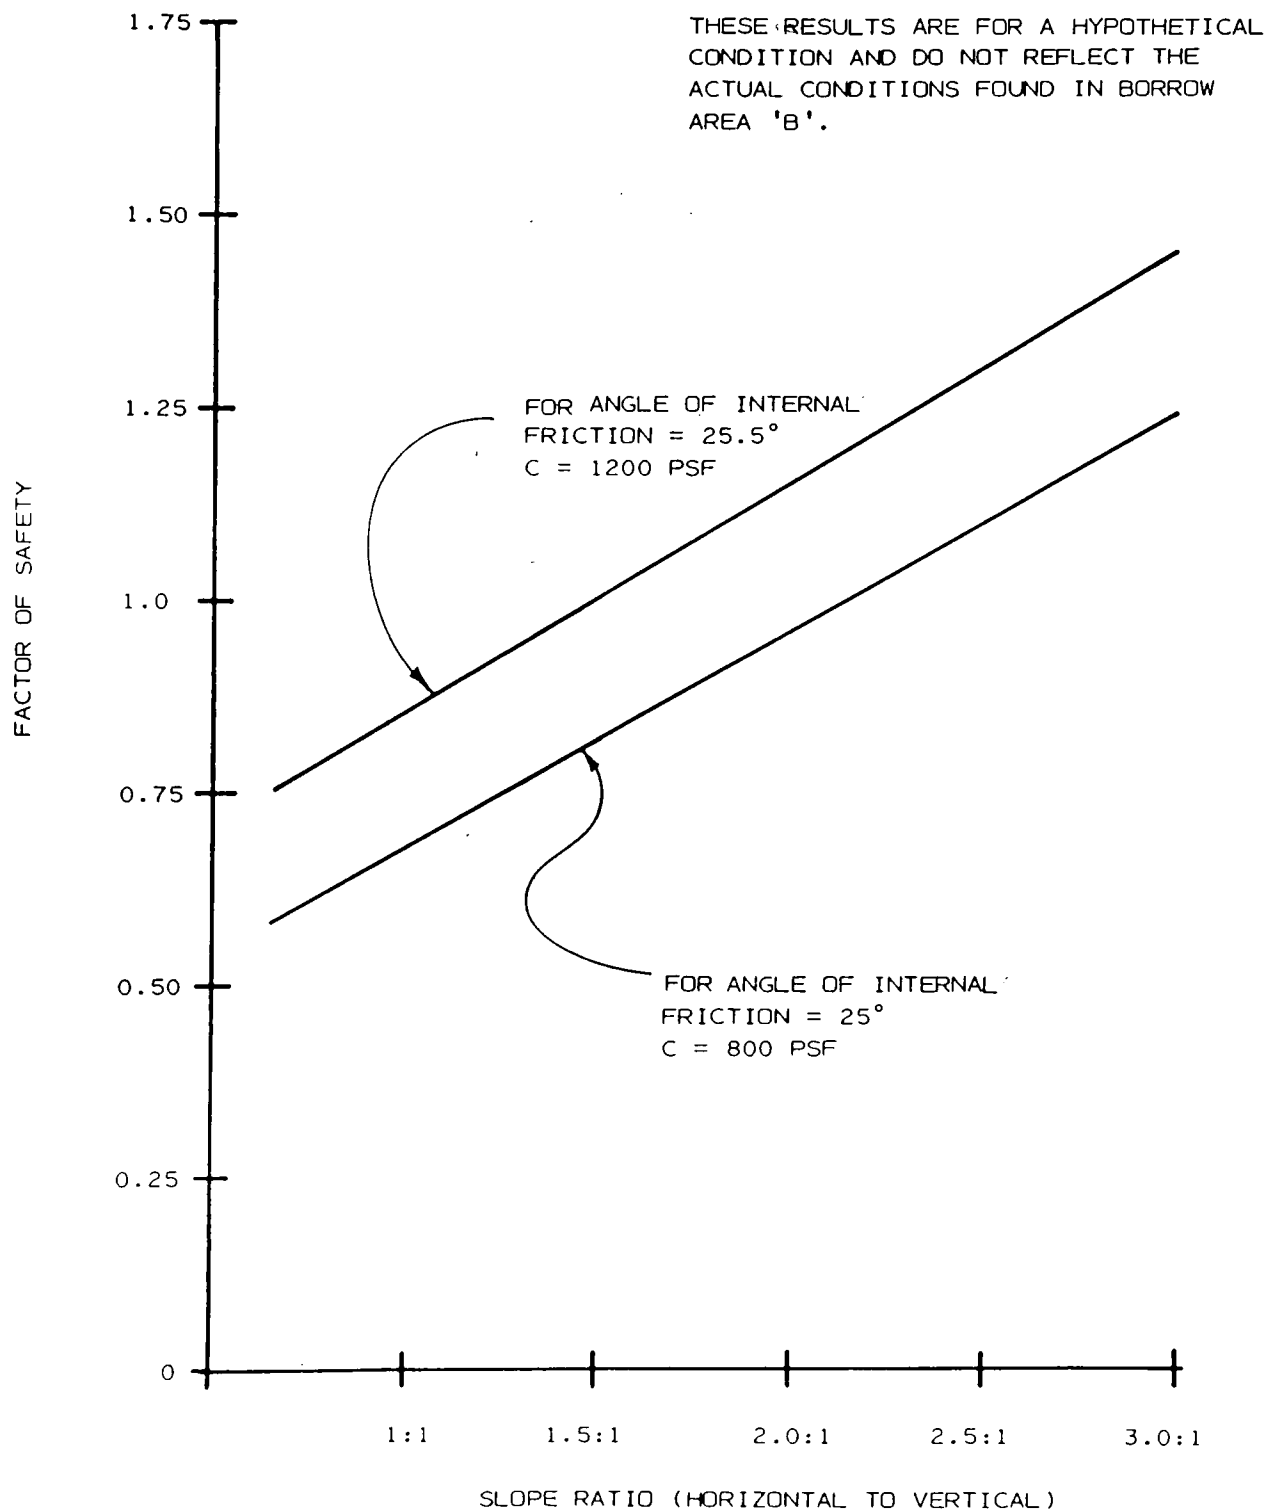
SLOPE CHART (BORROW AREA 'B')

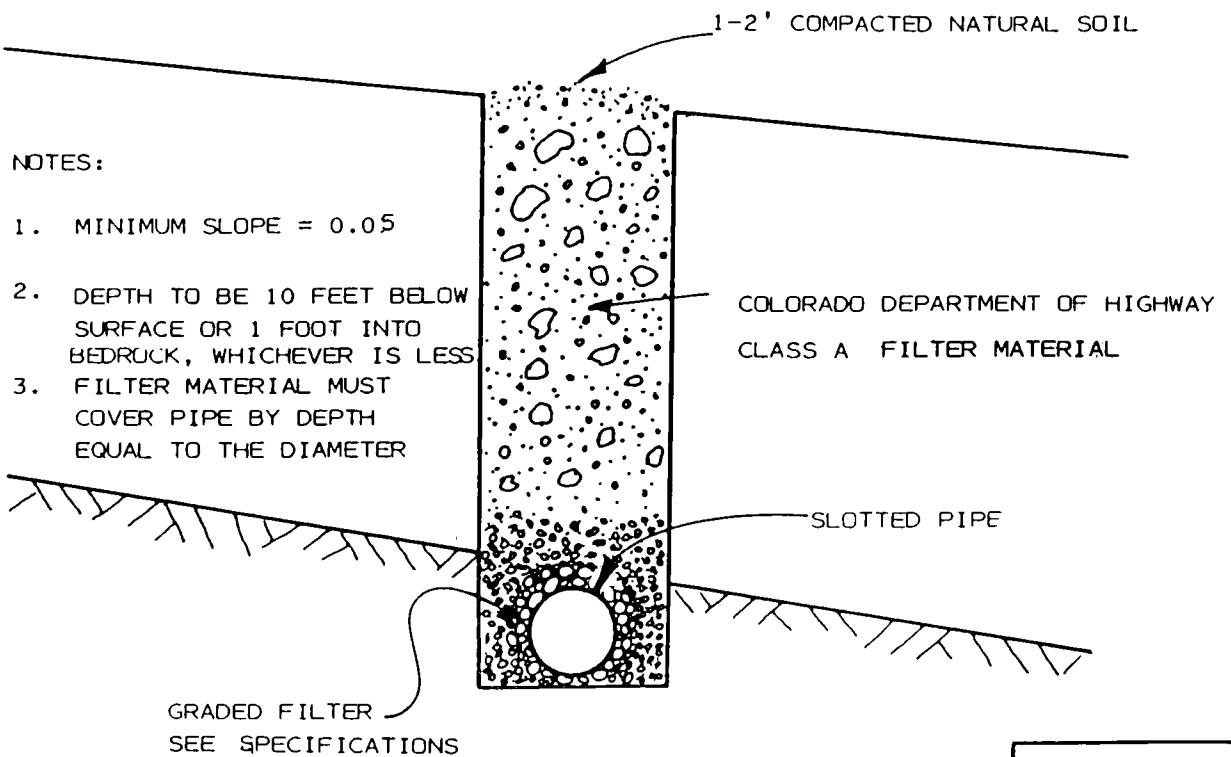
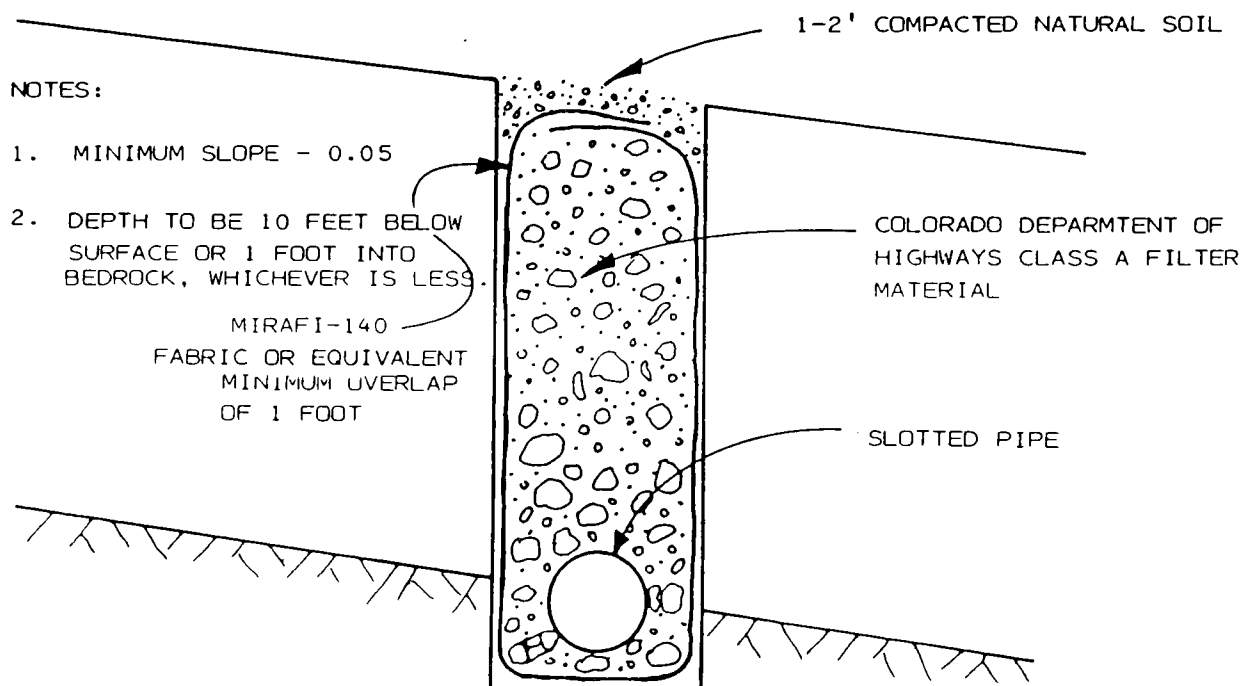
TYPICAL DRAIN DETAILS

TYPE I

TYPE II

The design of subdrains for both areas was based upon use of either a graded aggregate filter or a non-woven geotextile filter system. The alternative designs are illustrated on Fig. 8. Because of the different material types, the aggregate filter system required two specified gradations. One was for the glacial till which contained significant clay and silt sized particles, while the other was developed for the granular col-luvium. A non-woven, polypropylene geotextile was found suitable for either soils condition, less expensive and easier to install.

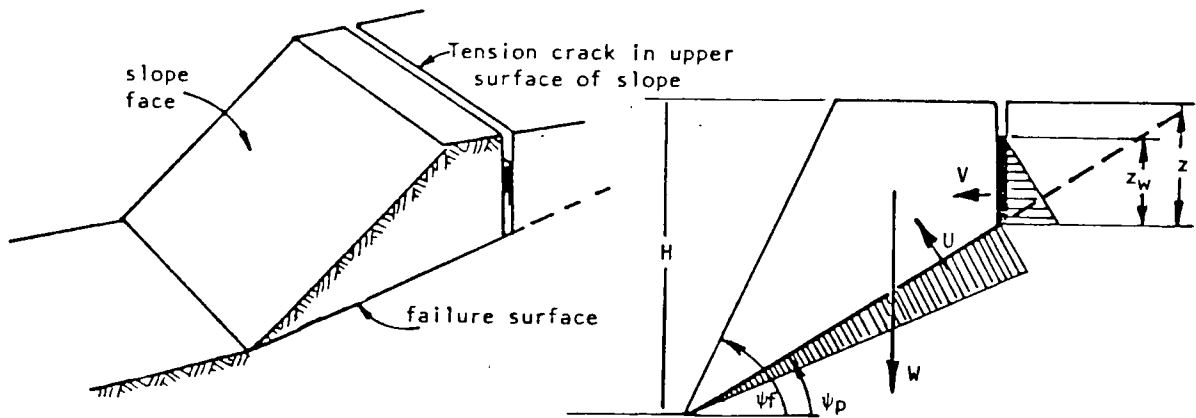
$$F = \frac{CA + (W \cos \psi_p - U - V \sin \psi_p) \tan \phi}{W \sin \psi_p + V \cos \psi_p}$$

V = lateral force exerted by water within tension crack

FIGURE 1 INFLUENCE OF WATER PRESSURE ON SLOPE STABILITY

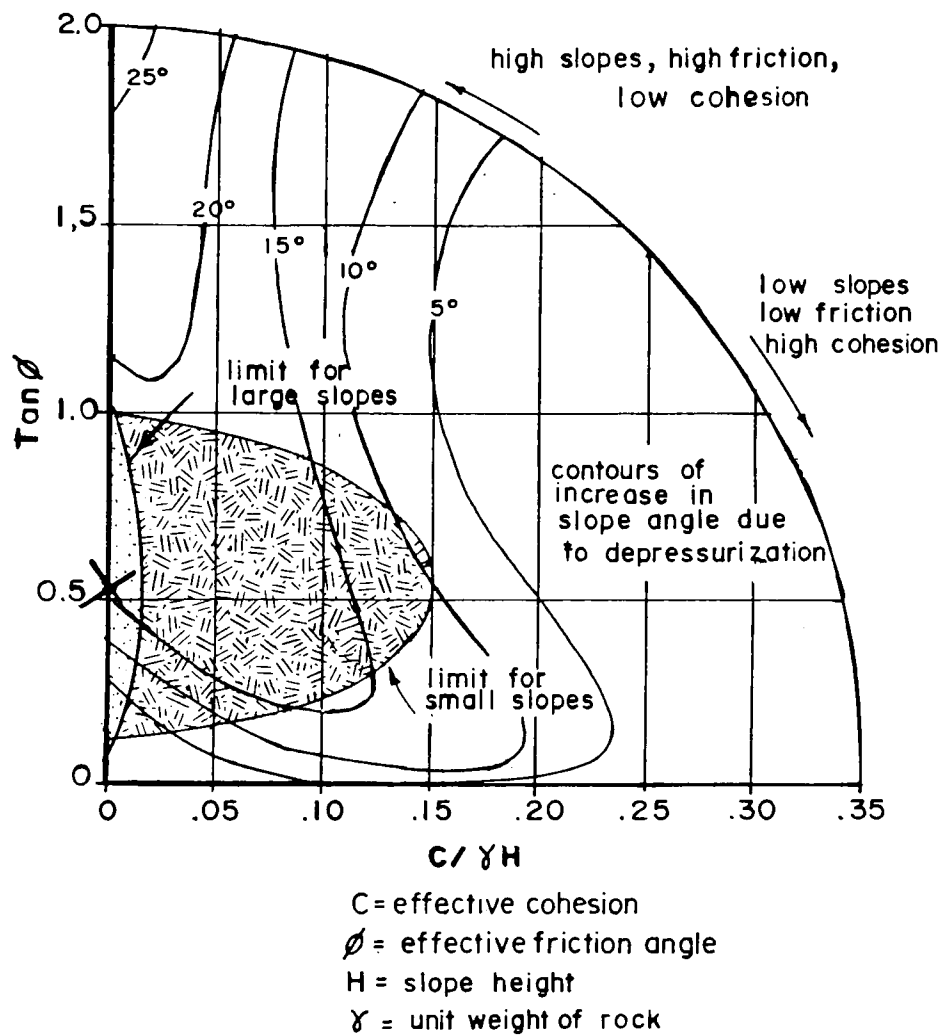
FIGURE 2 RESULTANT INCREASE IN SLOPE ANGLE DUE TO
TOTAL DEPRESSURIZATION

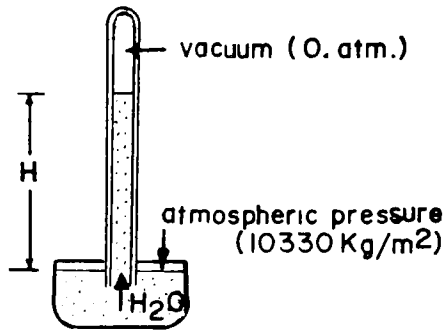
WHEREBY:

H = height of water column

$$= 10.3 \text{ m (at mean sea level)}$$

FIGURE 5A VACUUM PRINCIPLE

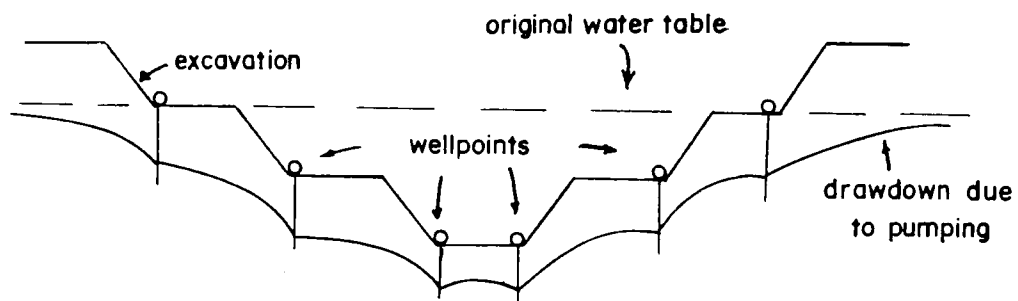
FIGURE 5B VACUUM WELLPOINTING APPLIED
ON 5m. LIFTS

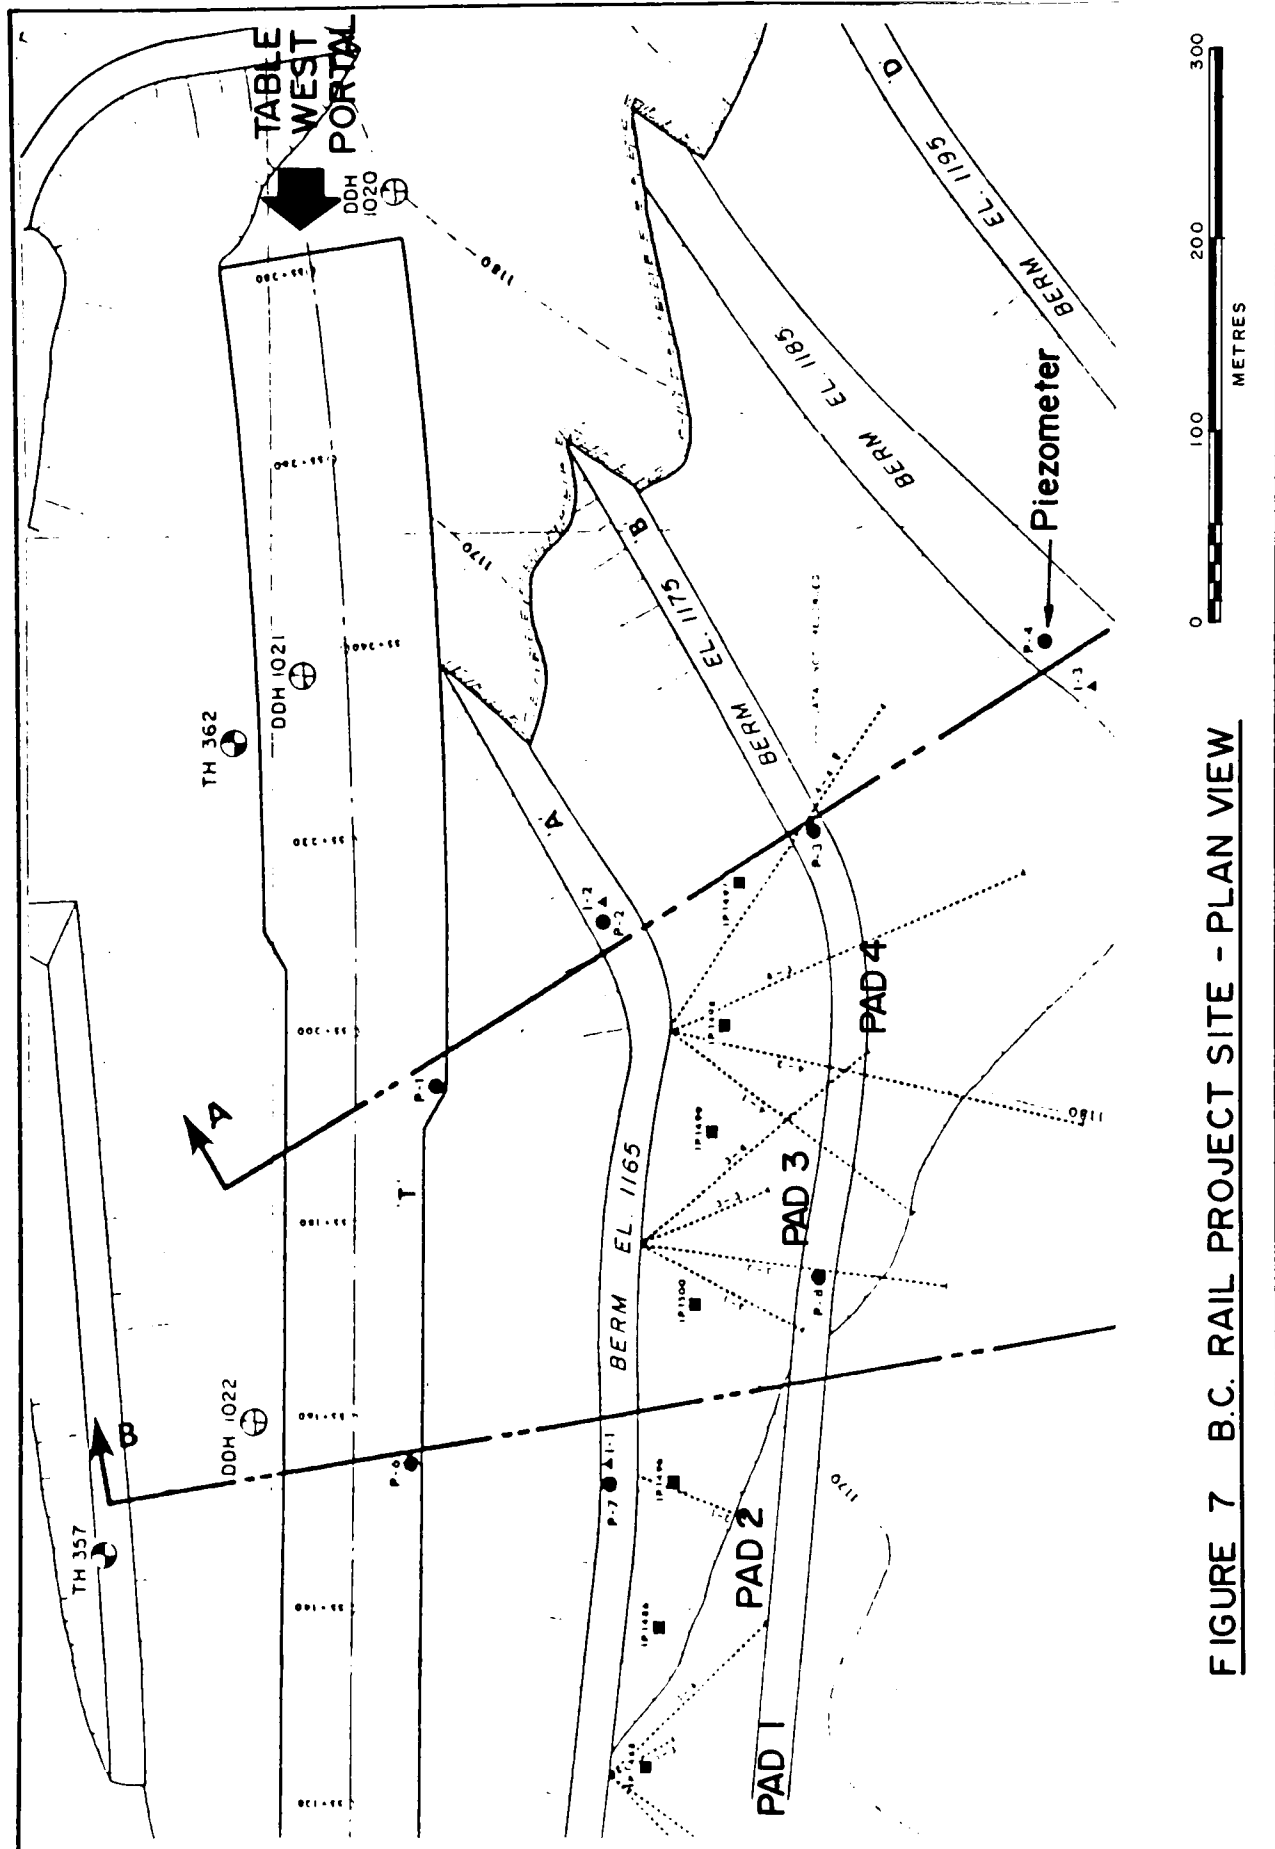
FIGURE 7 B.C. RAIL PROJECT SITE - PLAN VIEW

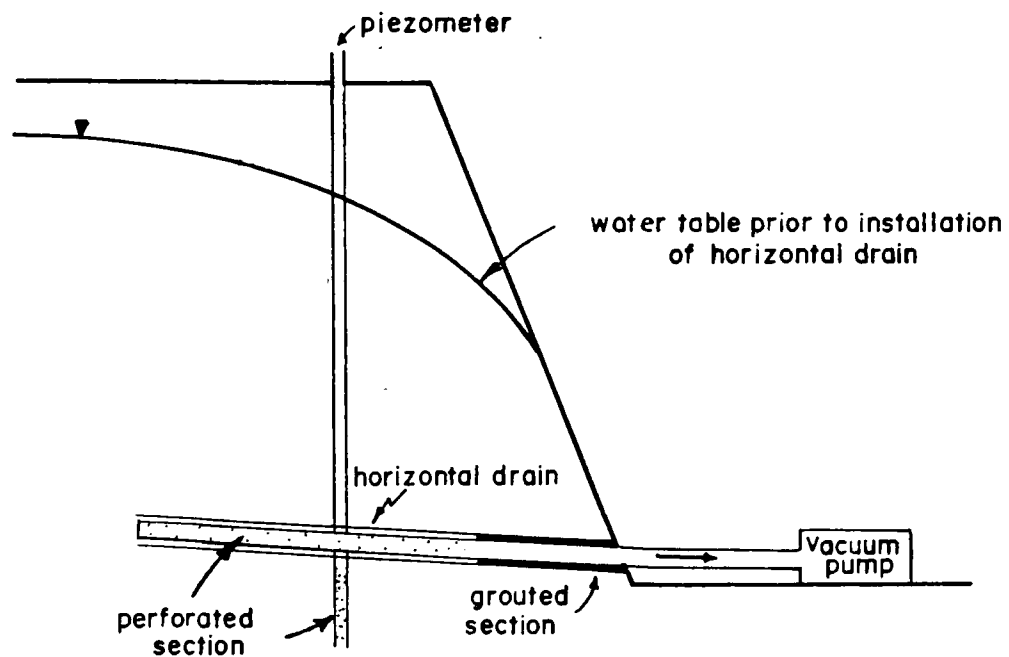
FIGURE 8 SCHEMATIC REPRESENTATION
OF
VACUUM SYSTEM

A schematic representation of the "vacuum system" is shown by Figure 8. The horizontal drain consists of a perforated section plus a grouted section which is to serve as a seal. The length of the grouted section is critical since it must "seal" any fissures that may penetrate to surface and consequently reduce the effectiveness of the vacuum. The vacuum pump, Figure 9, was capable of exhausting 12 l/sec of air and producing 0.7 m (Hg) of vacuum at mean sea level. A header system was employed whereby the four pads were connected to the vacuum pump through valves enabling a vacuum to be applied individually or in combination with each other. The exhausted water flow could be measured since flow to the pump exited through a port. The vacuum was monitored through the reading of a gauge attached to the unit. The pump was a diesel-driven, self-contained unit capable of exhausting a constant volume.

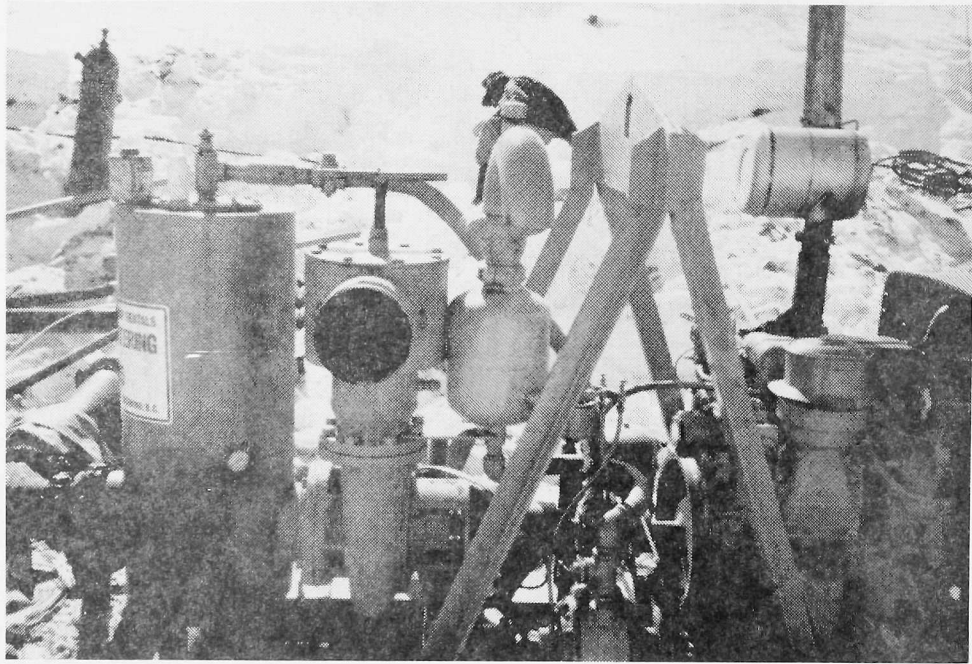
FIGURE 9 VACUUM PUMP DEPICTING-EXIT PORTAL
- VACUUM GAUGE

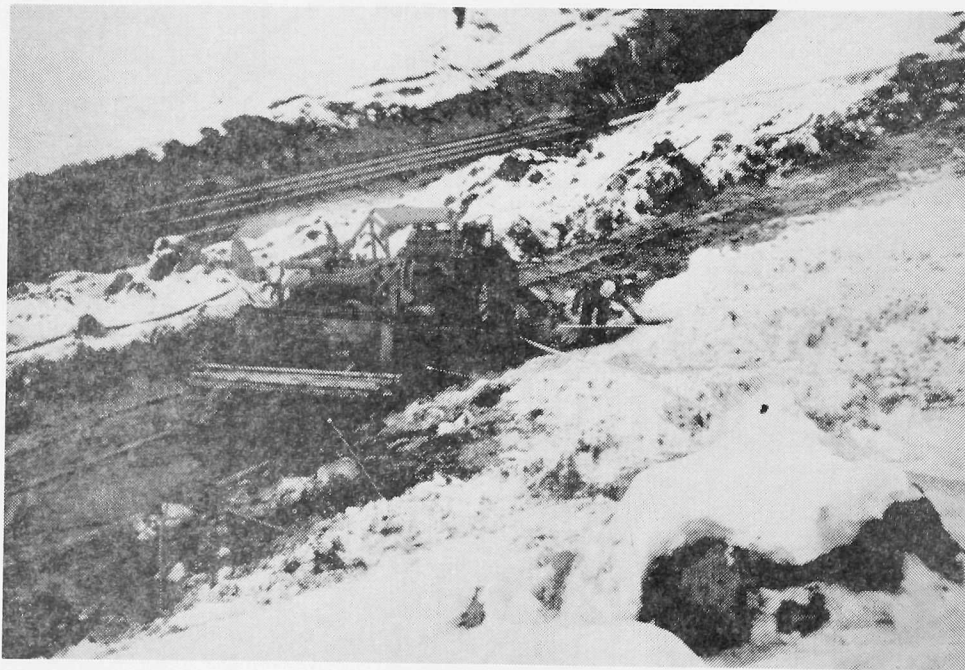
FIGURE 10 INSTALLATION OF VACUUM DRAINS

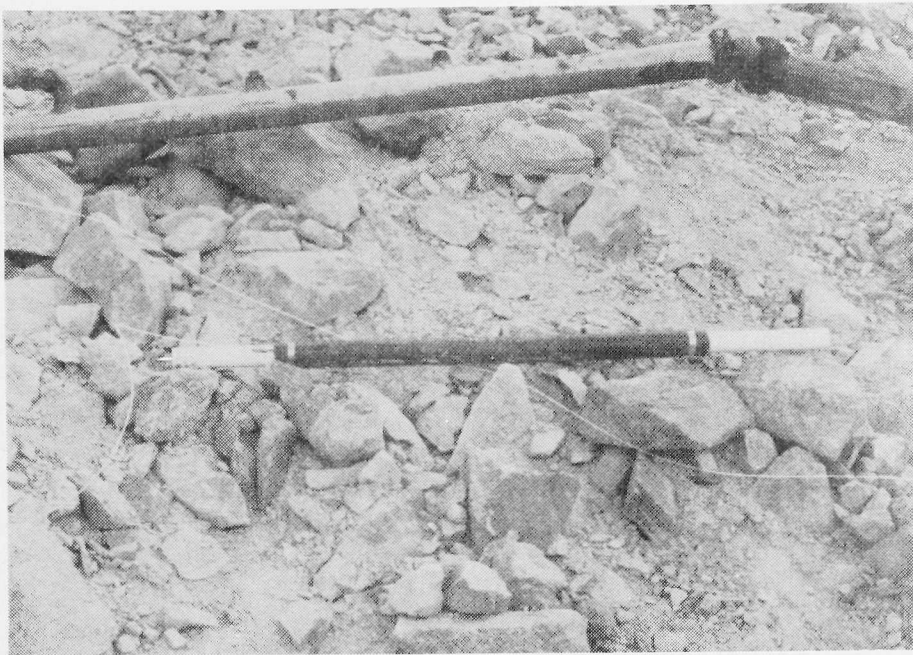
FIGURE 11 INFLATABLE SEAL

The seal of the annulus between the boring wall and the drain pipe is considered of utmost importance. For this reason, a special packer system was designed to (1) allow installation using the Aardvark Method and (2) provide an effective basis for vacuum application. The packer system was constructed of mandrell-laid rubber, slid over and banded to 3.2 cm PVC, Figure 11.

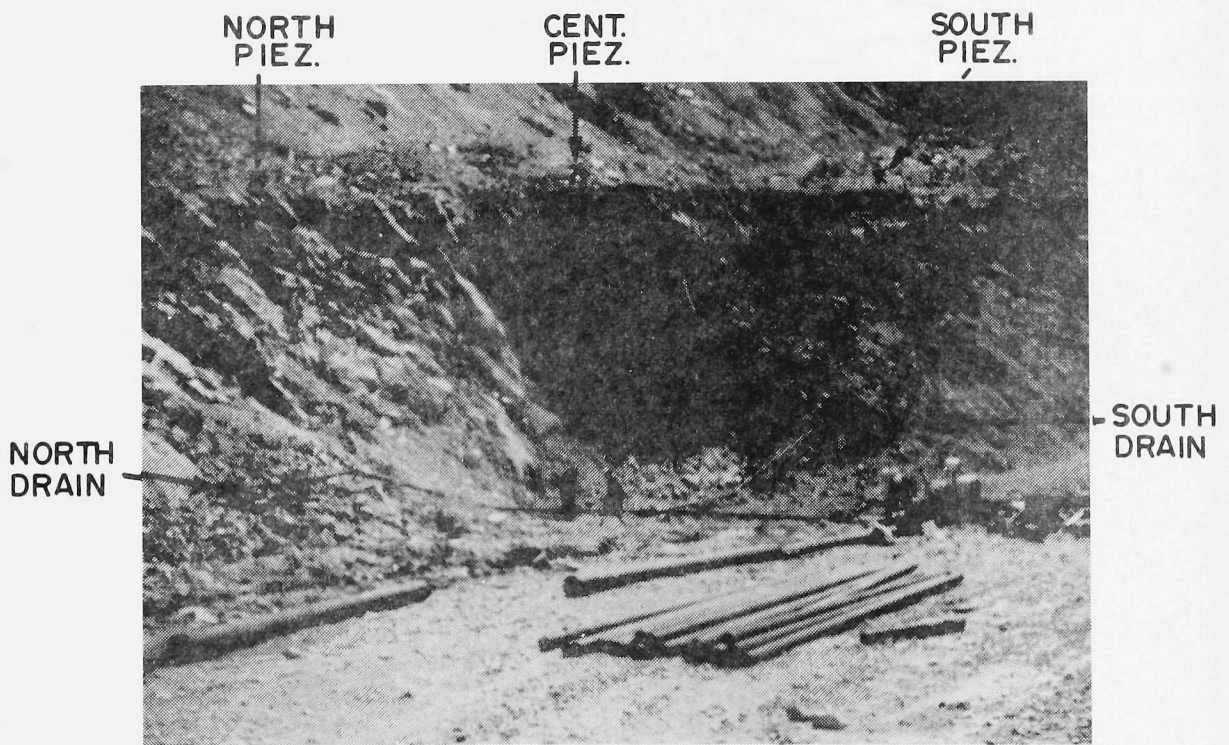
FIGURE 12 GIBRALTAR TEST SITE

The area selected had an average hydraulic conductivity of 10^{-7} m/sec in a moderately fractured rock slope, Figure 12. The study area was limited to a 13.7 m high bench. Three 15.2 m - 7.6 mm diameter vertical holes spaced approximately 15.2 m apart were drilled for the purpose of installation of standpipe piezometers. Three horizontal drains approximately twenty-one metres long were inclined at +2 percent and drilled from the bench below to be located midway between the previously drilled piezometers. A seal 6.1 m long was employed which was determined to be the extent of the highly fractured zone. This was required in order to ensure a vacuum tight system. The vacuum pump and seal were similar to that described previously (case study I). The piezometers were subsequently monitored in order to determine the effect that the horizontal

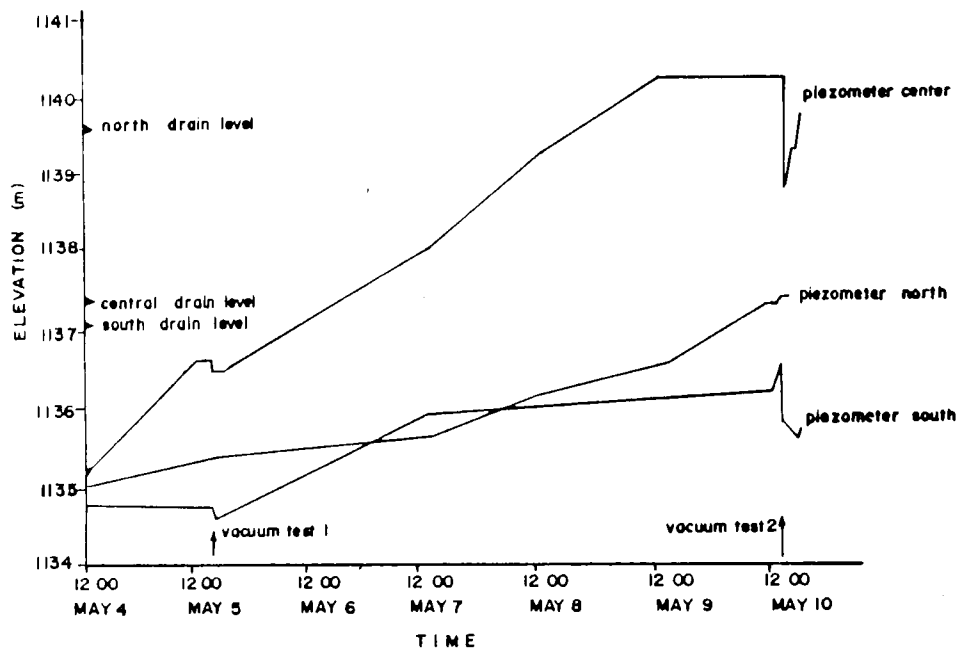
FIGURE 13 WATER LEVEL VERSUS TIME

The three drainholes were initially dry and subsequently the area was recharged to the level indicated by Figure 13 whereupon vacuum test I was conducted. Figure 13 shows the elevation of the three drains relative to the piezometric level. Upon the initiation of vacuum the following was observed:

The area was further recharged until the water levels were as indicated by Figure 13. The observations were as follows:

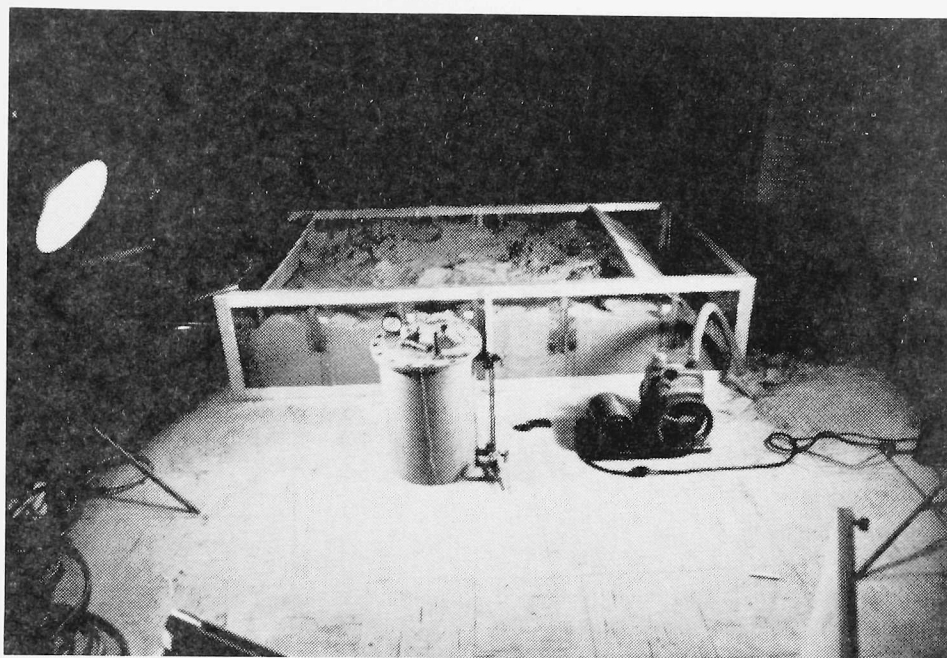
FIGURE 14 HORIZONTAL DRAIN MODEL

A laboratory model was constructed (Figures 14 and 15), having dimensions 120 cm x 215 cm x 45 cm high. Horizontal drains, 50 cm in length, were installed which were composed of a 15 cm perforated segment of 0.6 cm ID PVC pipe. The model was filled with 30 mesh sand which had a permeability of 10^{-2} cm/sec. A 1:1 slope was constructed with a recharge and discharge pond 45 and 15 cm in height respectively. Piezometers (0.6 cm ID) were installed in order to monitor the effect of drainage on the water table

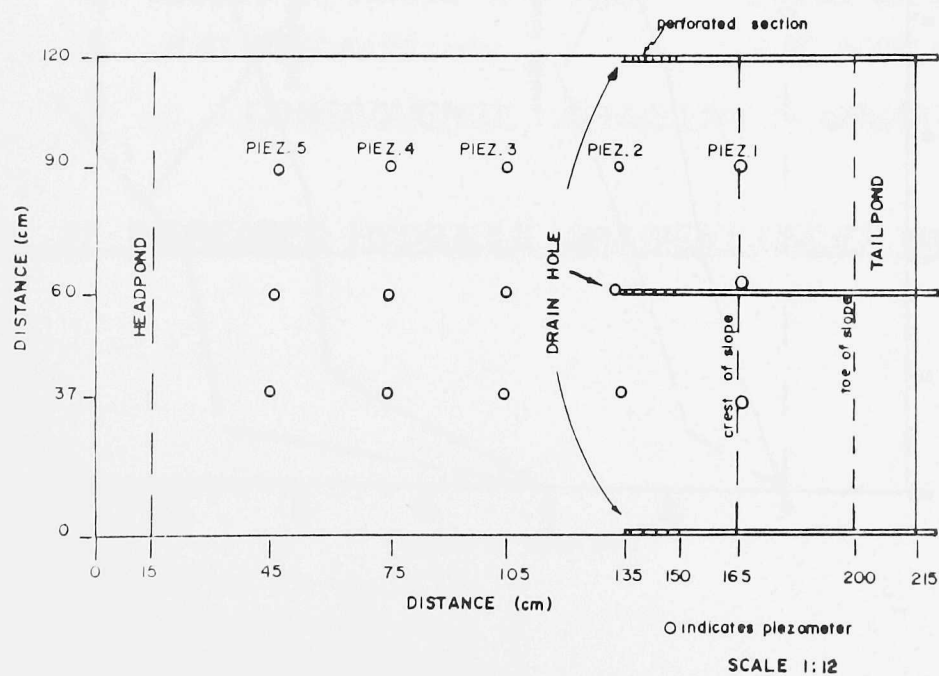
FIGURE 15 PLAN VIEW OF DRAINAGE MODEL

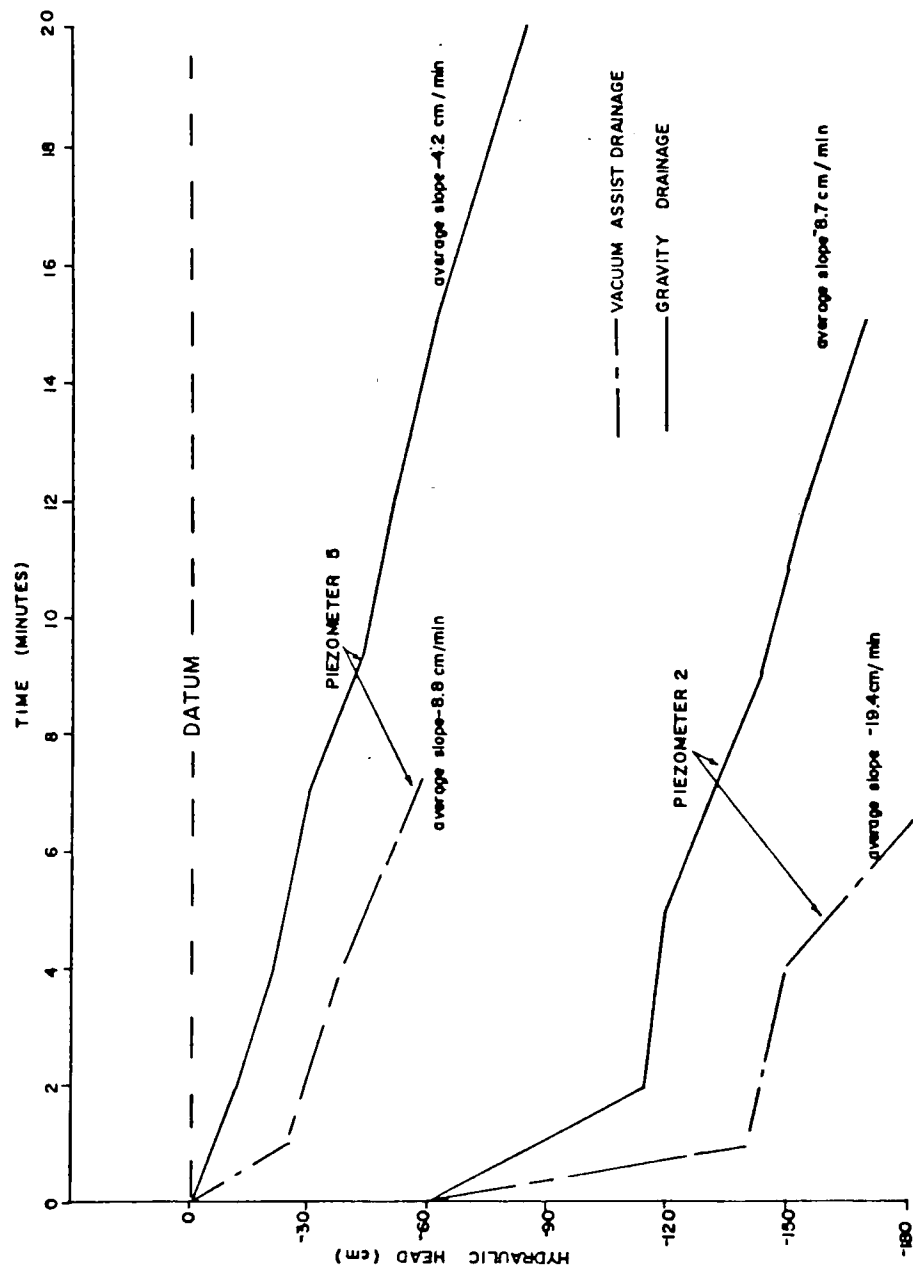
**FIGURE 16 PLOT OF DRAWDOWN VS. TIME UNDER: a) gravity drainage
b) vacuum drainage**

A comparative study between vacuum assist and gravity drainage was conducted by monitoring the drawdown rates within the individual piezometers. The model was recharged to a base situation and subsequently analyzed under the respective drainage conditions. Relative drawdown is shown by Figure 16.

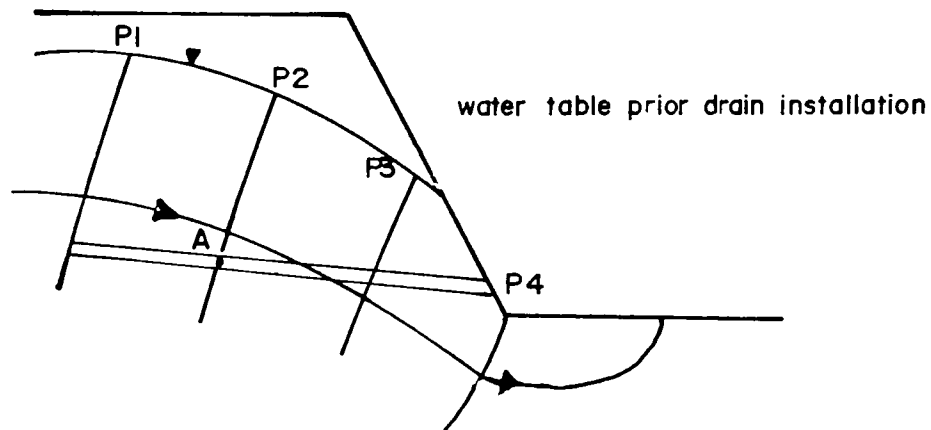
CASE 1
 ASSUME NO VACUUM ($P_4 = 1 \text{ atm.}$)
 $H \text{ AT POINT A} = P_2 - 1 \text{ atm.}$

CASE 2
 ASSUME VACUUM ASSIST
 $H \text{ AT POINT A} = P_2 - 0 \text{ atm.}$

CONSEQUENCE : GRADIENT IS GREATER: CASE 2

FIGURE 17 INCREASED HYDRAULIC GRADIENT UNDER VACUUM

- Vacuum assist drainage enables an individual drain to exhibit a wider zone of influence. This is partly due to an increased permeability; the capillary effects within the joints are partially negated by the increased hydraulic gradient, (Figure 17). In addition, the water table can be drawn a further 5 m below the level of the drain. Consequently fewer drains have to be installed in order to produce benefits similar to those of gravity drains.

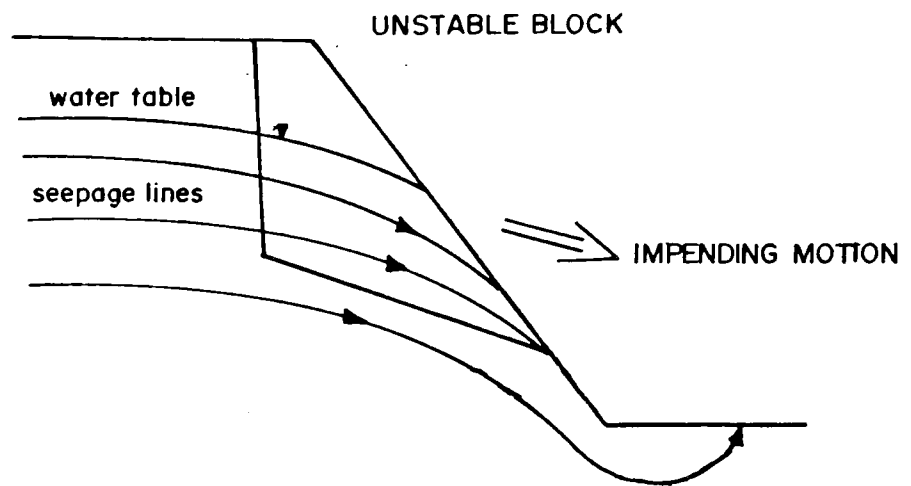
FIGURE 18A SEEPAGE FORCES REDUCING STABILITY

- Vacuum assist drainage may be employed in sub-surface galleries in order to assist drainage in the stabilizing of major slides.
- Vacuum drainage re-directs seepage forces so that they act perpendicular to the failure surface. This is shown by Figures 18A and 18B whereby the drain is below the failure plane. The consequence is that the normal load acting on the failure plane is increased and, as a result, the shear strength of the material is increased.

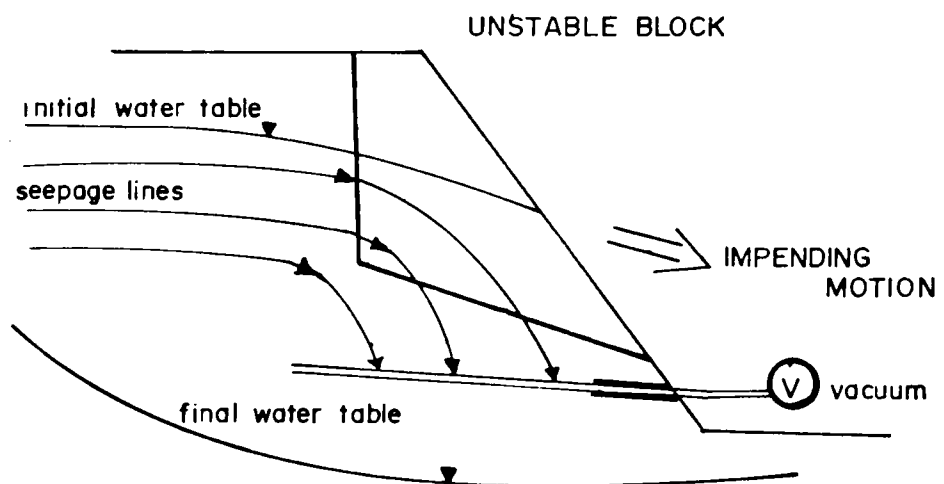
FIGURE 18B SEEPAGE FORCES INCREASING STABILITY

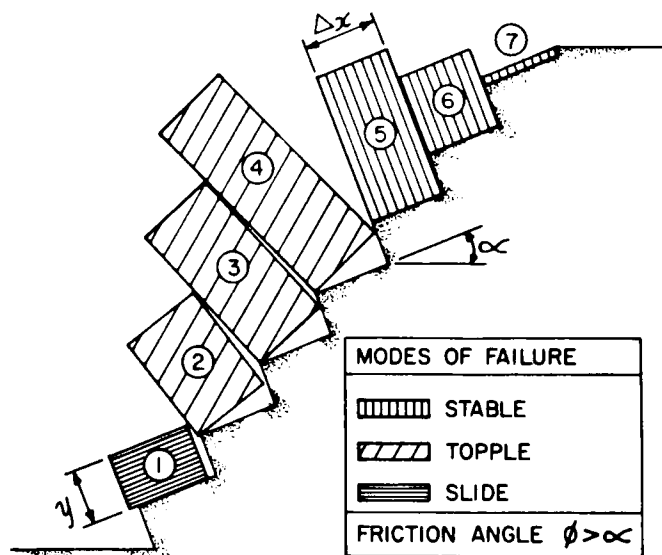
Short slabs at the crest which do not meet the criterion shown in Equation (1) and do not slide on the base, are stable (Figure 1, slabs 5,6,7). A longer slab which topples (slabs 2,3,4) exerts a thrust on the slab immediately below it on the slope. This thrust produces a turning moment on the lower block which increases its tendency to topple creating a "domino effect".

Figure 1 Mechanism of Toppling Slope Failure

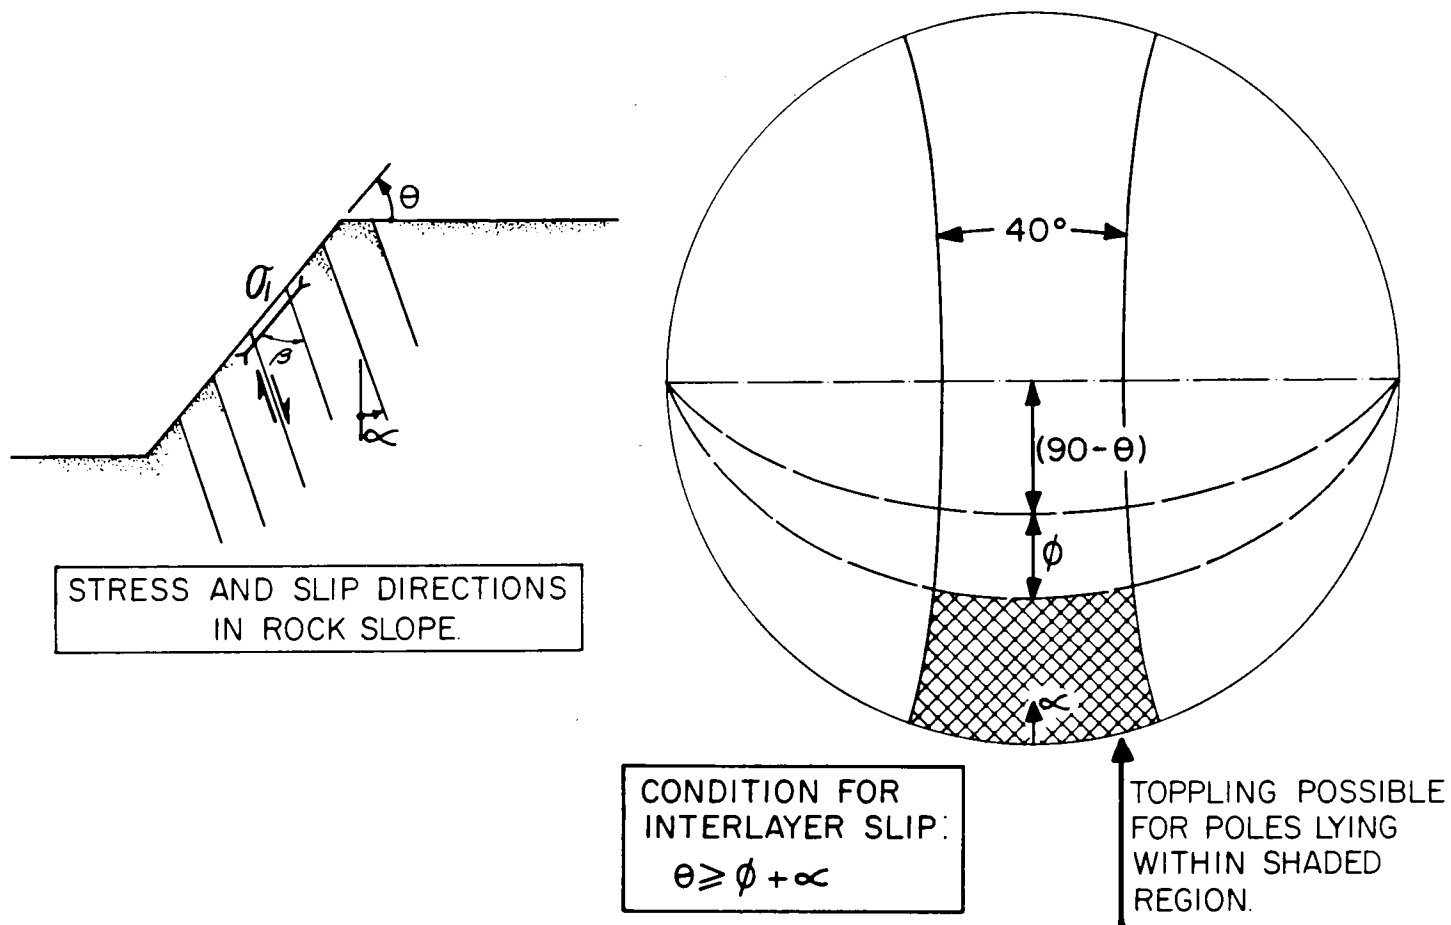
Figure 2 Kinematic Condition For Flexural Slip Which Precedes Toppling

This condition for slip is shown on the stereonet Figure 2 where planes with poles lying within the shaded region, i.e. dips range from $\alpha = 0$ (vertical) to $\alpha = (\theta - \phi)$, have potential for causing toppling. The lateral limits of the shaded zone are governed by the range of strike of the planes in relation to the strike of the cut. Where the strike of these planes differs from the strike of the slope by an amount greater than about 20° , the planes form a series of stepped faces with each slab supporting the one behind it and toppling failure is inhibited. There-

Figure 2 illustrates a slope cut at an angle of θ° , containing fractures which dip into the slope at an angle of $(90-\infty)$. Assume that the friction angle of these fractures is θ . In the region of the slope close to the face, there will be a uniaxial stress condition with stress σ_1 , parallel to the slope face, the normal and shear stresses acting on the fractures are:
