PROCEEDINGS of the 33rd ANNUAL HIGHWAY GEOLOGY SYMPOSIUM

ENGINEERING GEOLOGY and ENVIRONMENTAL CONSTRAINTS

PROCEEDINGS OF THE 33RD ANNUAL
HIGHWAY GEOLOGY SYMPOSIUM

Engineering Geology
and
Environmental Constraints
in
Vail, Colorado
1982

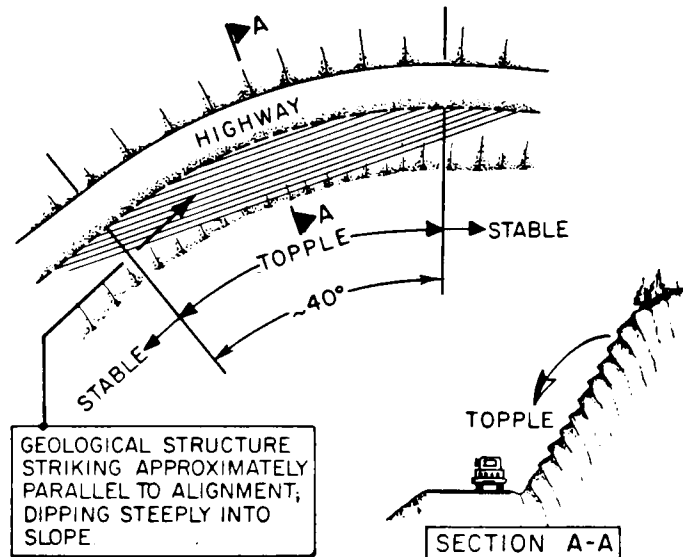
fore, the difference between the strike of the fractures causing toppling and the strike of the highway cut will show the approximate lateral extent of the toppling failure (Figure 3). This figure also shows that the smaller the radius of the curve, the shorter the length of the toppling failure.

Figure 3 Relationship between highway curvature and toppling failure

- c) Realign the highway so that the strike of the cut slope is not parallel to the strike of the toppling fractures. The difference in angle should be about 20° to ensure that continuous faces of toppling slabs are not exposed. Figure 4(c) shows re-alignment of a tangent, while Figure 3 shows how the radius of curvature influences the length of a toppling slope.

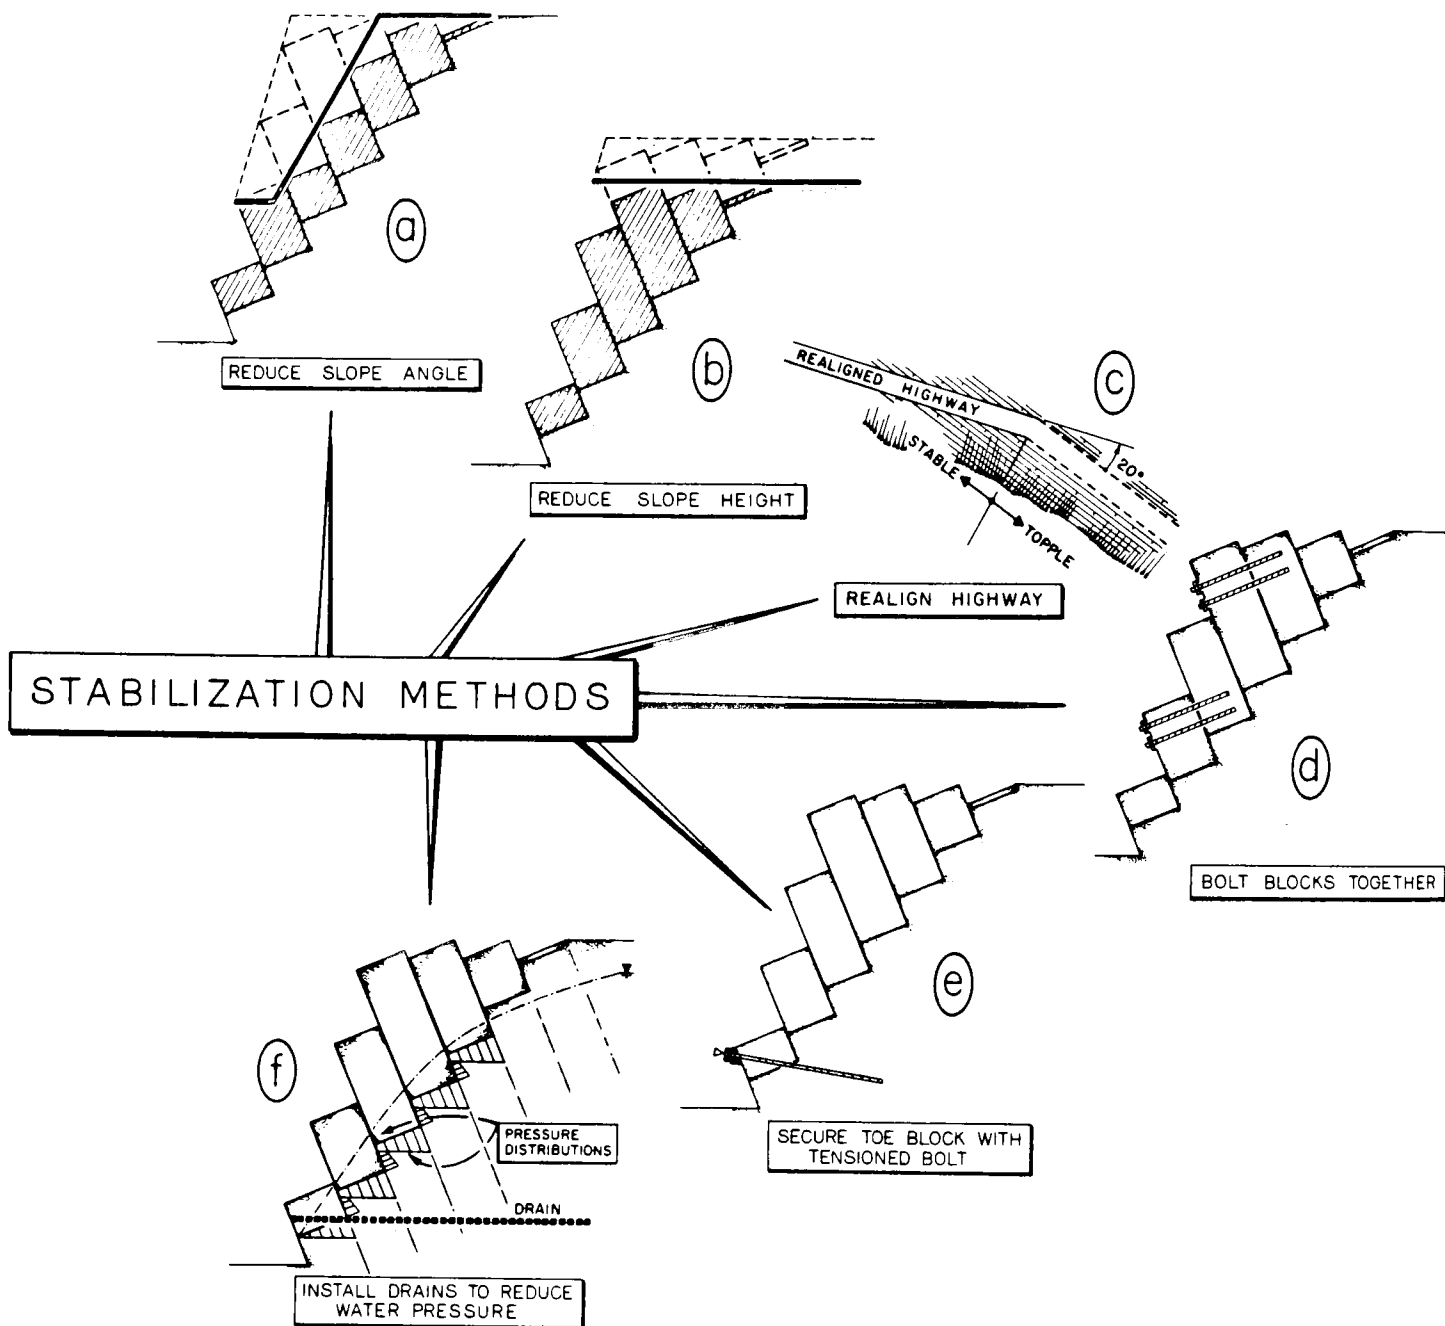
The following paragraphs discuss six different stabilization methods for toppling failures, and discuss the relative merits and practicability of each. The techniques are shown diagrammatically in Figure 4.

Figure 4 Stabilization Methods for Toppling Failures

Drainage can often be achieved by drilling horizontal drains from the toe of the slope as illustrated in Figure 4(e). If there is little hydraulic connection between the steep fractures forming the toppling slabs, then the drain must be long enough to intersect those fractures which outcrop near the slope crest to ensure good drainage. Piezometers should also be installed to monitor water pressures.

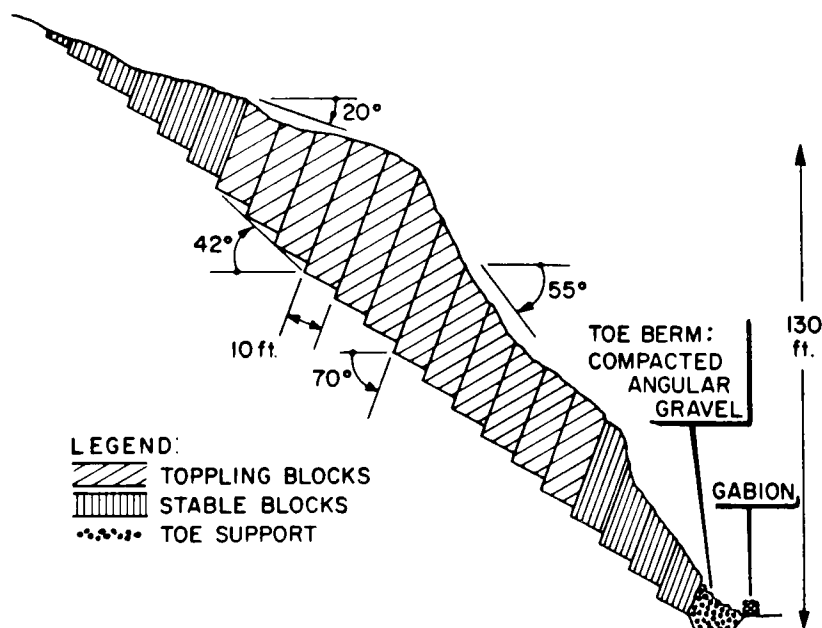
Figure 5 Toe Berm to Stabilize Toppling Slope Failure

This paper also describes a 130 ft. high toppling rock slope failure which was stabilized by constructing a compacted gravel toe berm. The berm incorporated a gabion wall which formed a ditch to catch rock falls.

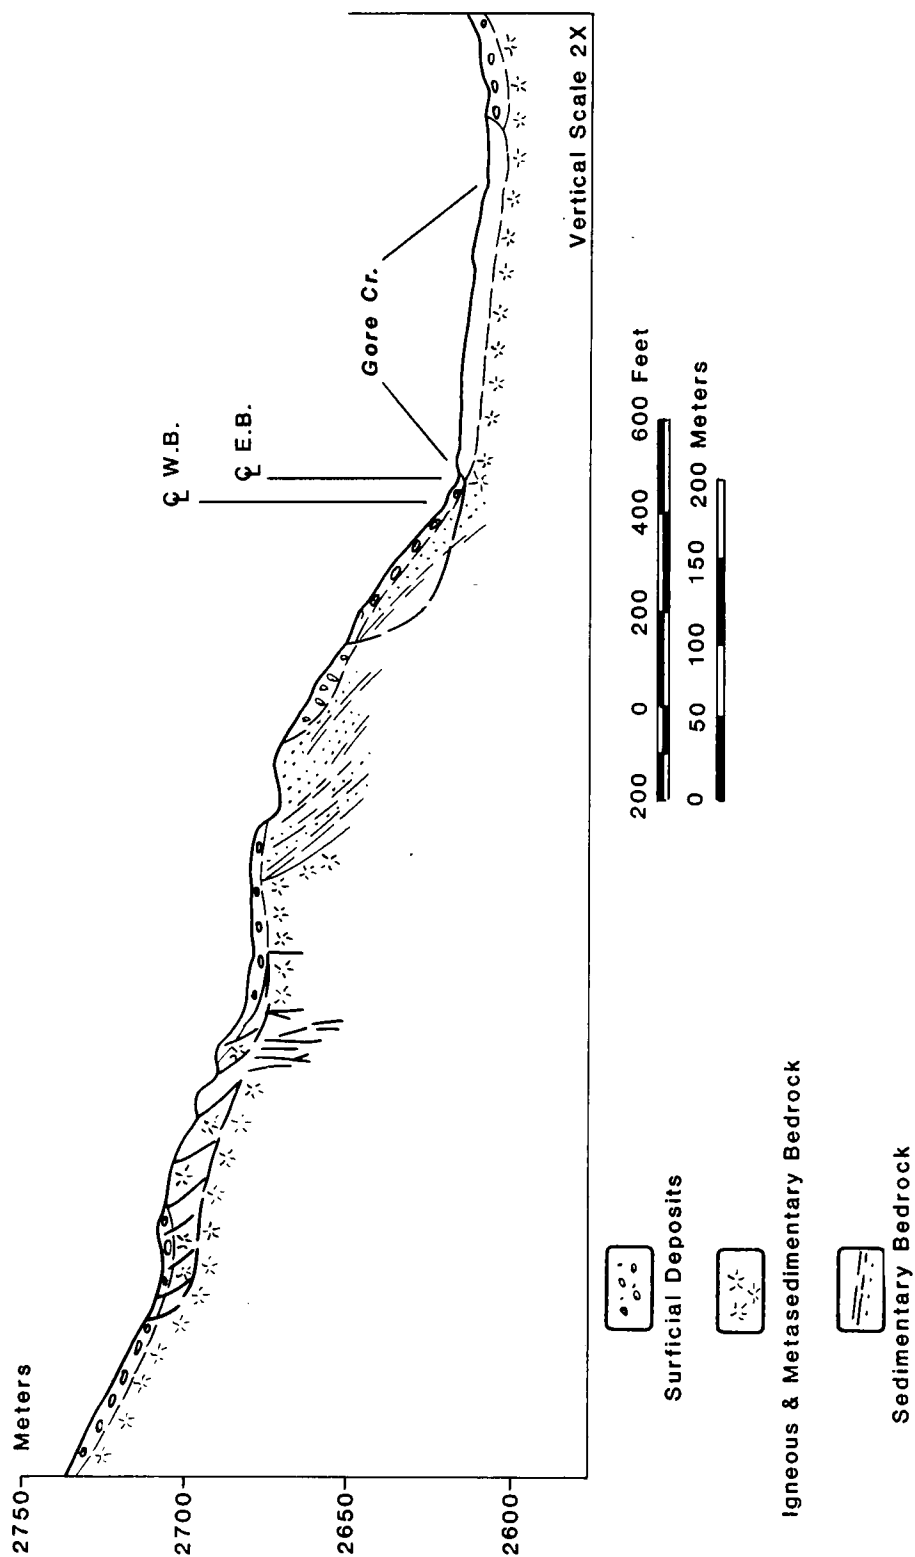
**Figure 5.--CROSS SECTION OF BEDROCK LANDSLIDE
IN IGNEOUS AND METASEDIMENTARY ROCK (Station 3)**

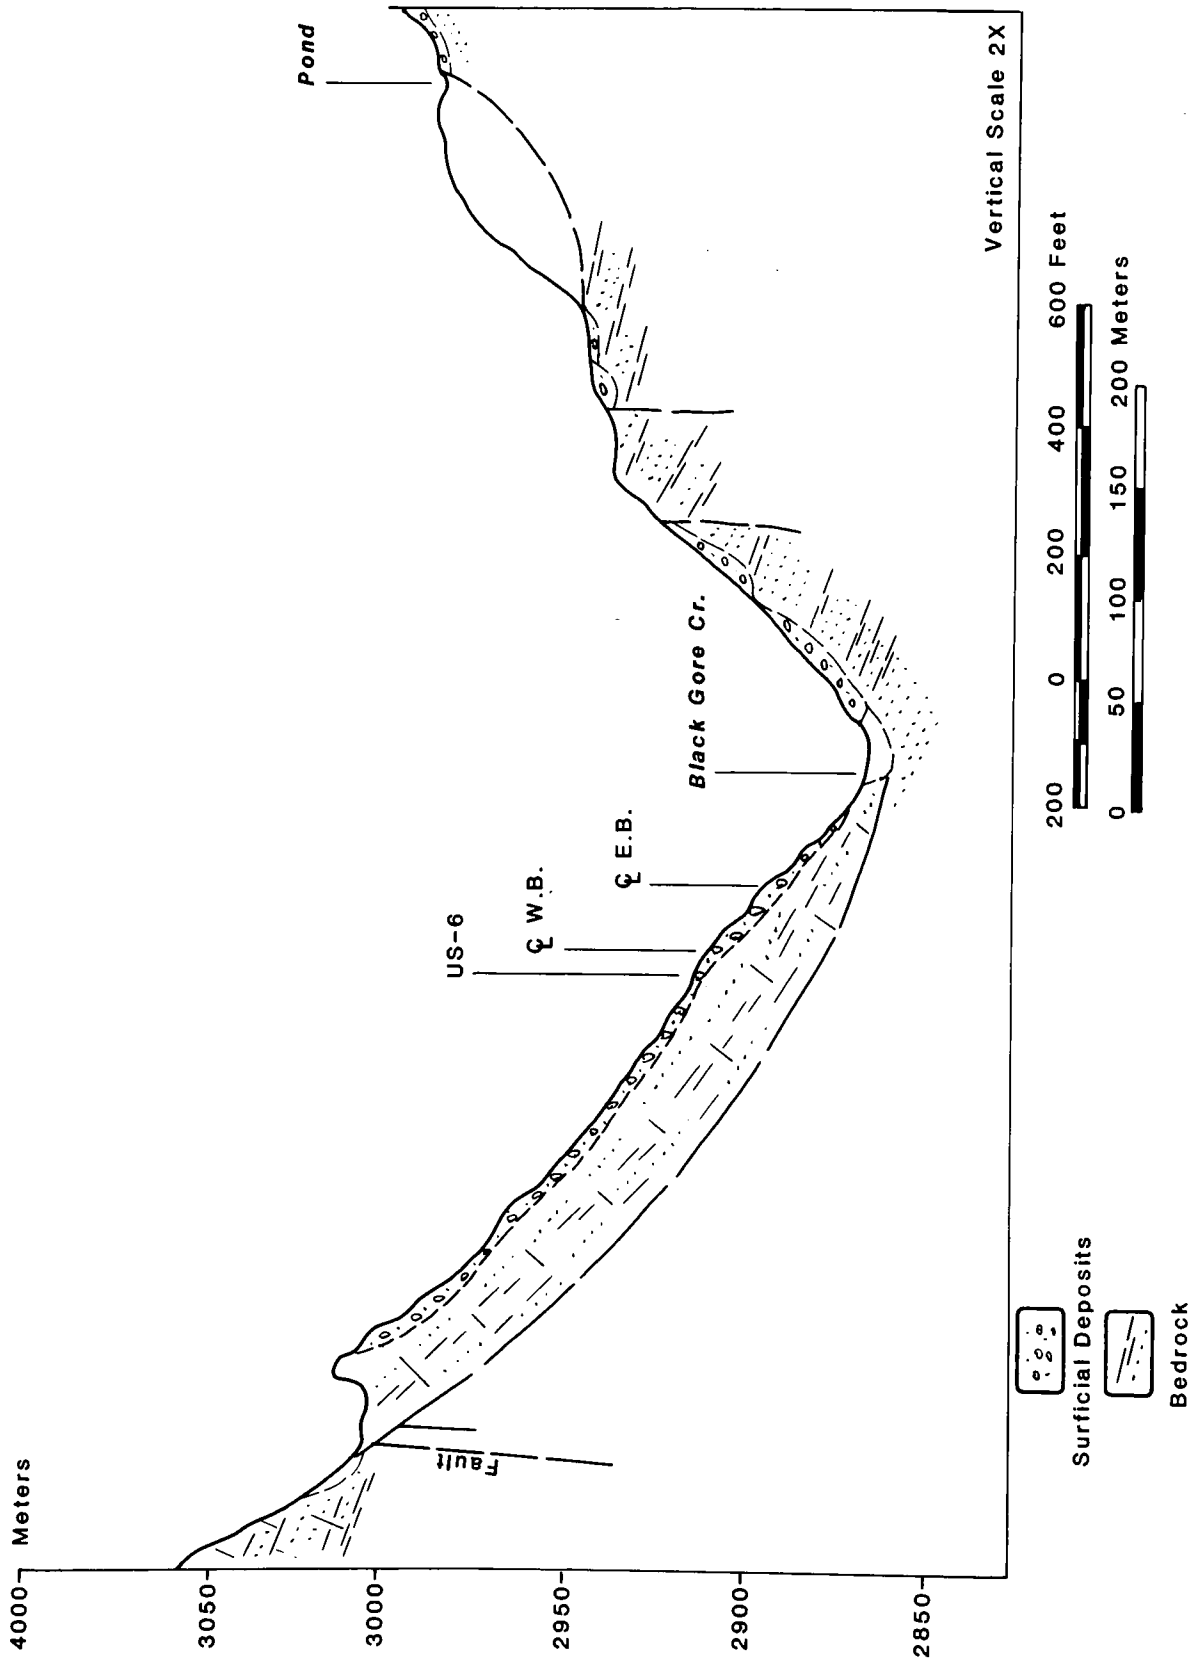
**Figure 6.--CROSS SECTION OF BEDROCK LANDSLIDE IN SEDIMENTARY ROCK
VAIL PASS AREA, COLORADO**

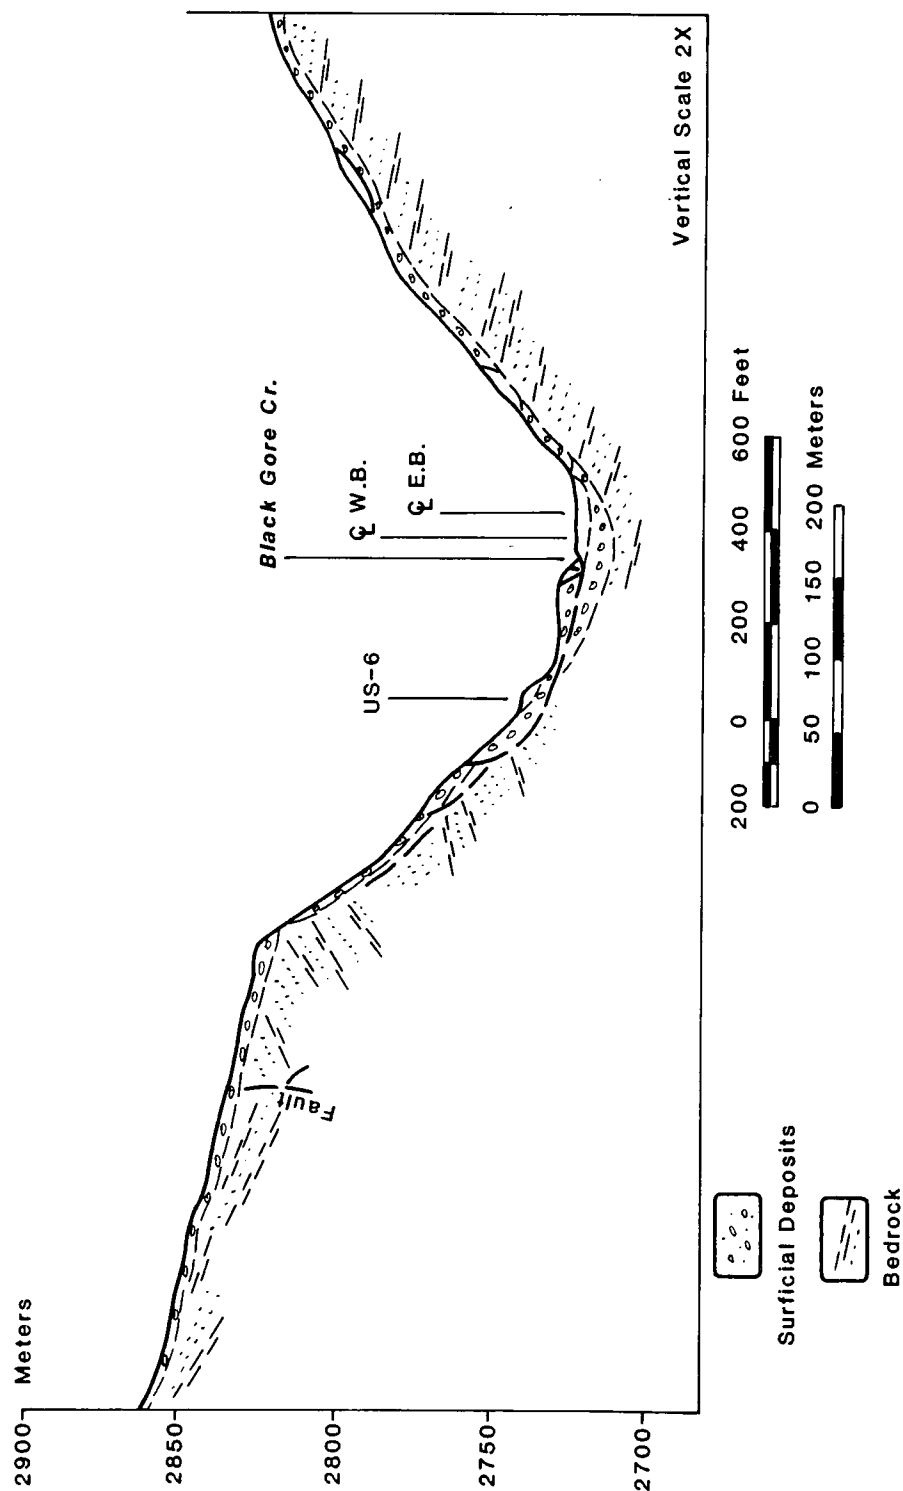
**Figure 7.--CROSS SECTION OF LANDSLIDE IN SURFICIAL DEPOSITS
VAIL PASS AREA, COLORADO**

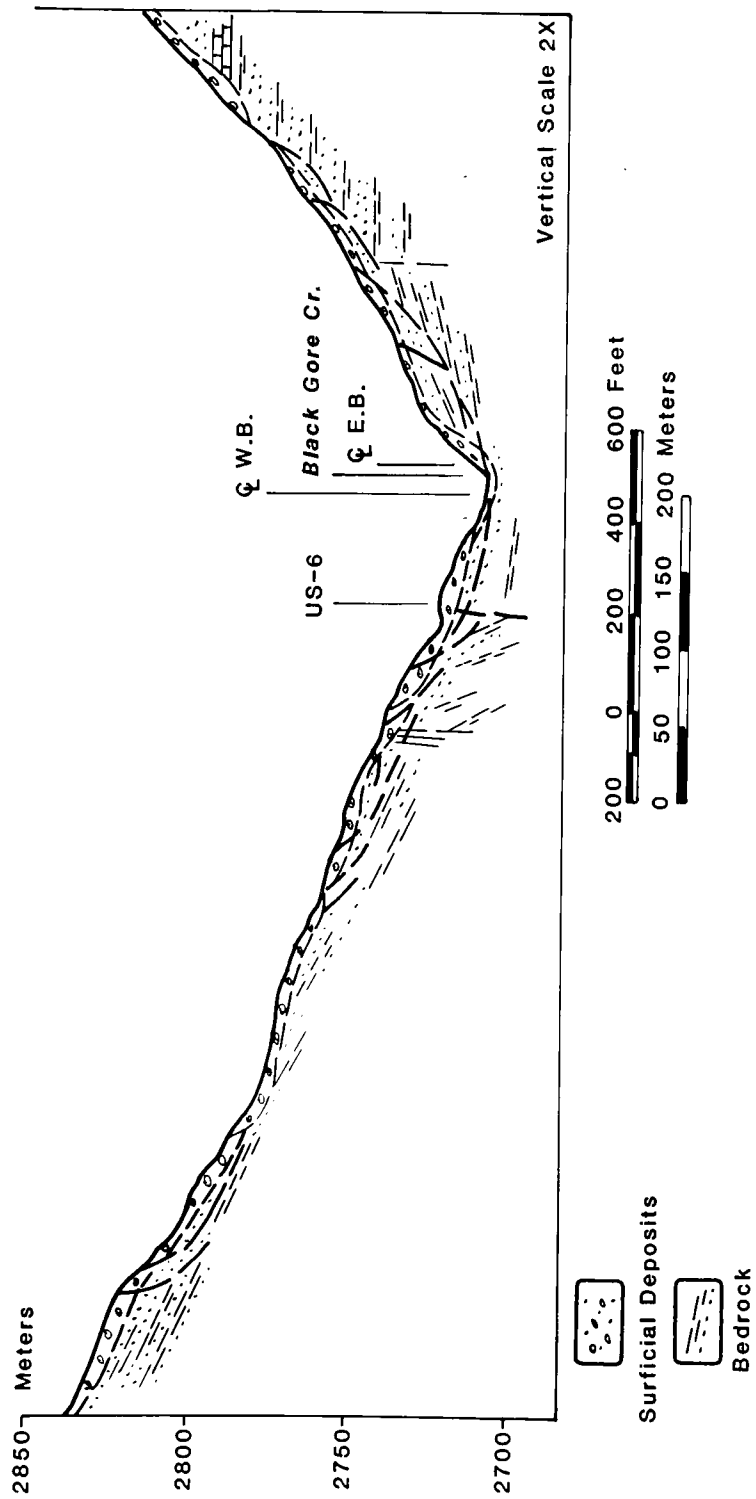
**Figure 8.--CROSS SECTION THROUGH ABUTING LANDSLIDES
VAIL PASS AREA, COLORADO**

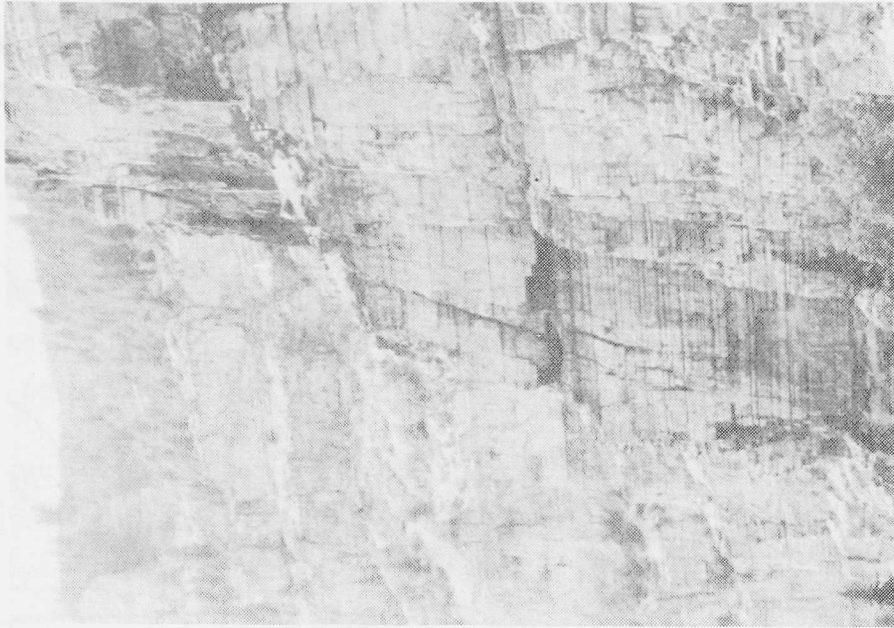
Fig. 8 - Rockfall hazard near Deadhorse Creek,
note the continuity of jointing and "wedging"
of lower block.

The in-place bedrock, where exposed along the right-of-way, possesses excellent bearing and stability characteristics. If there is a problem associated with the bedrock it is most certainly the significant risk of rockfall associated with almost the entire length of the Narrows. (Fig. 8).

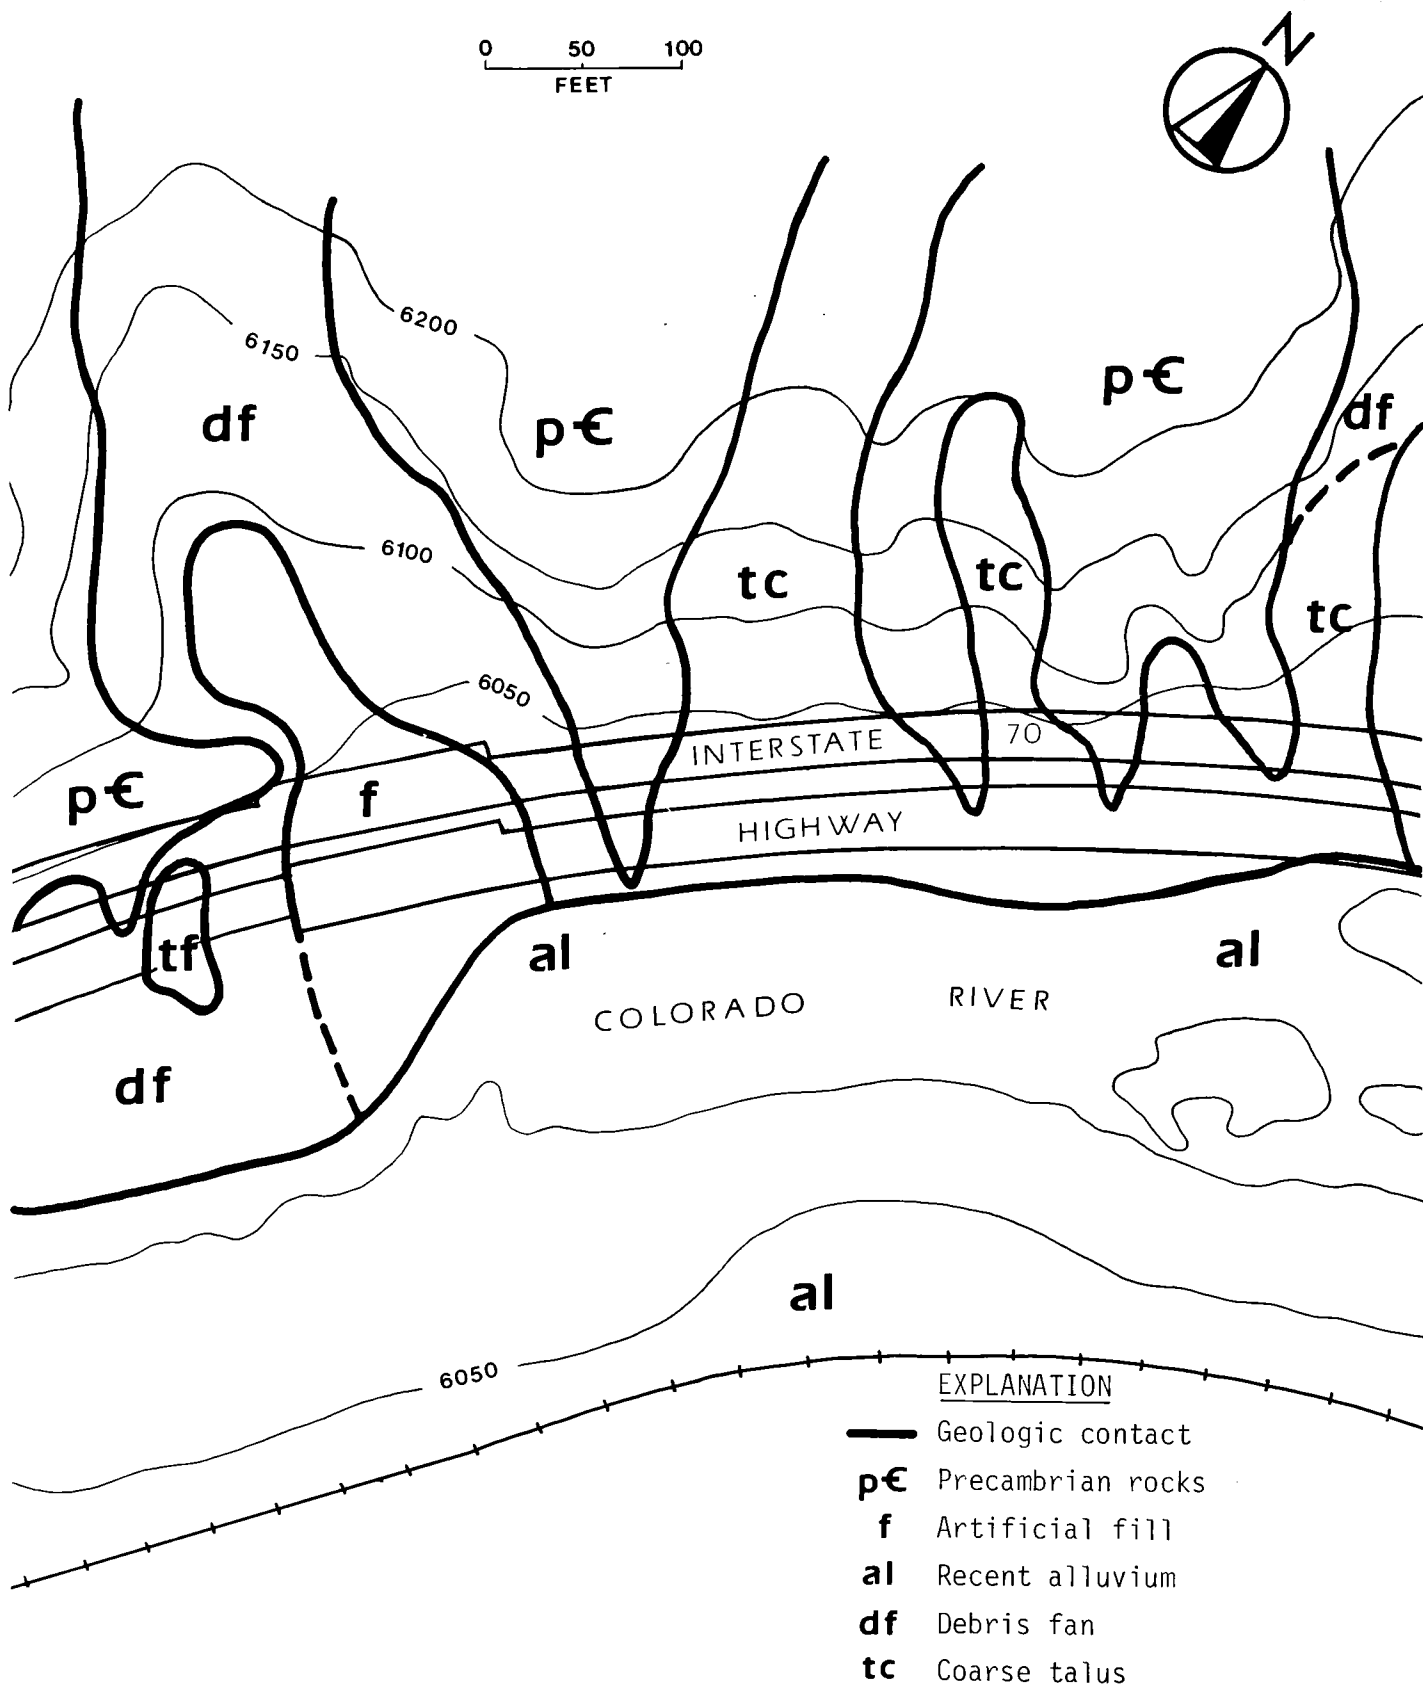
Fig. 9 - Engineering geology and surficial deposits along a reach of I-70 just west of Hanging Lake Reststop (from Colorado Dept. of Highways).

The Glenwood Canyon is deeply incised through several thousand feet of early Paleozoic sedimentary and pre-Cambrian igneous and metamorphic rocks of the White River Uplift (Fig. 1). The bottom of the canyon, also known as the Narrows, contains Quaternary deposits including talus, debris fans, terrace deposits and thick clay beds (Fig. 9).

Quaternary deposits of talus, debris fans, alluvium and clay lenses can be observed in a narrow, discontinuous zone bounded by the river channel and the confining bedrock cliffs (Fig. 9). These deposits generally underly the actual roadway alignment and their presence and abrupt boundaries represent the major engineering geological implications associated with the construction of the highway.

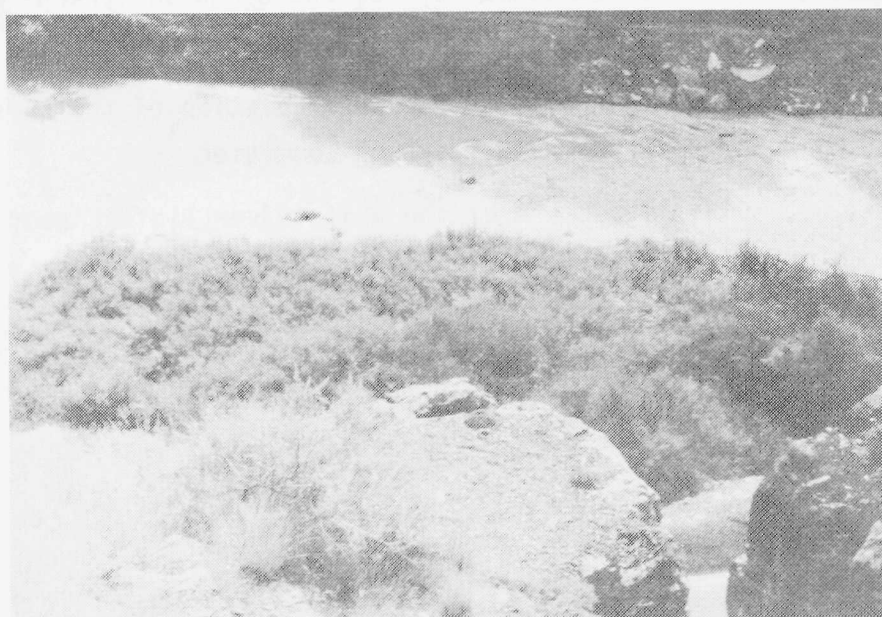
Fig. 11 - Debris fan at Tie Gulch restricts the channel to approximately half its normal width.

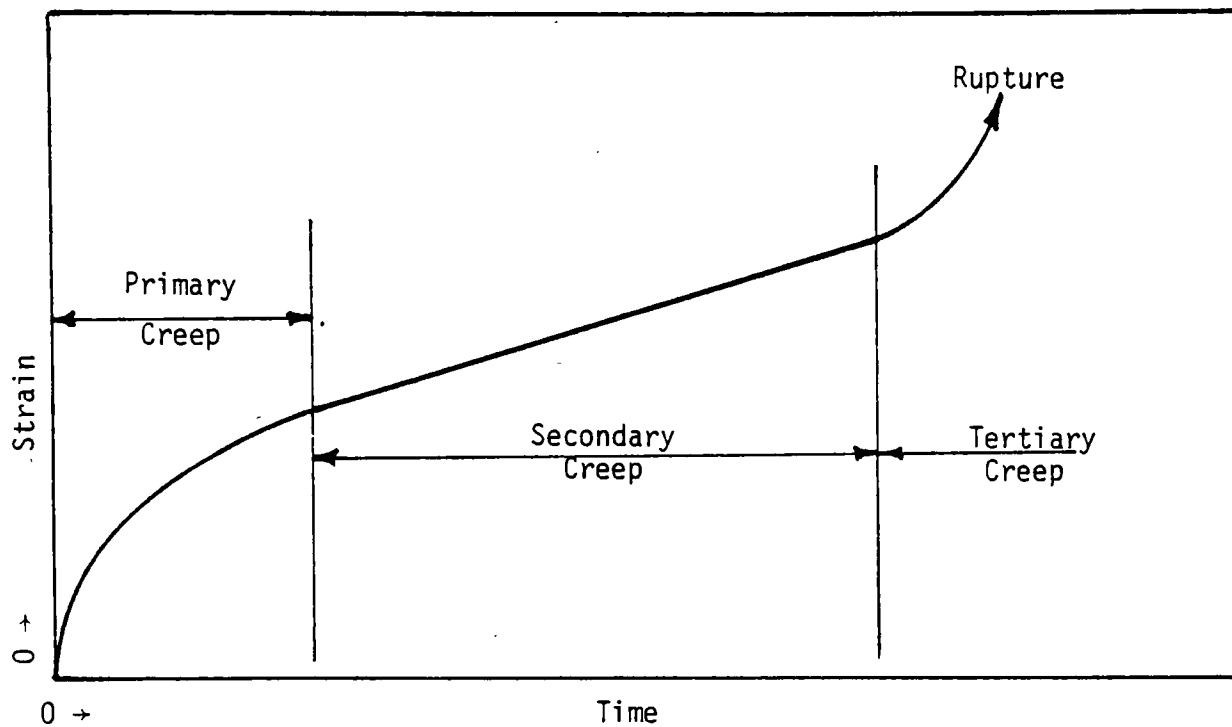
FIGURE 3 Phases of Creep for a Typical Geotextile Tested in Isolation at Constant Load and Temperature.

The recommended working loads in Table 2 are selected to prevent failure by tertiary creep. The various phases of creep are illustrated in Figure 3. Tertiary creep can be prevented by limiting the applied loads to values less than some critical value below which tertiary creep will not occur during the design life. Experience and tests show this critical value is controlled, for a given geotextile, by loading and environmental conditions. The recommended values were suggested by tests performed at Oregon State University (8).

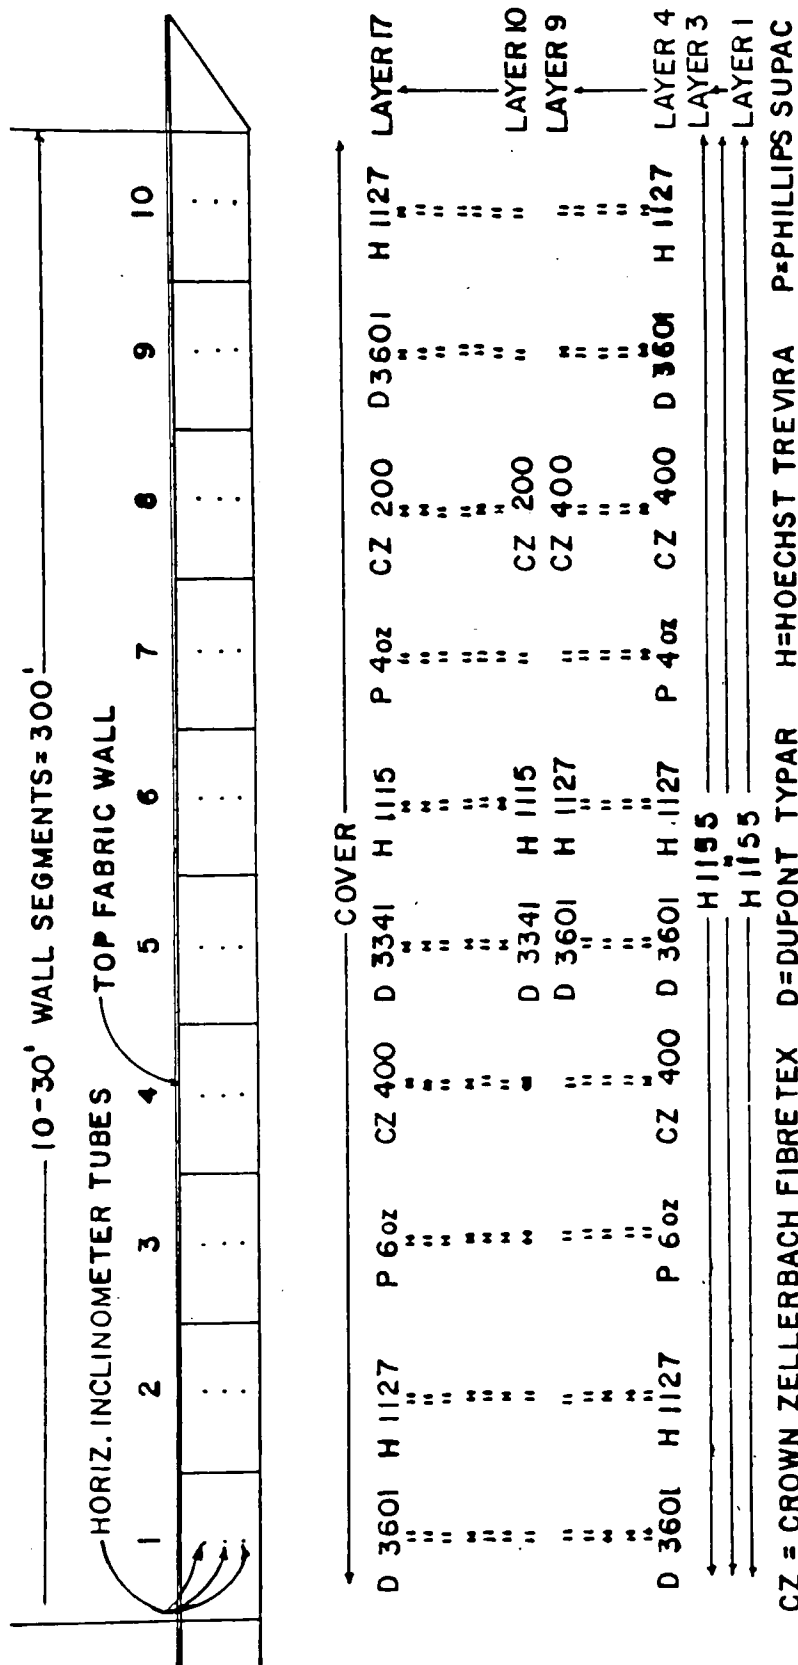
FIGURE 4 -- GEOTEXTILE WALL ELEVATION SHOWING TEST SEGMENTS AND FABRIC TYPES

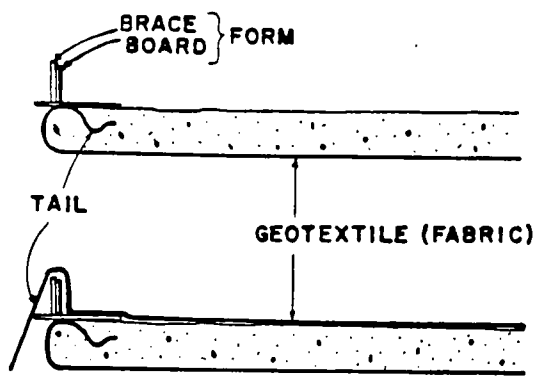
① SET FORM ON COMPLETED LIFT

② UNROLL FABRIC AND POSITION SO THAT A 3± FOOT WIDE "TAIL" DRAPES OVER THE FORM

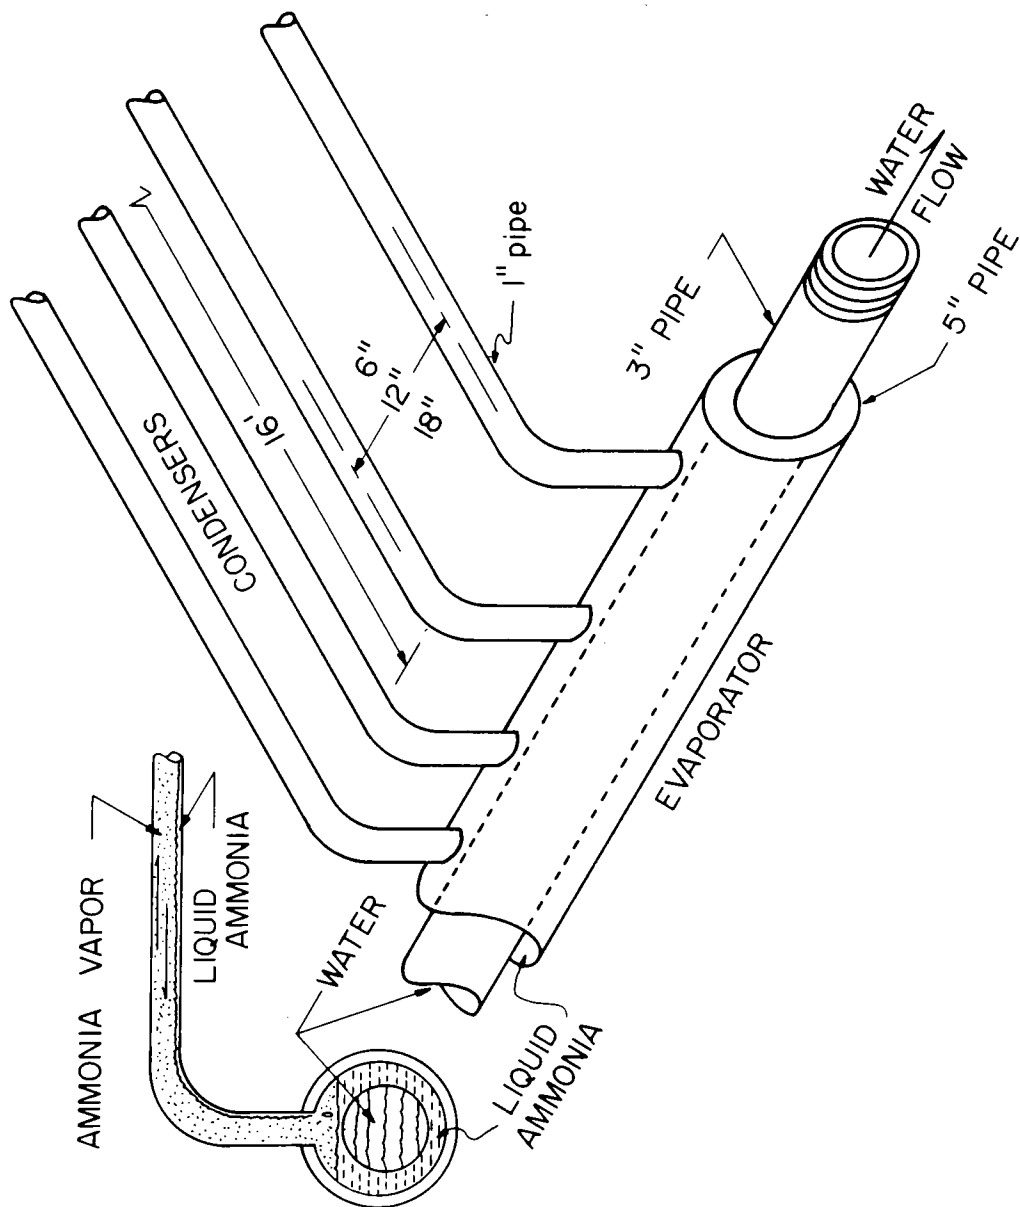
Figure 1. SETA's Heat Pipe Design for the Glenwood Springs Geothermally Heated Bridge.

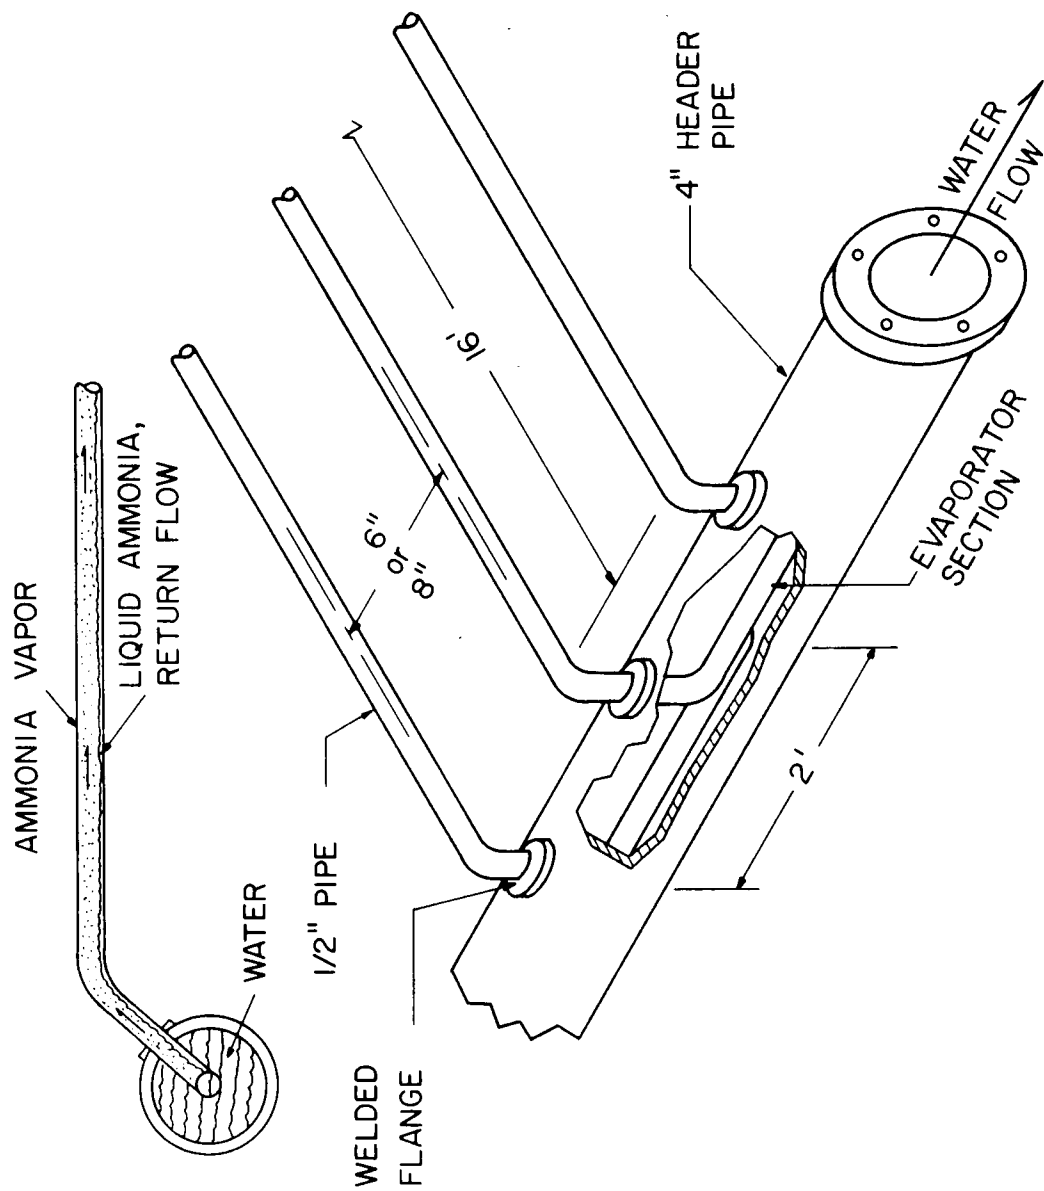
Figure 2. EEI's Heat Pipe Design for the Glenwood Springs Geothermally Heated Bridge.

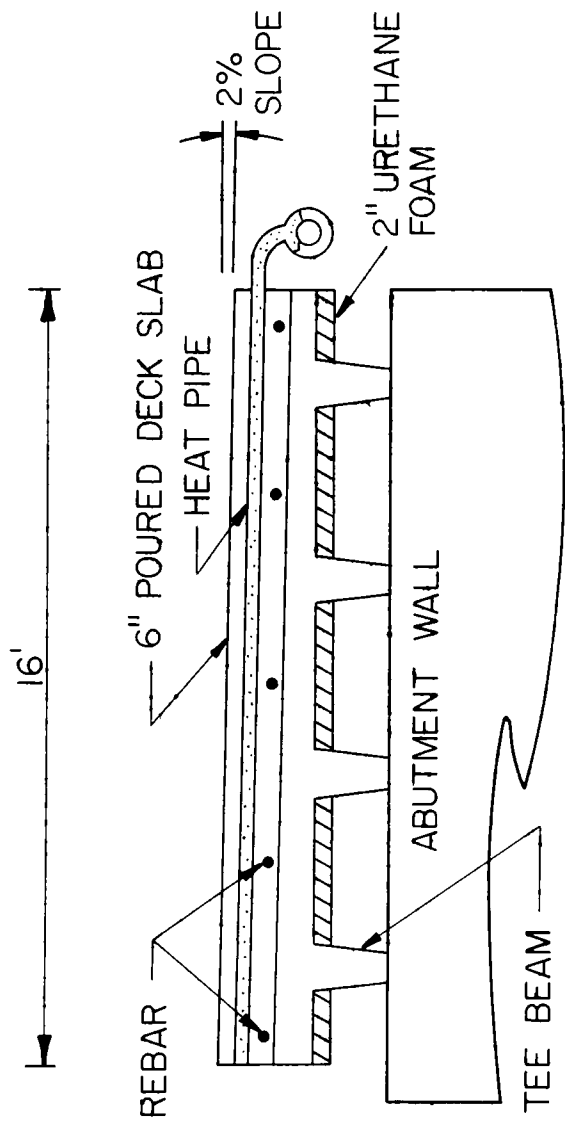
Figure 3. End View of Prototype Bridge.

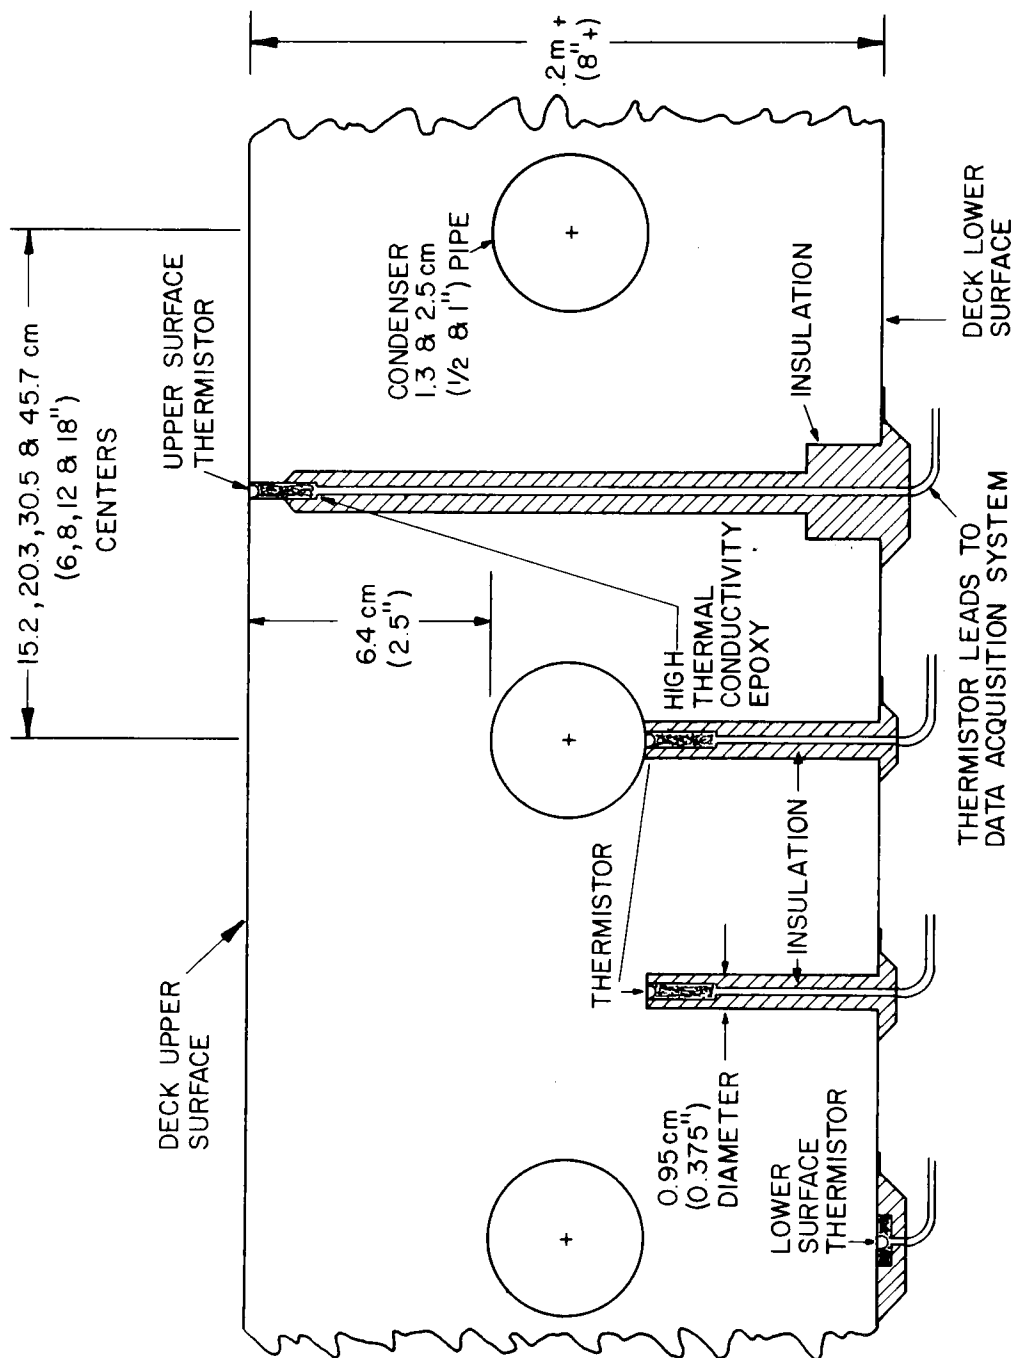
Figure 4. Typical Temperature Instrumentation in the Deck.

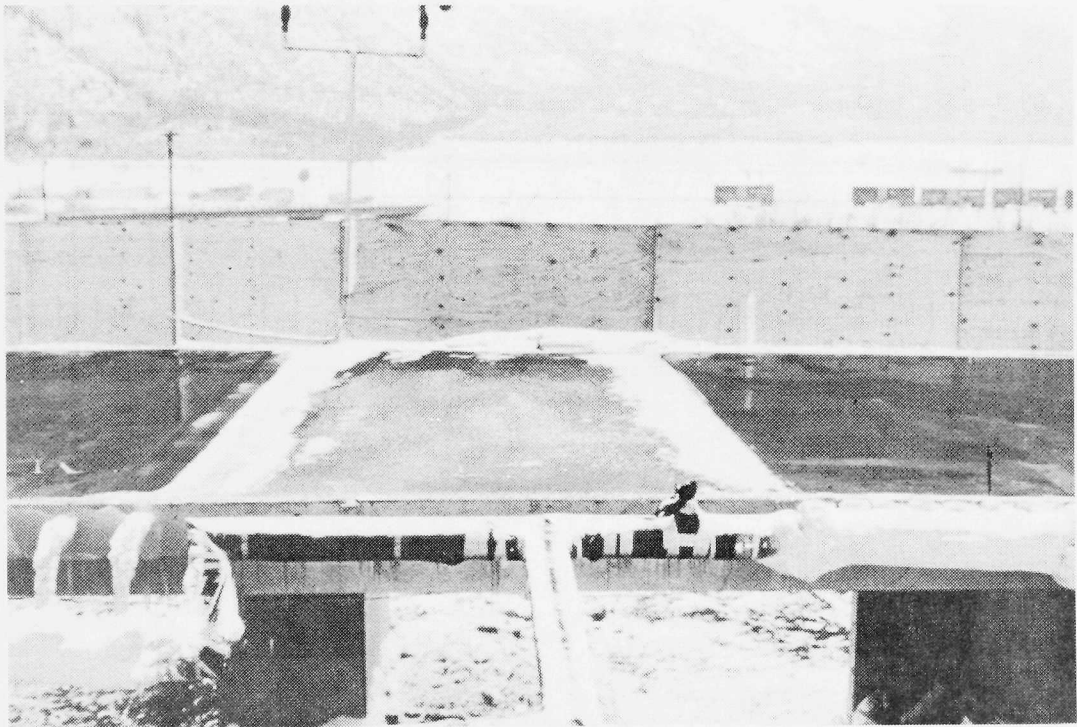
Figure 5. Typical Melting Event with an Ice Covered Unheated Control and Wet Heated Surfaces.

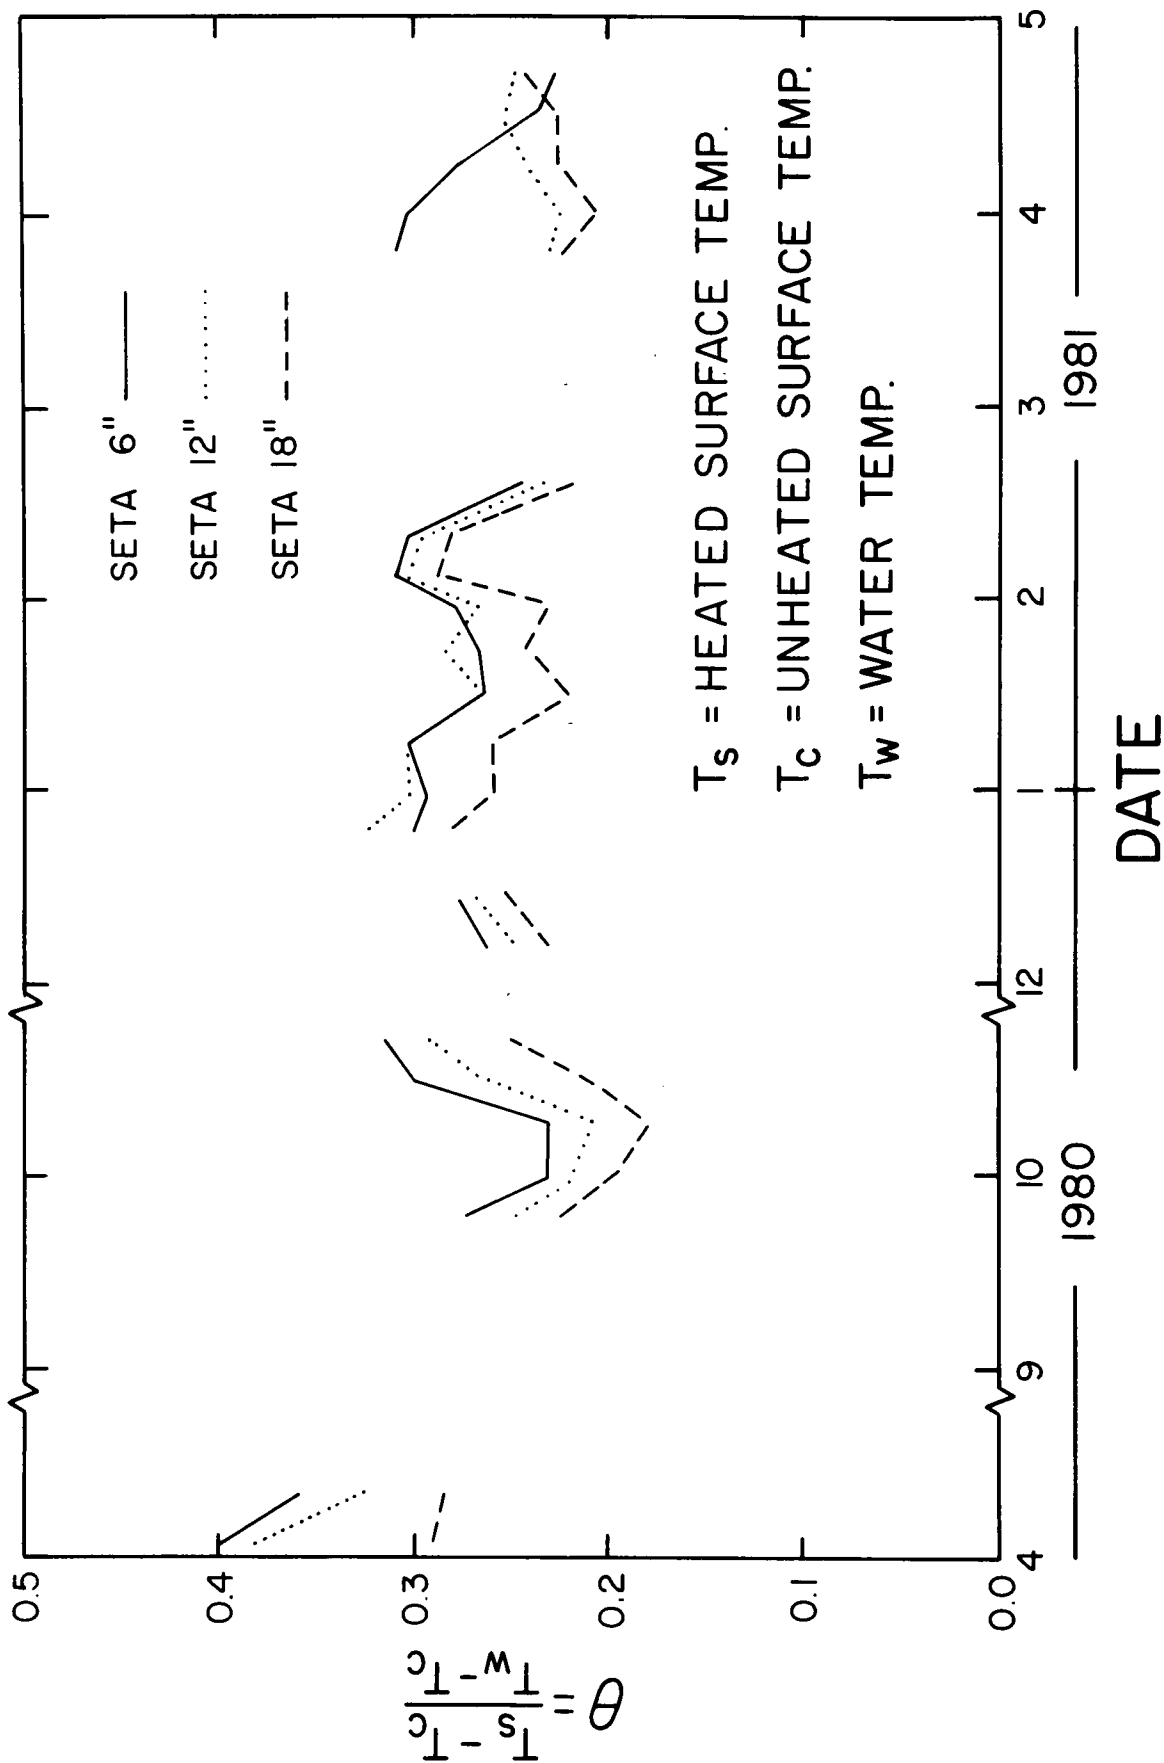
Figure 6. Coefficient of Performance θ versus Time for the SETA Heat Pipe Modulus.
