PROCEEDINGS of the 33rd ANNUAL HIGHWAY GEOLOGY SYMPOSIUM

ENGINEERING GEOLOGY and ENVIRONMENTAL CONSTRAINTS

PROCEEDINGS OF THE 33RD ANNUAL
HIGHWAY GEOLOGY SYMPOSIUM

Engineering Geology
and
Environmental Constraints
in
Vail, Colorado
1982

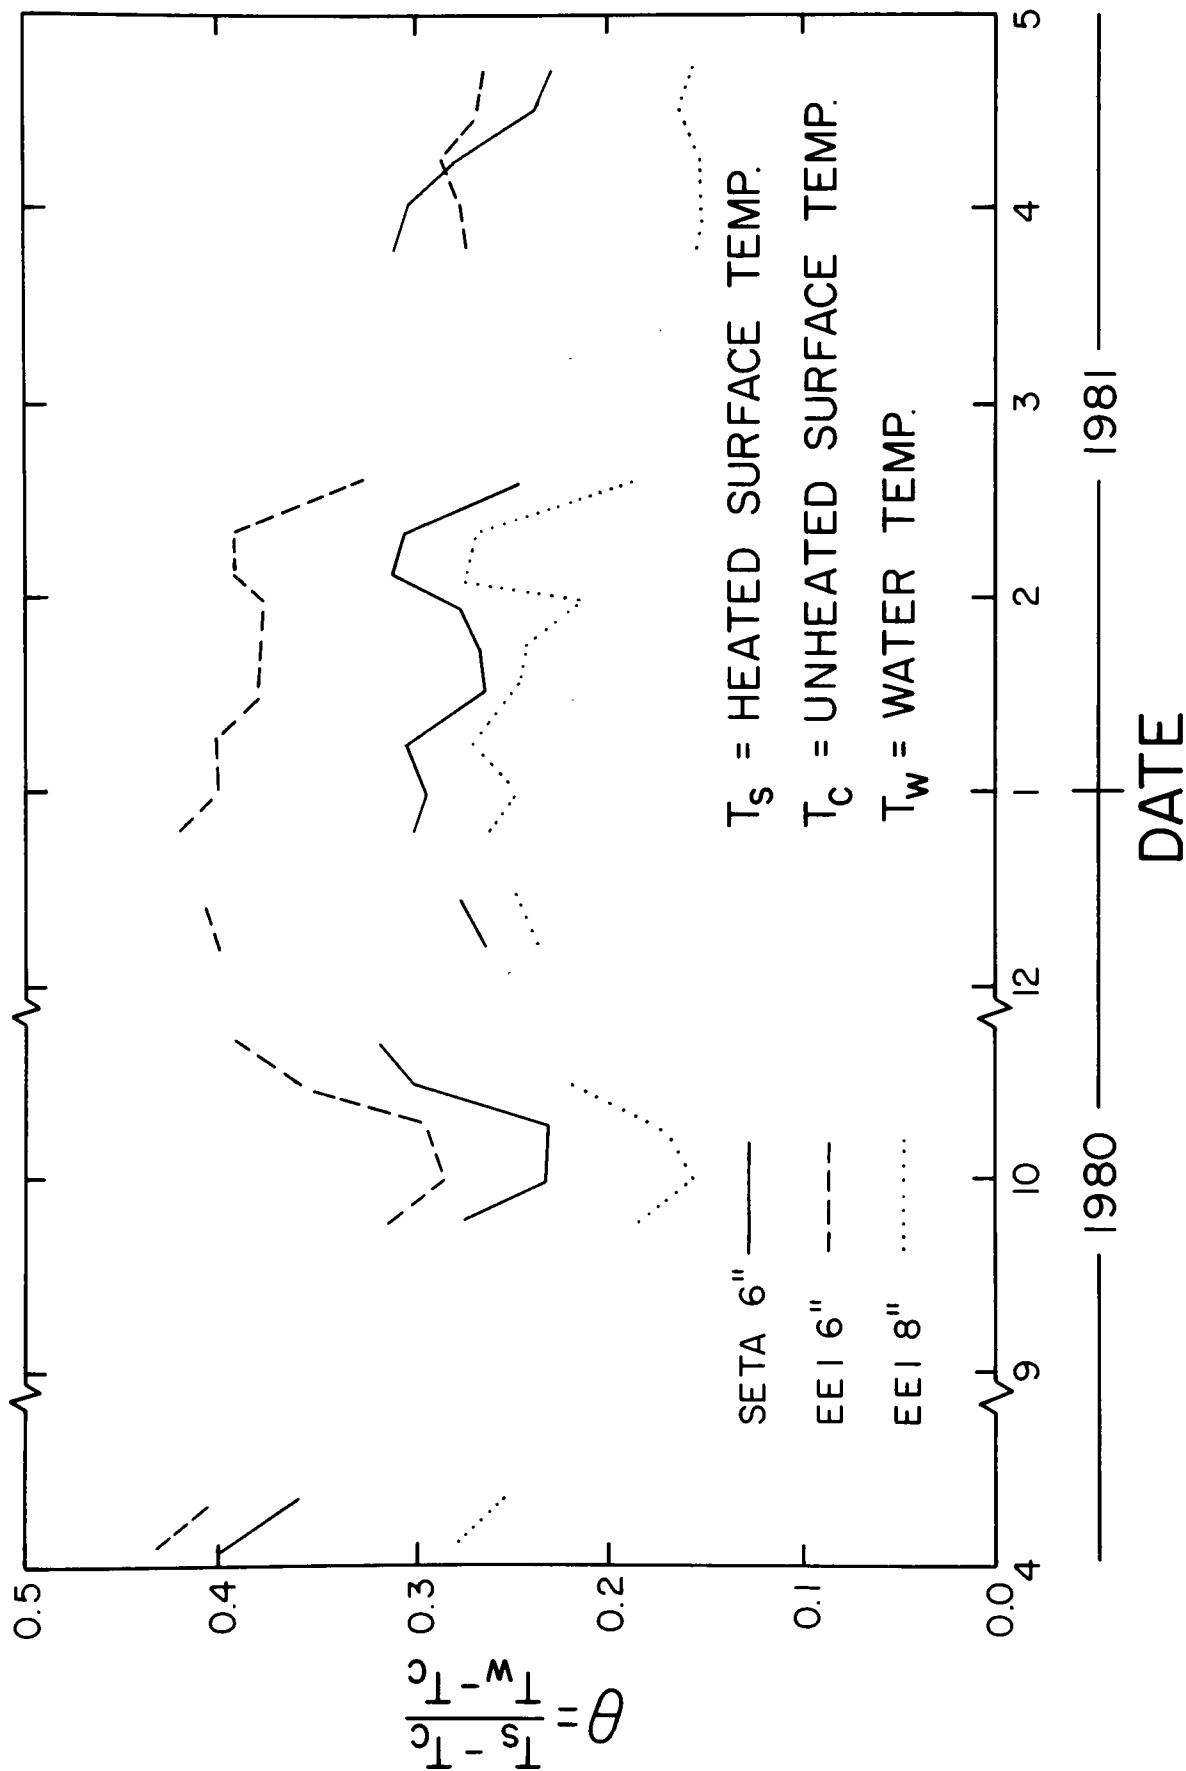
Figure 7. Coefficient of Performance θ versus Time for the EEI Heat Pipe Modulus and the SETA 6" Modulus.

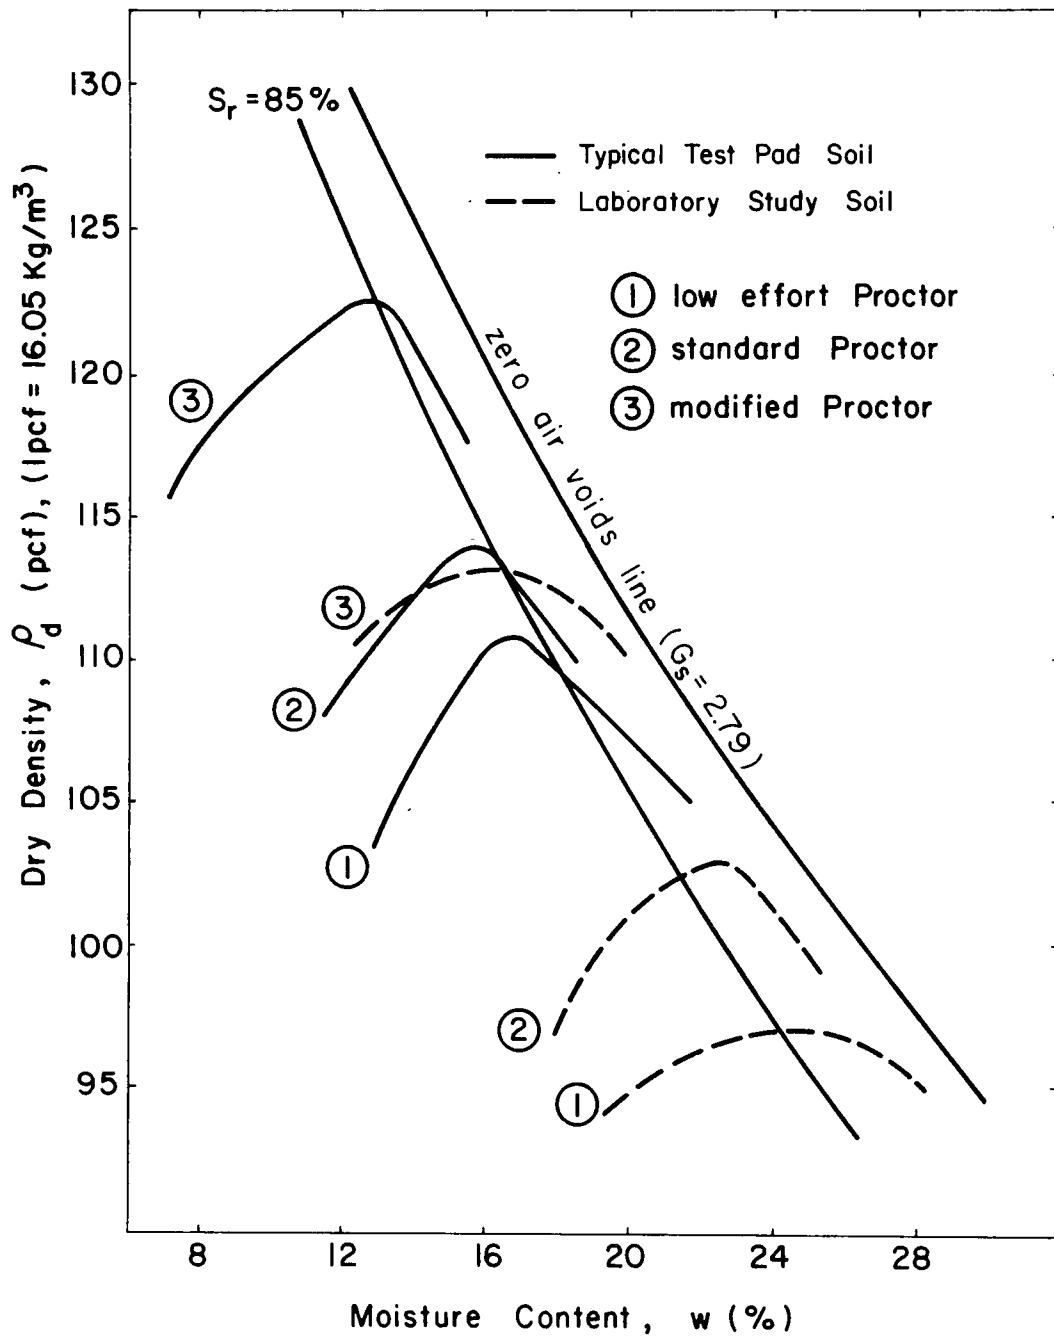
Figure 1: Impact Compaction Curves for Test Pad and Laboratory Study Soils.

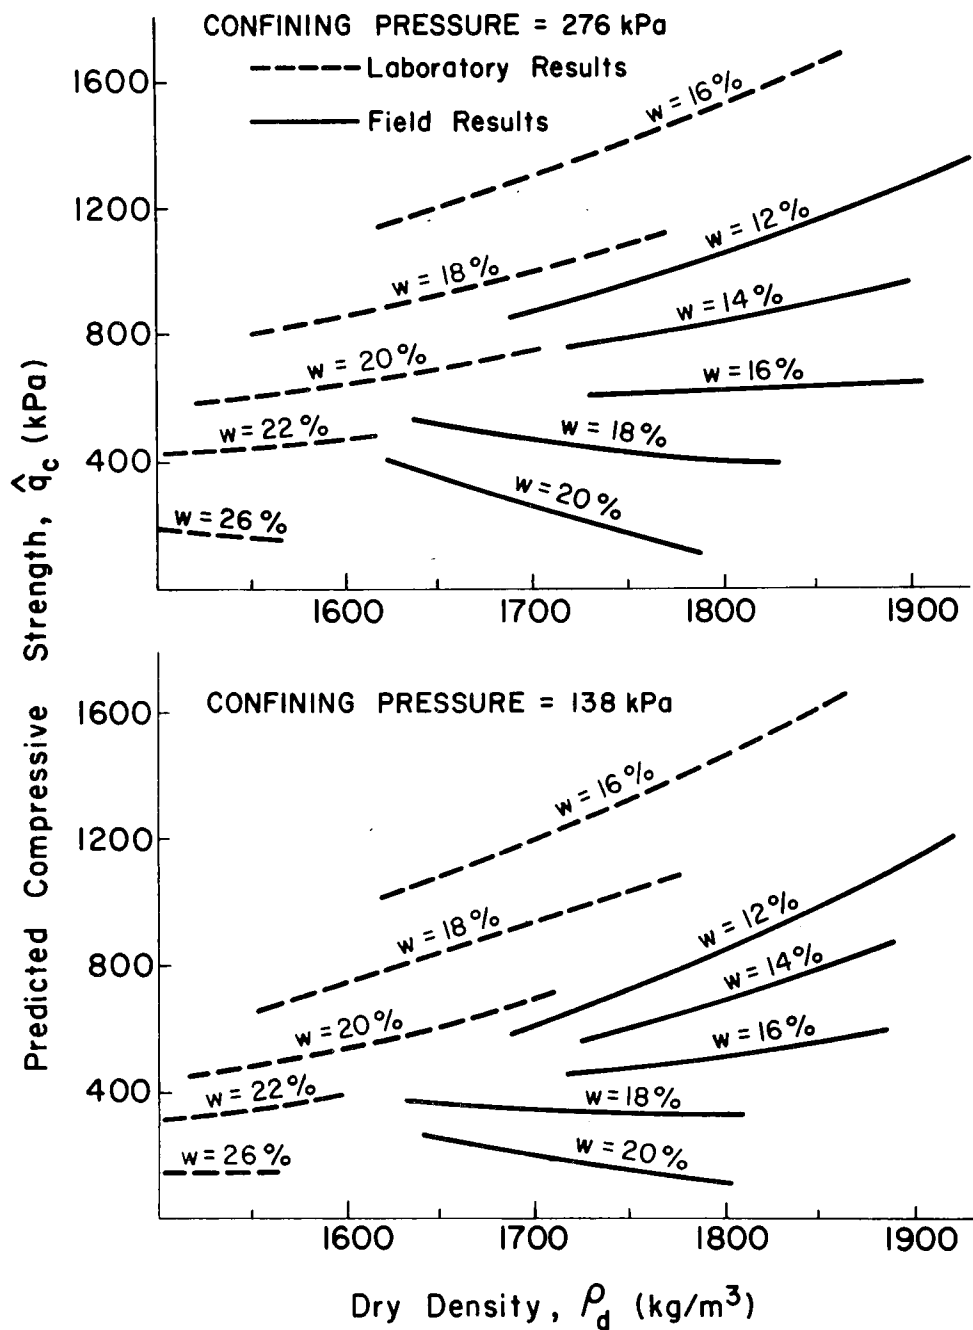
Figure 2: Predicted Compressive Strength–Dry Density Relationship at Constant Water Content.

where \hat{q}_c is the estimated compressive strength in kPa. Typical values are shown in Figure 2.

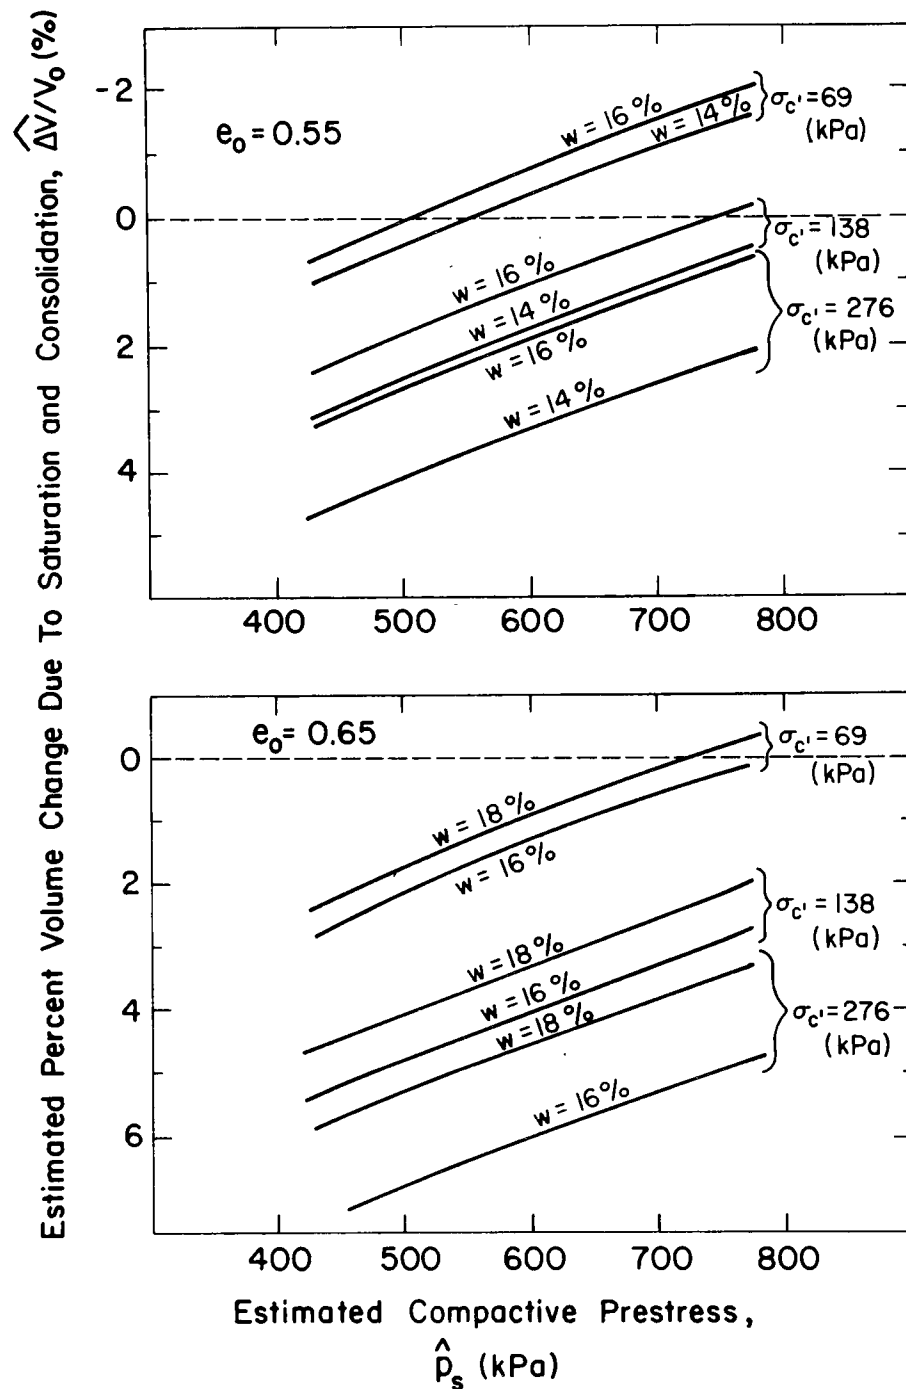
Figure 3: Prediction of Field Percent Volume Change Due to Saturation Under Confinement at a Constant Initial Void Ratio. (Swell is Negative)

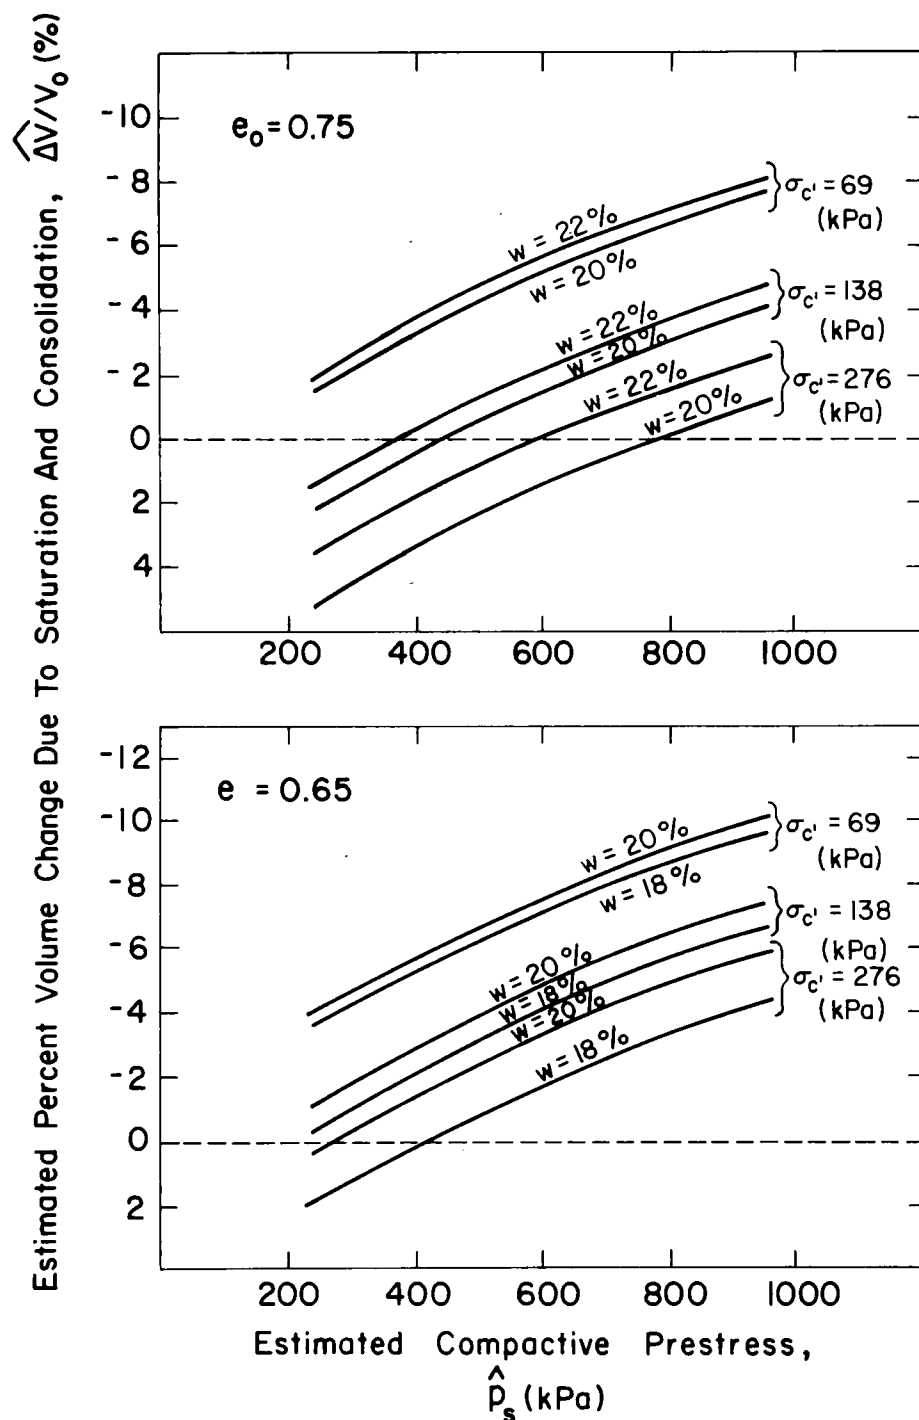
Figure 4: Prediction of Laboratory Percent Volume Change Due to Saturation Under Confinement at a Constant Initial Void Ratio. (Swell is Negative)

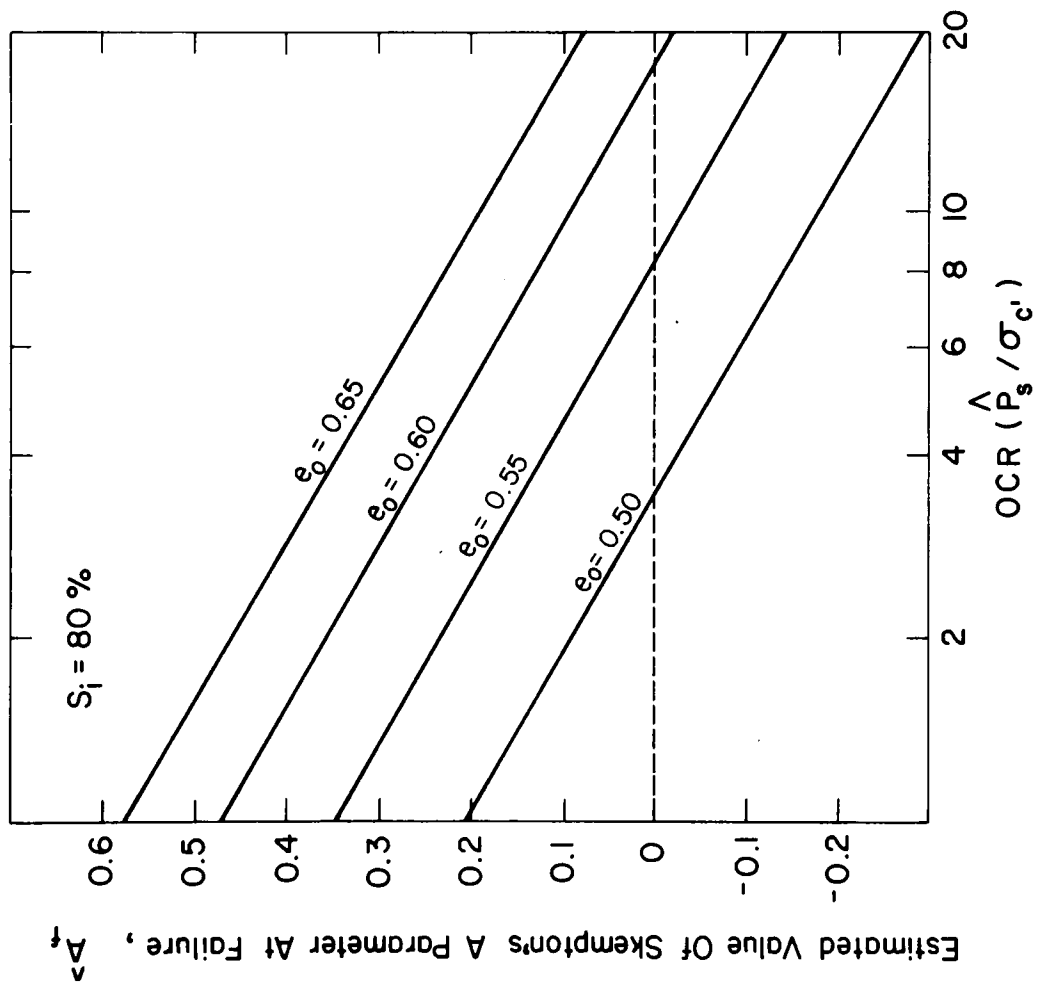
Figure 5: Field Skempton's A Parameter at Failure Verses OCR at a Constant Initial Saturation.

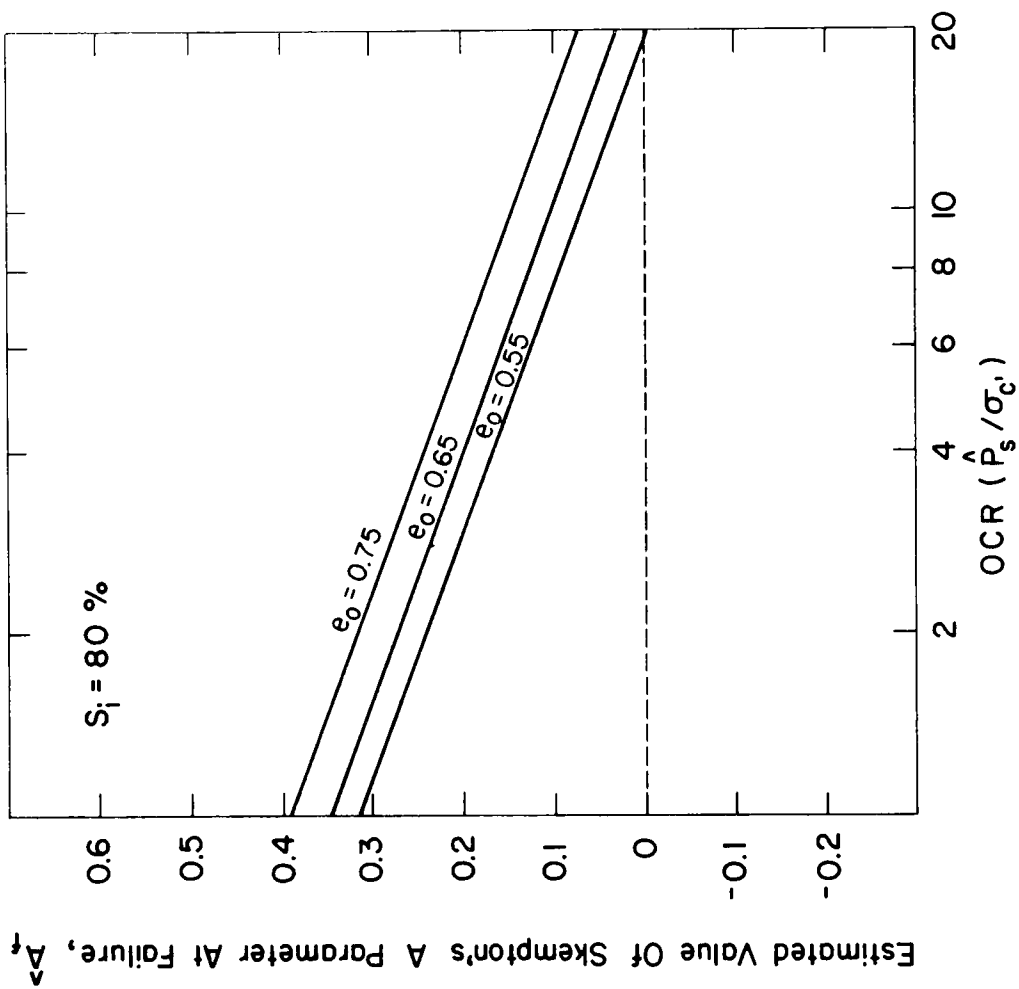
Figure 6: Laboratory Skempton's A Parameter at Failure Verses OCR at a Constant Initial Saturation.

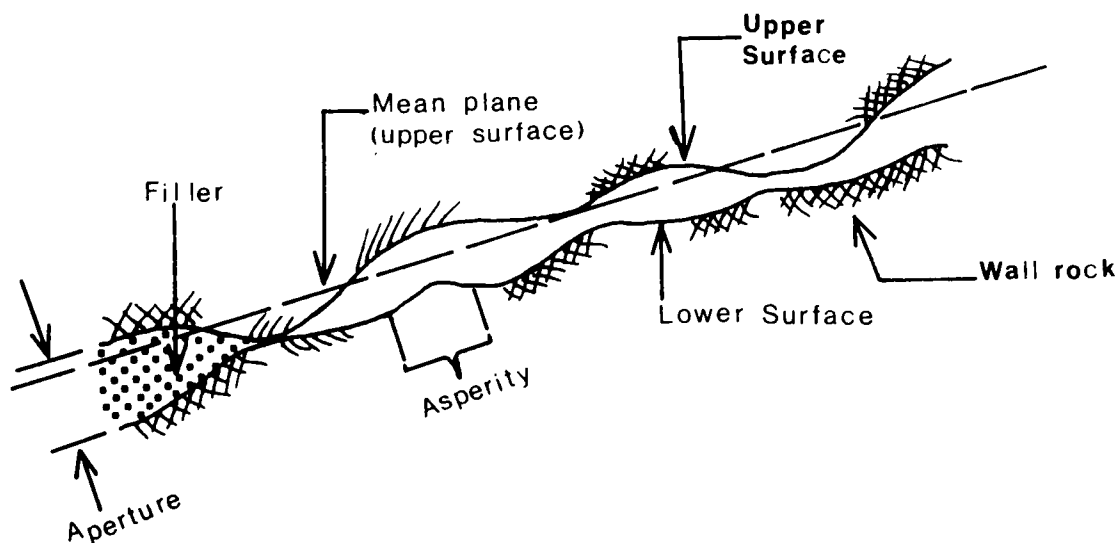
Figure 1. Characteristic features of an Individual Discontinuity (modified from 3)

- (i) An aperture is the distance between discontinuity surfaces, measured perpendicularly to the mean plane. This term, however, becomes rather ambiguous if the surfaces touch only at a few points such as shown in Figure 1.
- (ii) The filler is the transported material which takes up the space between the discontinuity surfaces, either in a complete or partial fashion.
- (iii) The asperities are the deviations of the surface of the discontinuity from a mean plane as viewed at various scales. The largest deviations are referred to as "undulations" whereas the smallest deviations are regarded as "roughness". Detailed descriptions of discontinuities in rock can be found in (1) and (2).

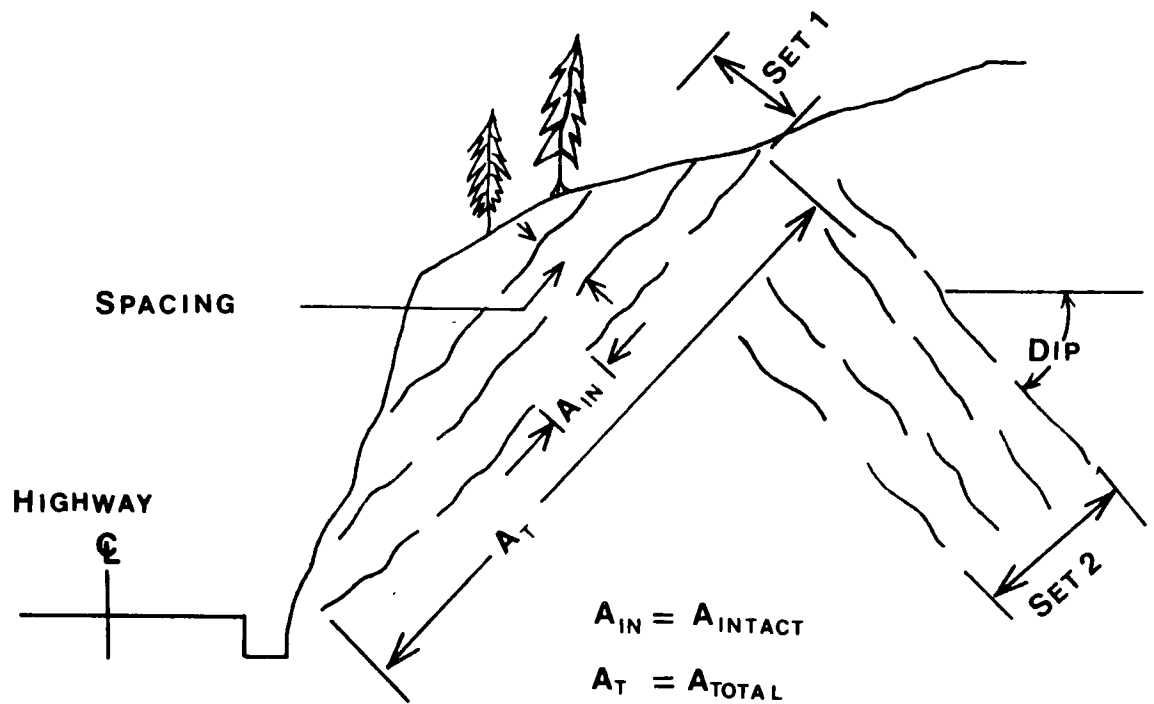
Figure 2. Geometry of typical discontinuity planes on a highway slope (modified from 3)

Rock mass discontinuities are groups of planar surfaces that occur in a given rock mass. Characteristic features of rock mass discontinuities include (i) attitude, (ii) set, (iii) spacing, (iv) system, and (v) persistence. These features are shown schematically in Figure 2 and are defined below. These definitions are based on reference (7).

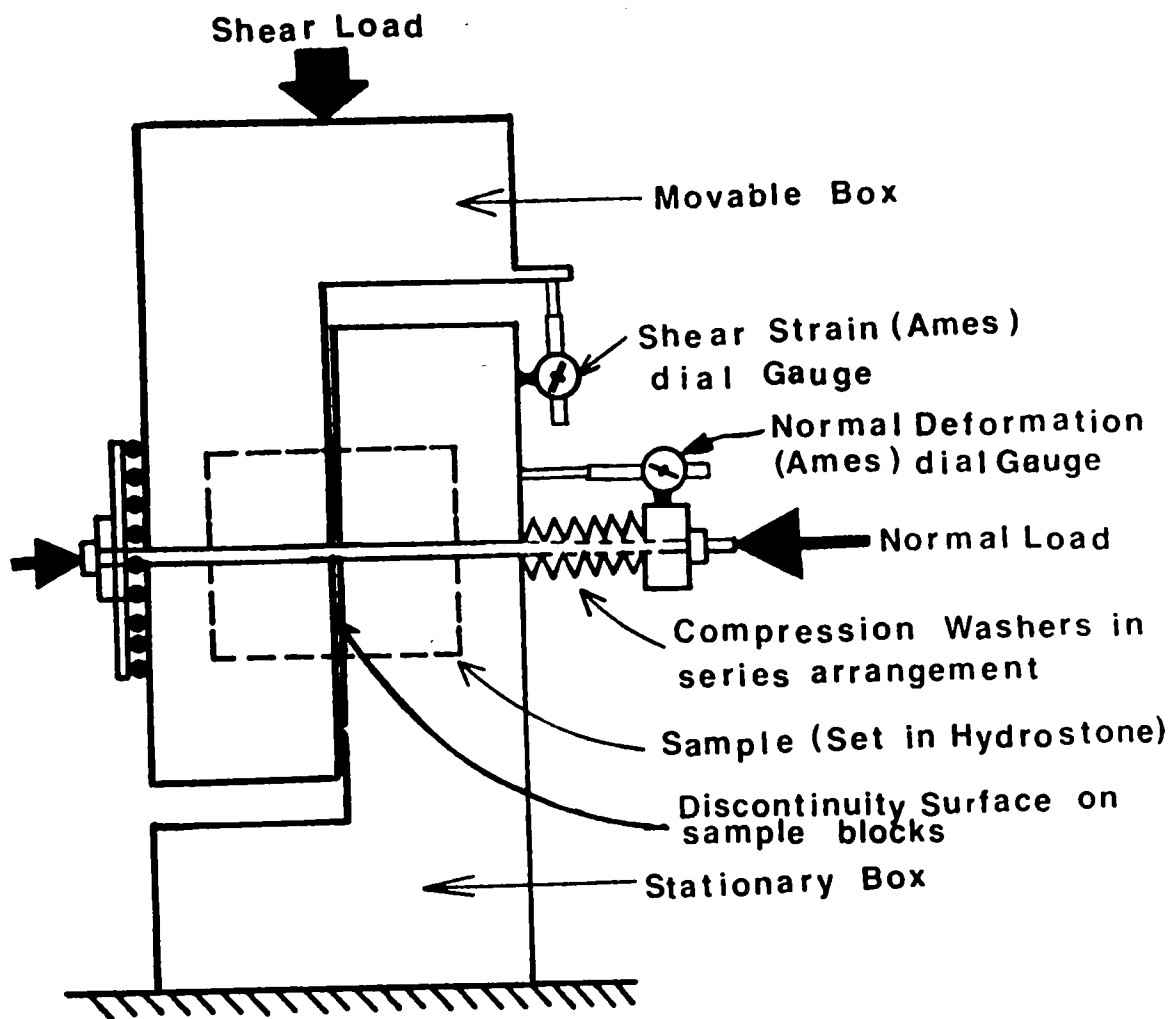
Figure 4 Diagrammatic representation of the arrangement for the direct shear test.

Using the apparatus shown in Figures 4 and 5, it was possible to follow a loading path in which the normal stiffness was held constant. That is, the normal force was set at an initial value using a spring and the shear force was gradually increased until constant readings or a drop in readings were obtained in the shear dial gauges. The change in the normal force either during a test or during an increment at the end of a test, was equal to the displacement in the normal direction multiplied by a spring constant.

This shear apparatus is generally similar to the Ohio River District (U.S. Army Corps of Engineers) shear apparatus described in (3) except that the normal load in this case is applied through 20 Belleville Spring washers arranged in series instead of using a hydraulic jack. The deflections produced in the normal displacement dial gauges, as a result of compression of the washers, is multiplied by the spring constant to

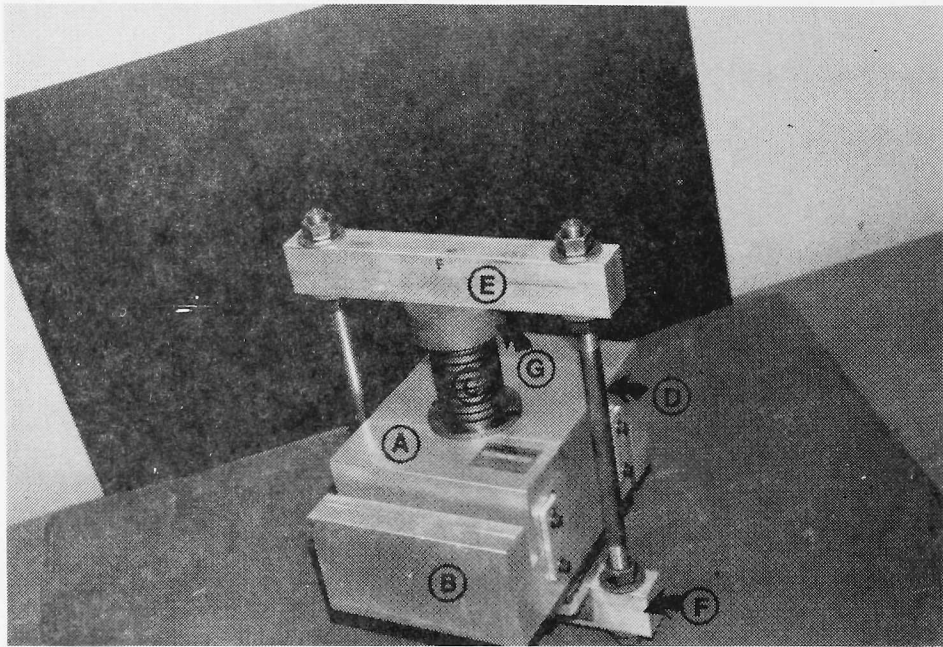
A = Stationary box
 B = Movable box
 C = Belleville Washers(20)
 in series arrangement

D = Vertical fastening rod
 E = Upper loading platform
 F = Lower loading platform
 G = Hardened steel guide

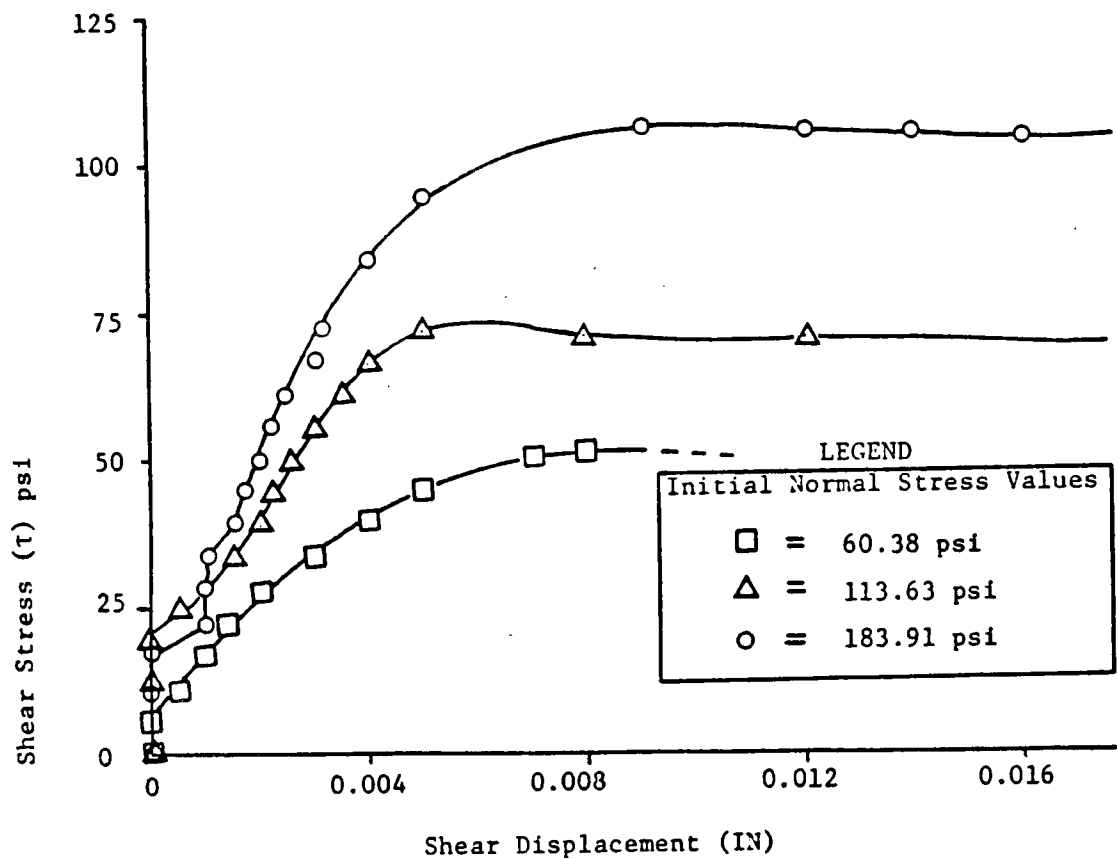
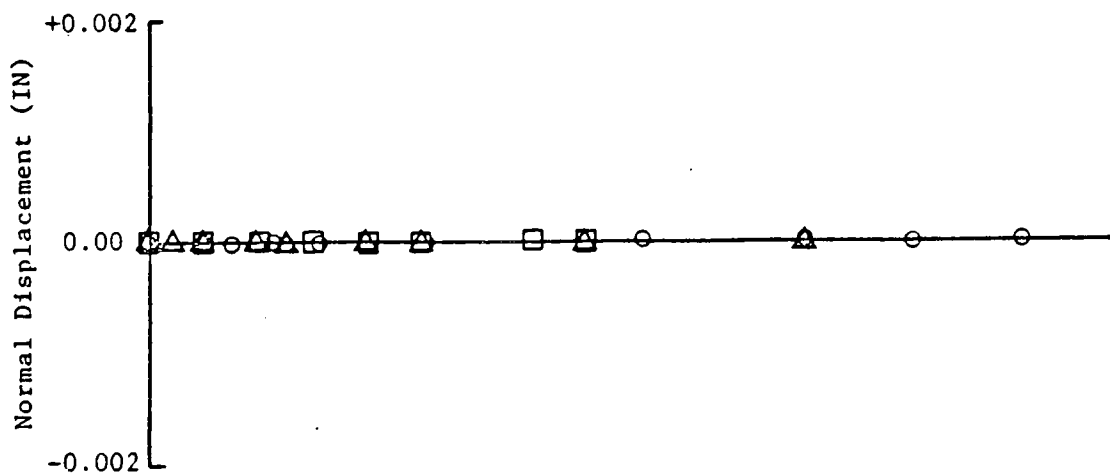
Figure 6. Direct shear test on fine-grained sandstone. Shear stress () and normal displacement versus shear displacement. Test #1.

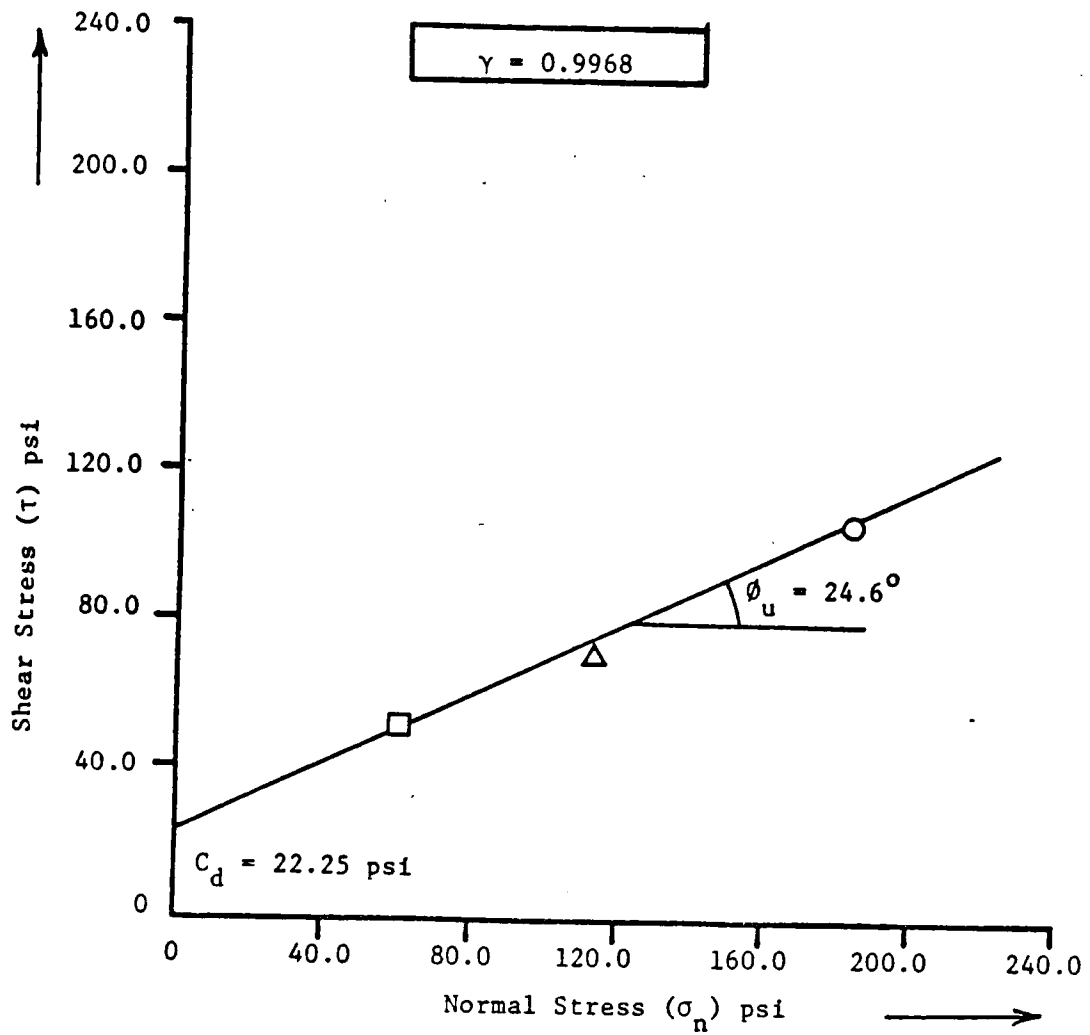
Figure 7. Direct shear test on a fine-grained sandstone from Narrow-Lake, Greene-Sullivan County, Indiana. Test #1

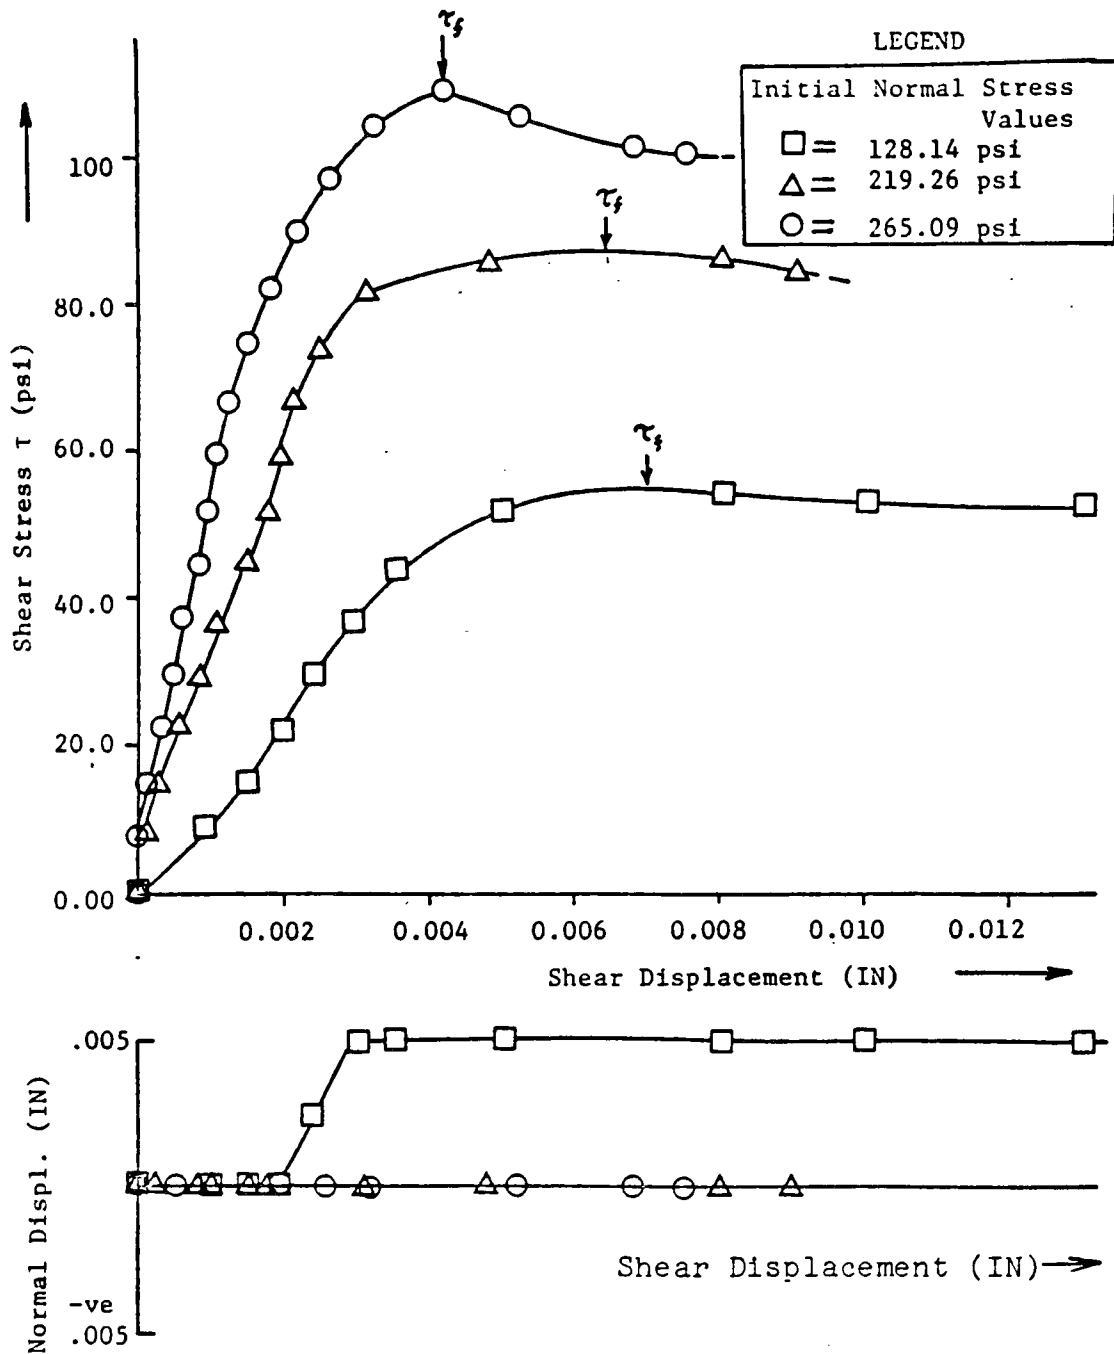
Figure 8. Direct shear test on fine-grained sandstone. Shear stress (τ) and normal displacement versus shear displacement. Test #5.

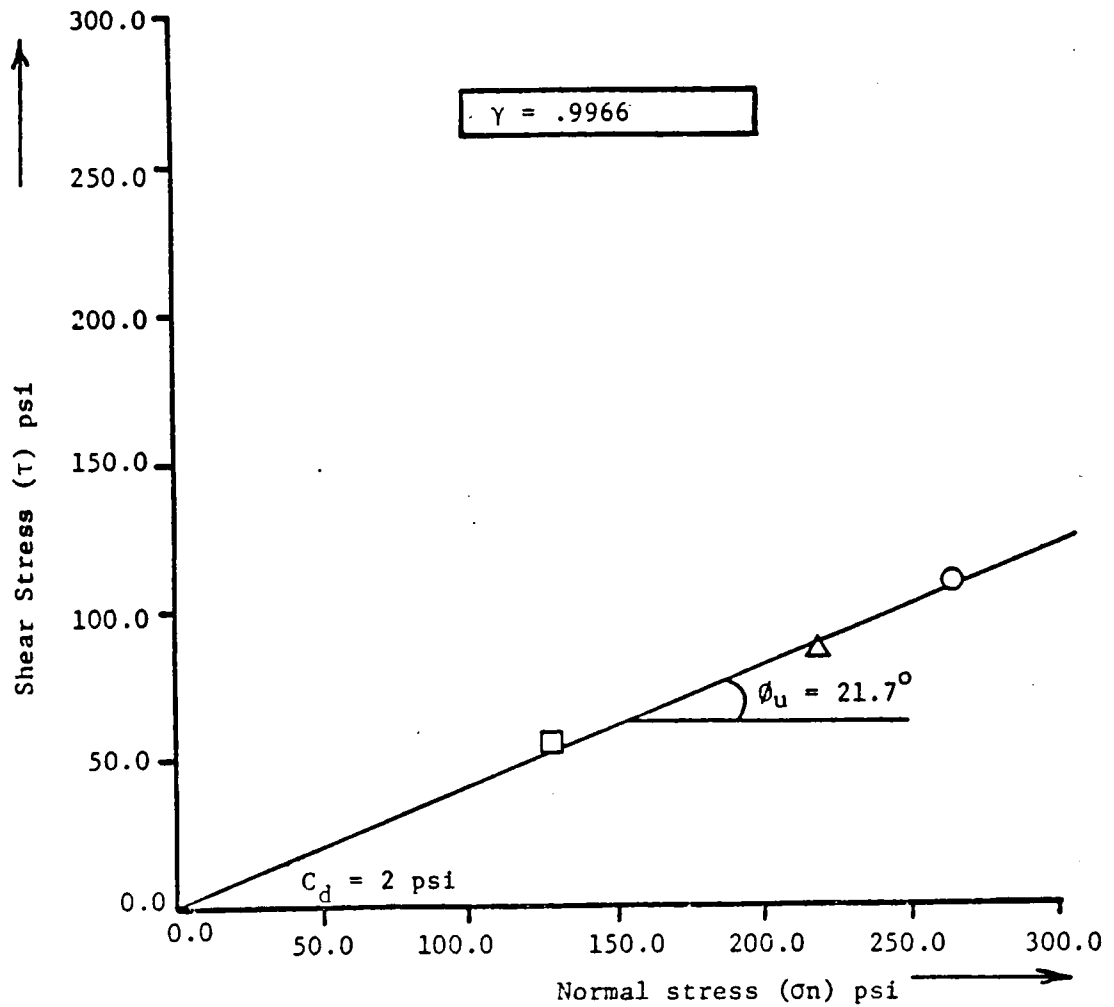
Figure 9. Direct shear test on a fine-grained sandstone from Lonnie-Lake, Greene-Sullivan County, Indiana. Test #5

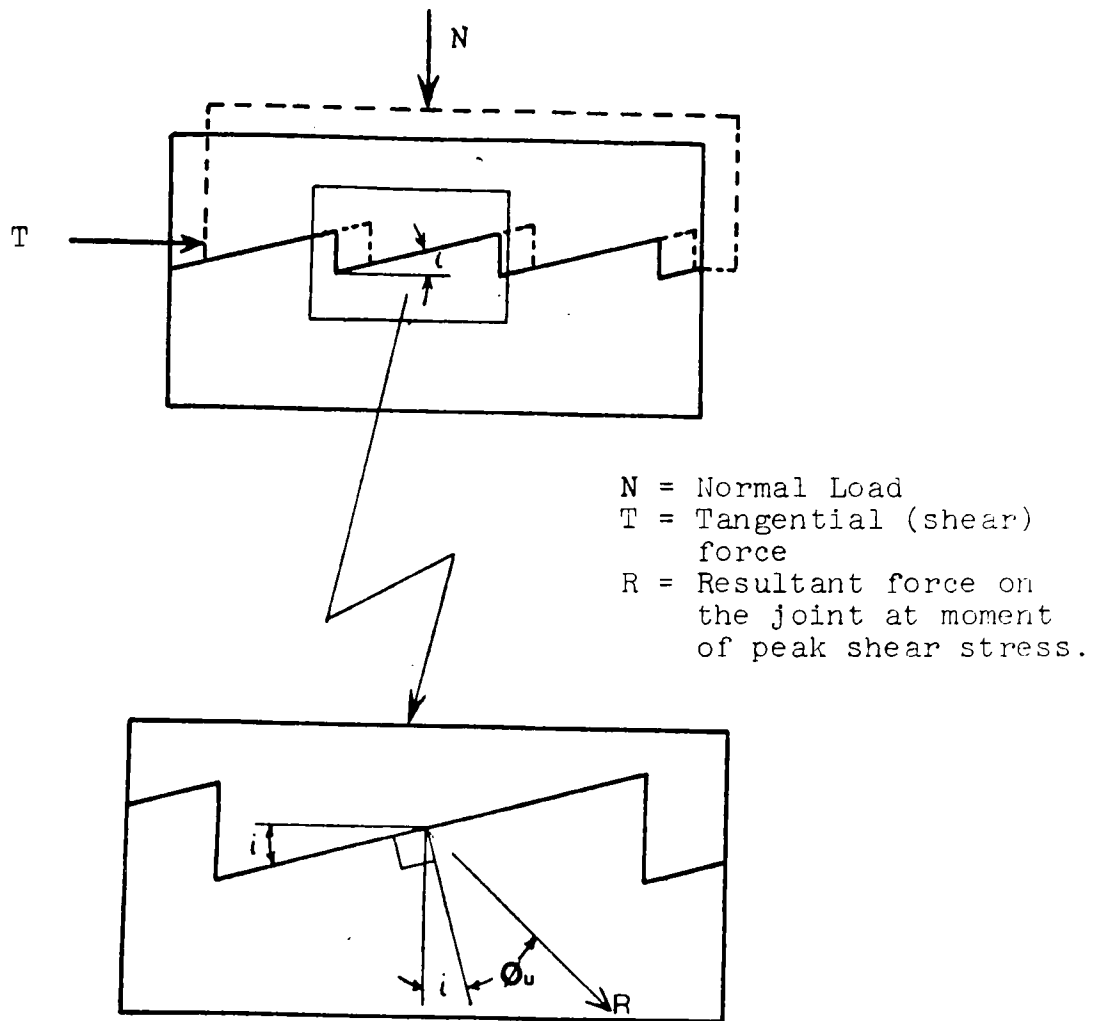
Figure 10. The basis for Patton's Law for joint shear strength (modified from Goodman, 1980).

The rather wide range of values of friction angles (ϕ) and shear strength intercepts (C_d) is probably due to the fact that the joint surfaces had asperities with various degrees of roughness. Thus, the values of the tabulated friction angles in Table 2 which are higher than the mean value could be represented by the relationship $\phi_{eff} = (\phi_u + i)$ according to Patton's law (5,9) for joint shear strength, where ϕ_{eff} = effective friction angle for the joint; ϕ_u = friction angle of a smooth joint ($\approx \phi_r$ which is the residual friction angle for intact rock specimens); and i = angle of inclination of the asperity relative to the mean joint plane (see Fig. 10).

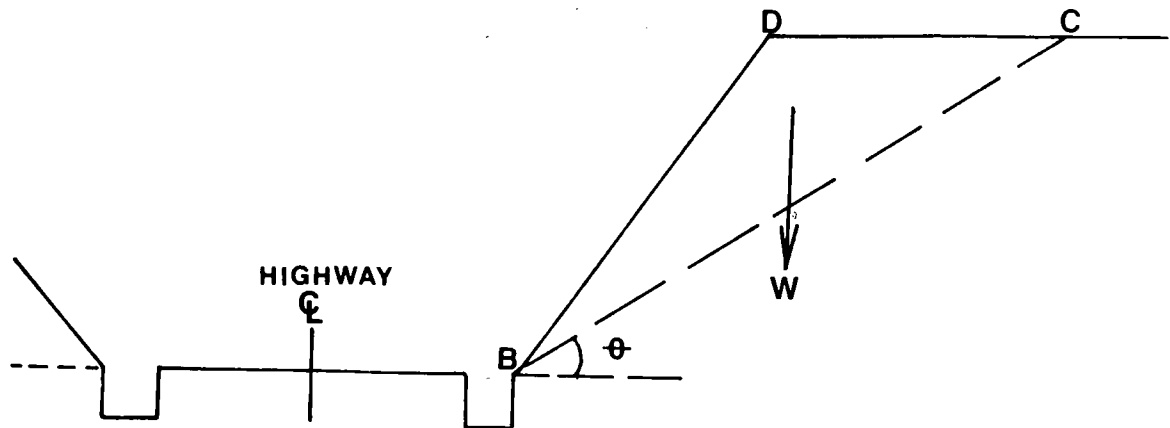
BC=through-going discontinuity surface with shear strength properties C_d and ϕ

C_d = discontinuity cohesion intercept (not a physical property)

Figure 11 A schematic two-dimensional representation of a highway cut .

Shown in Figure 11 is a two-dimensional schematic representation of a highway cut with a through-going discontinuity surface BC, in a dry condition (i.e. absence of groundwater is assumed). With reference to Figure 11, the Factor-of-Safety (F.S.) of this highway cut with respect to rock slope failure is given by the relationship:

where the various parameters are as defined in Figure 11.

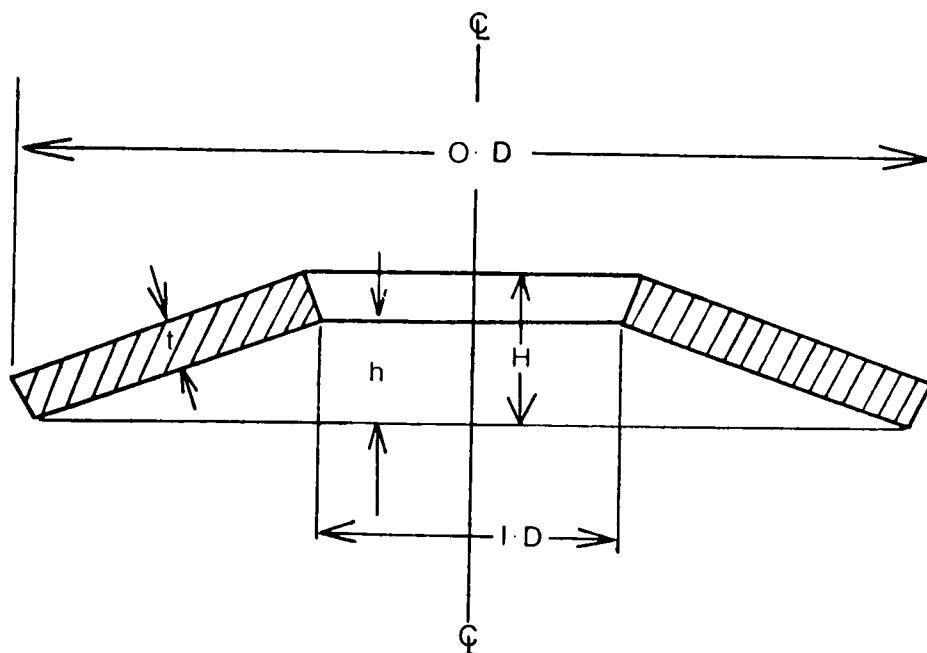
Outside Diameter (O.D) = 2.50 in (63.50 mm); $h = (H - t) =$
0.06 in (1.524 mm)
Inside Diameter (I.D) = 1.250 in (31.75 mm)
Thickness (t) = 0.120 in (3.048 mm)
Load at flat position = 3200 lb (1451.5 Kg)

Figure A1.1 Configuration of the Belleville Spring Washer

The configuration of each Belleville spring washer, manufactured by the Associated Spring Corporation, is as shown in Figure A1.1. The type used is Catalog Number B2500-120, made of spring steel material and has dimensions shown in Figure A1.1.

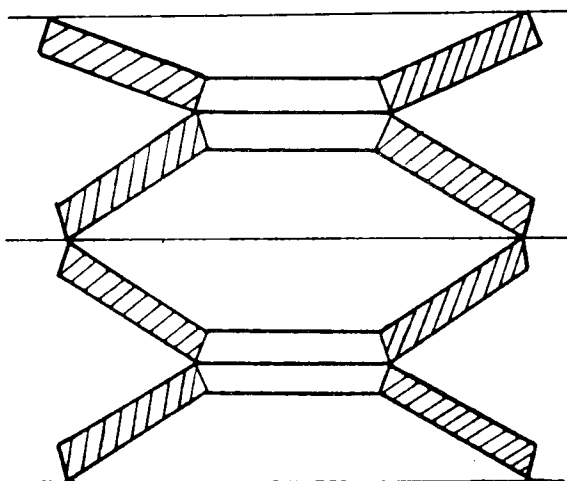
Figure A1.2 Arrangement of Belleville spring washers in series.

The two halves of the direct shear box with no samples inside, were assembled such that the stationary box (Figure 3.13) lay on top. A stack of 20 spring washers, arranged in series (see Figure A1.2) was installed on a rod attached to the top of the stationary box. A hardened guide was therefore placed on top of the springs. The shear box and spring assembly then was placed between the upper and lower loading platforms of a Baldwin-Tate-Emery Universal Testing machine which provided the load for the spring calibration process.
