PROCEEDINGS of the 33rd ANNUAL HIGHWAY GEOLOGY SYMPOSIUM

ENGINEERING GEOLOGY and ENVIRONMENTAL CONSTRAINTS

PROCEEDINGS OF THE 33RD ANNUAL
HIGHWAY GEOLOGY SYMPOSIUM

Engineering Geology
and
Environmental Constraints
in
Vail, Colorado
1982

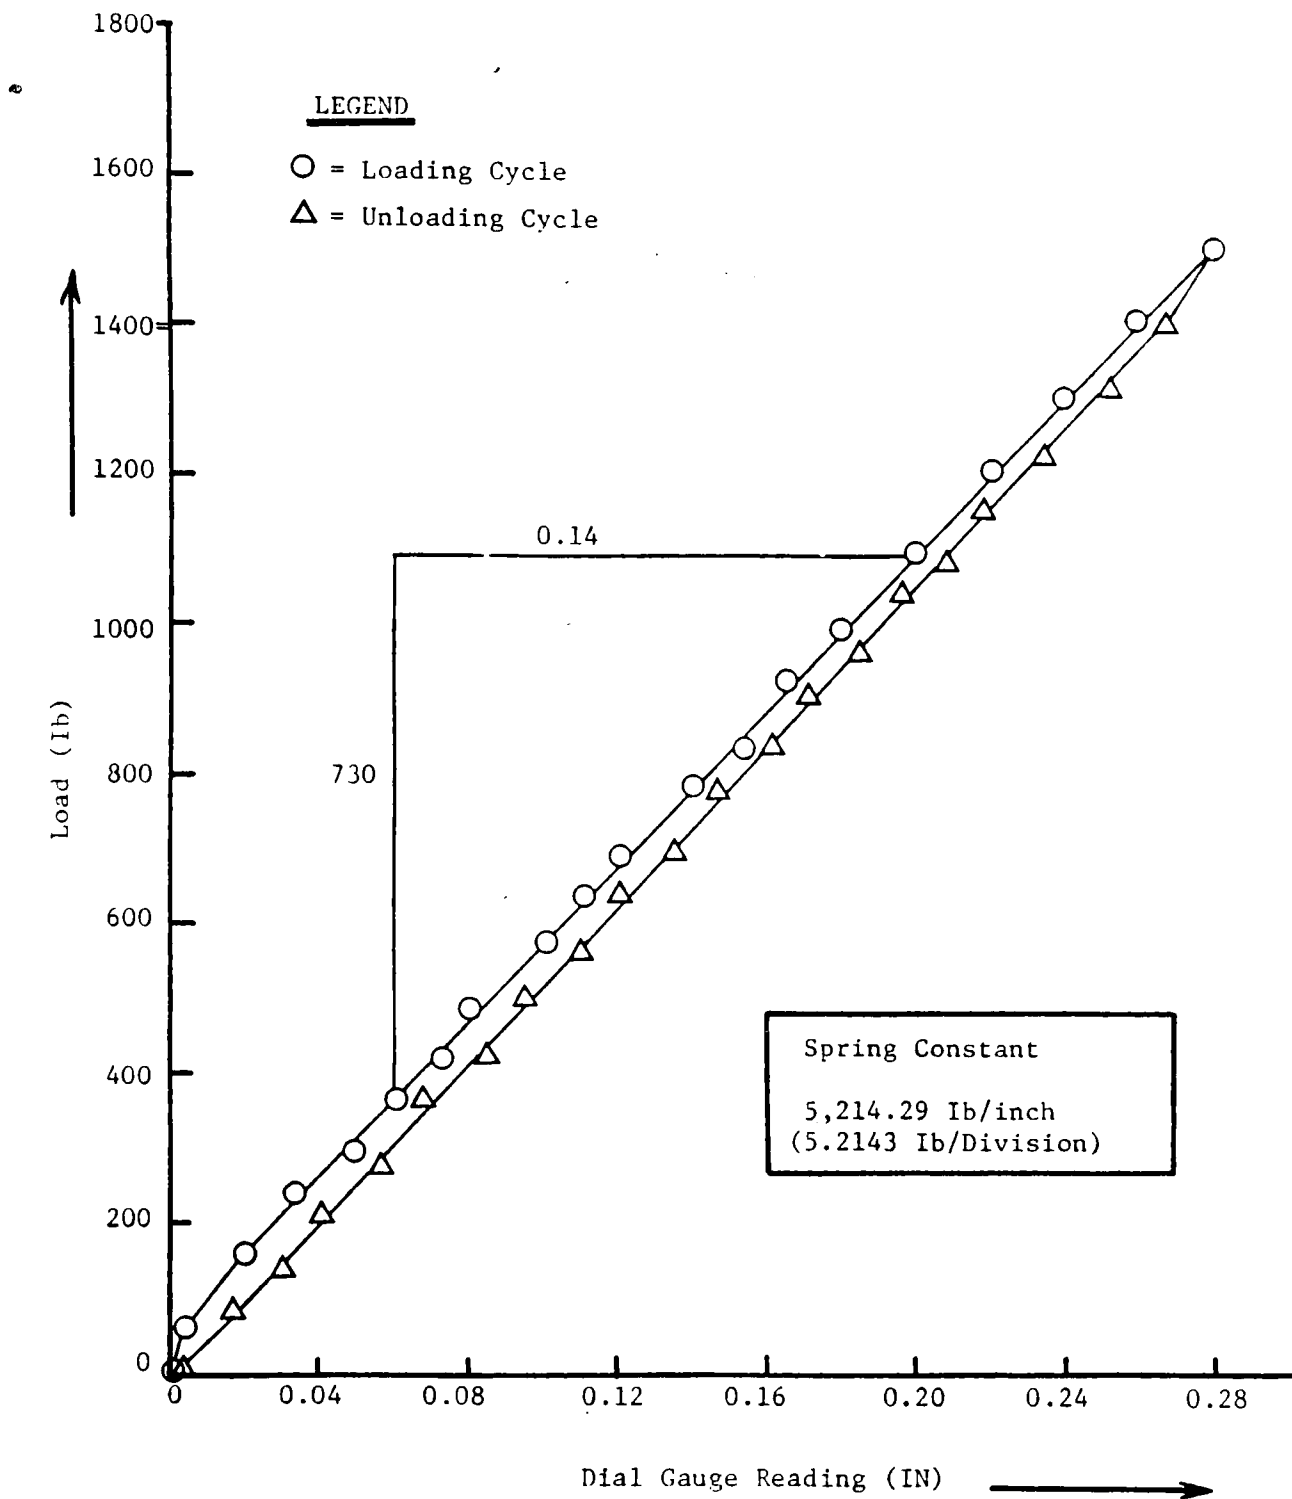
Figure A1.3 Shear-box spring calibration curve (20-washers in series arrangement).

Load Load was applied at an average rate of about 40 Ib per minute until a dial gauge deflection of about $\frac{1}{4}$ inch was attained before unloading at an approximate rate of 40 Ib per minute also. A plot of load versus dial gauge reading was made (Figure A1.3) and the spring constant determined as 5,214.29 Ib per inch. The shear box spring system calibration data are presented in Table A1.1.

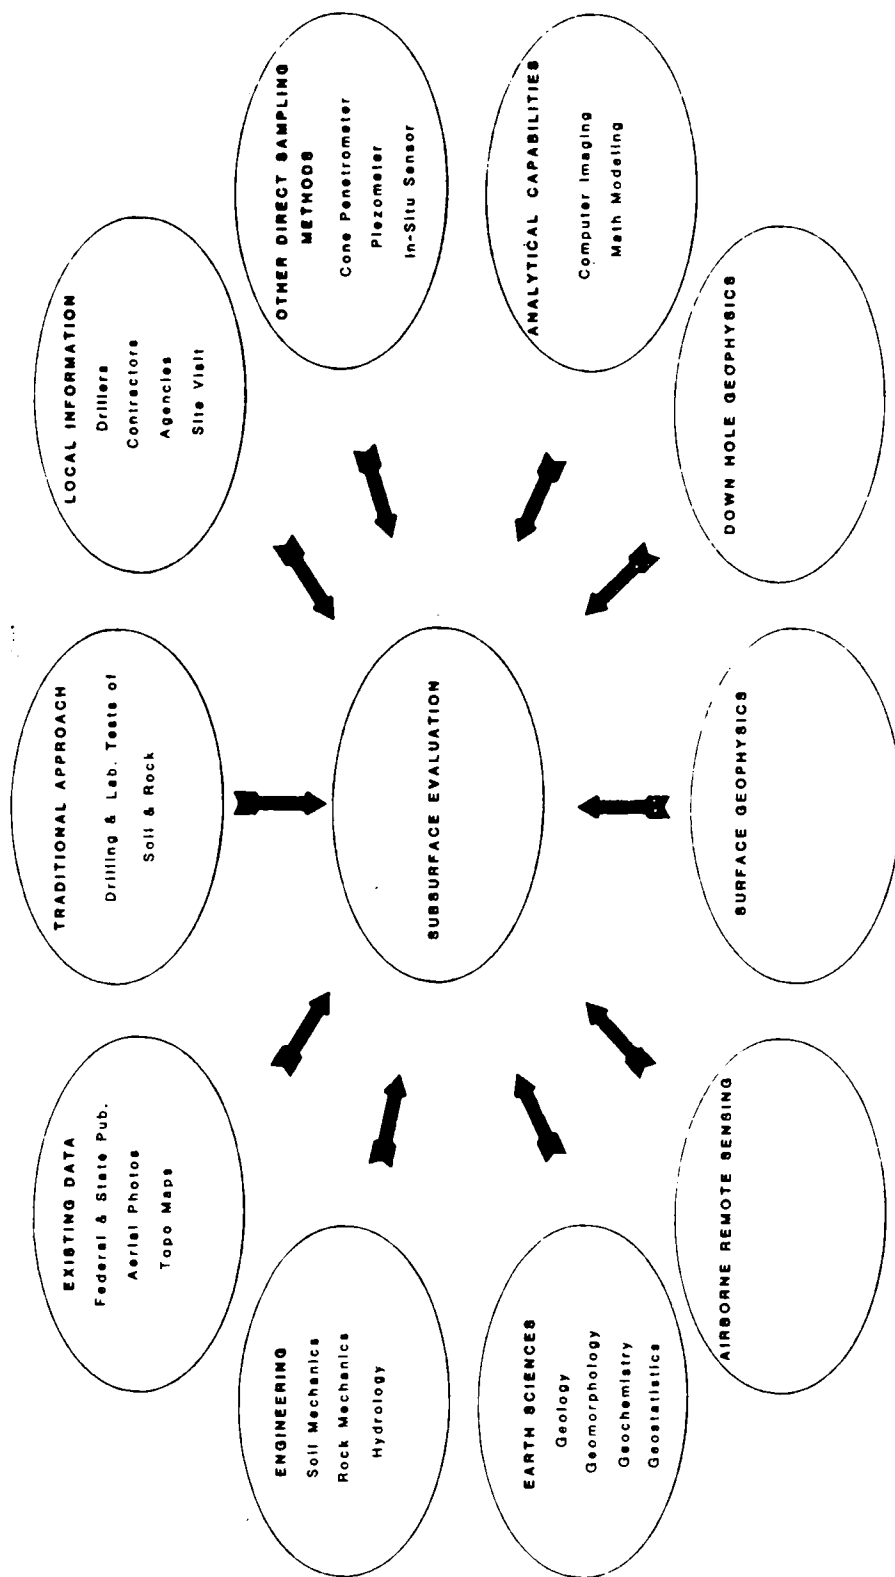
FIG.1 Technical resources and tools which can be utilized in a subsurface investigation.

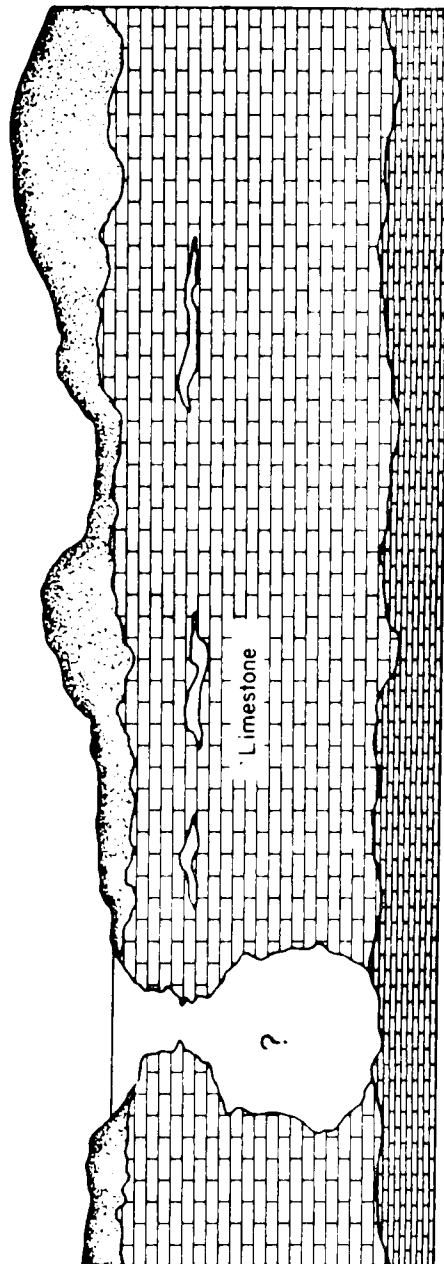
FIG.3 Generalized geologic section based upon regional information
and initial on site drilling.

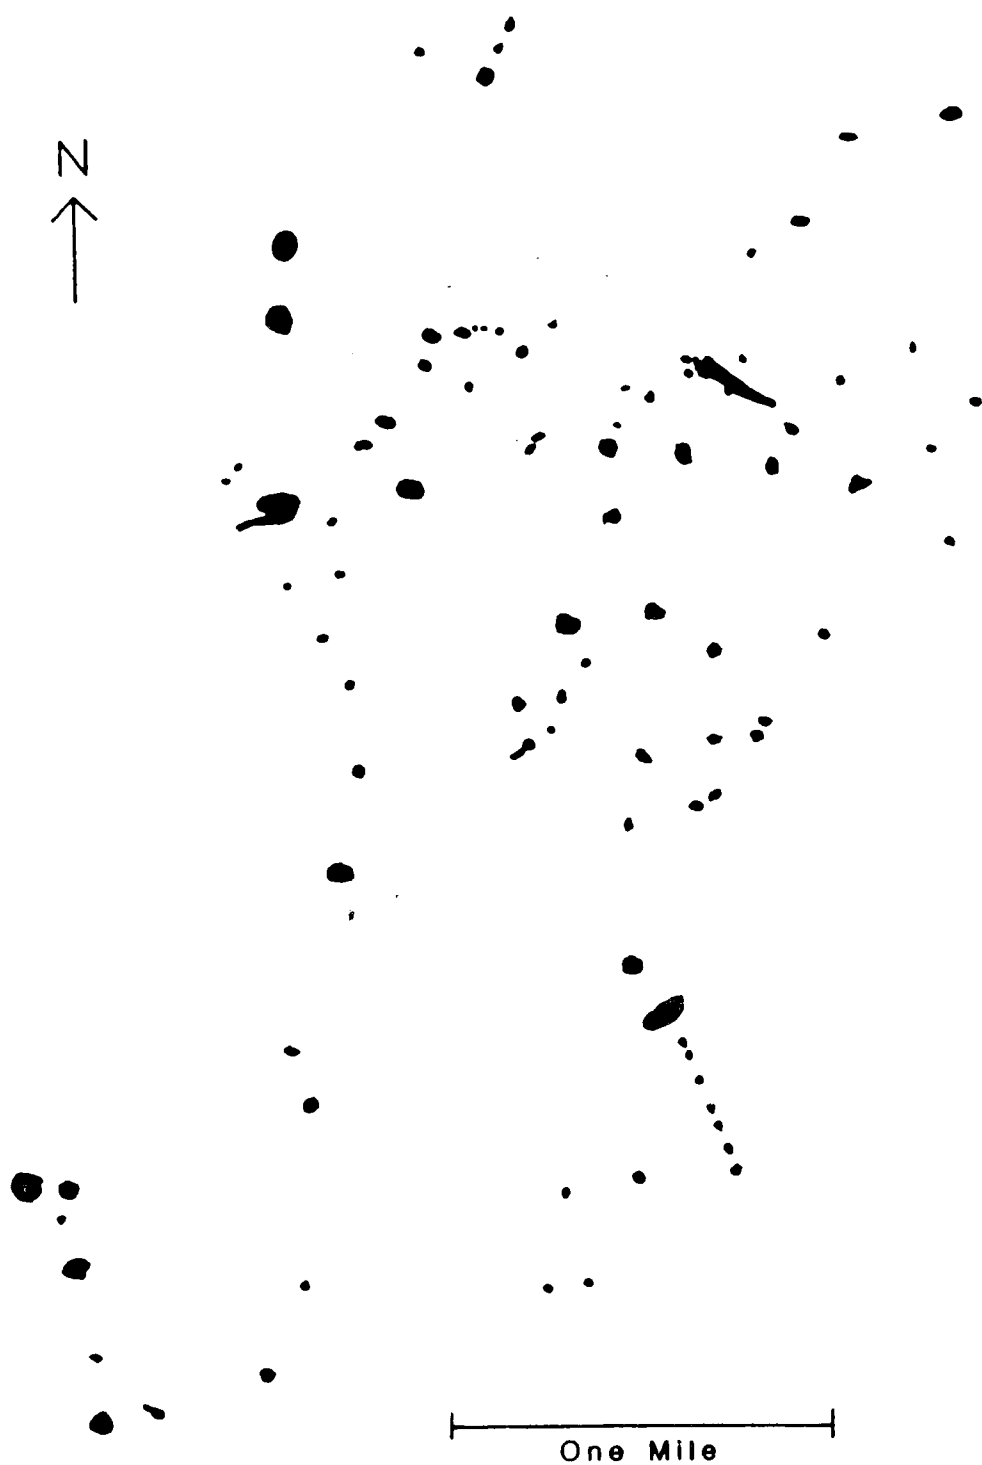
**FIG.4 Distribution of sinkholes based upon
existing aerial photography.**

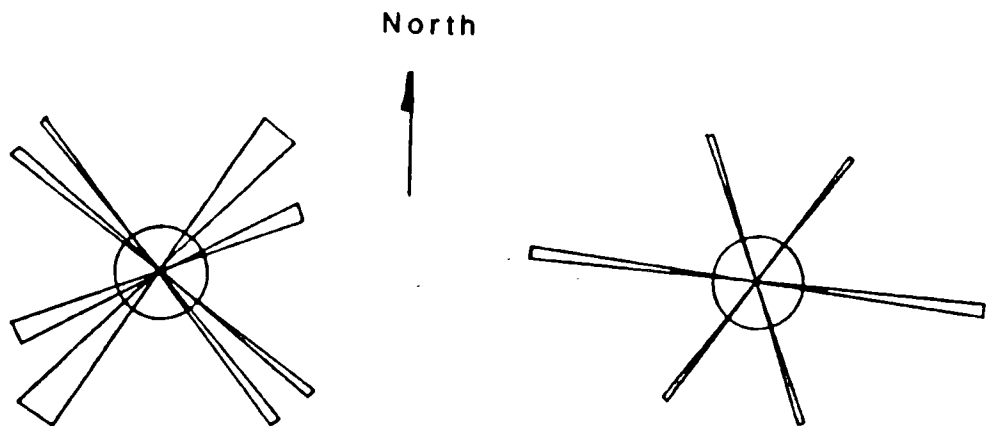
FIG.5 Lineament angle relationships.

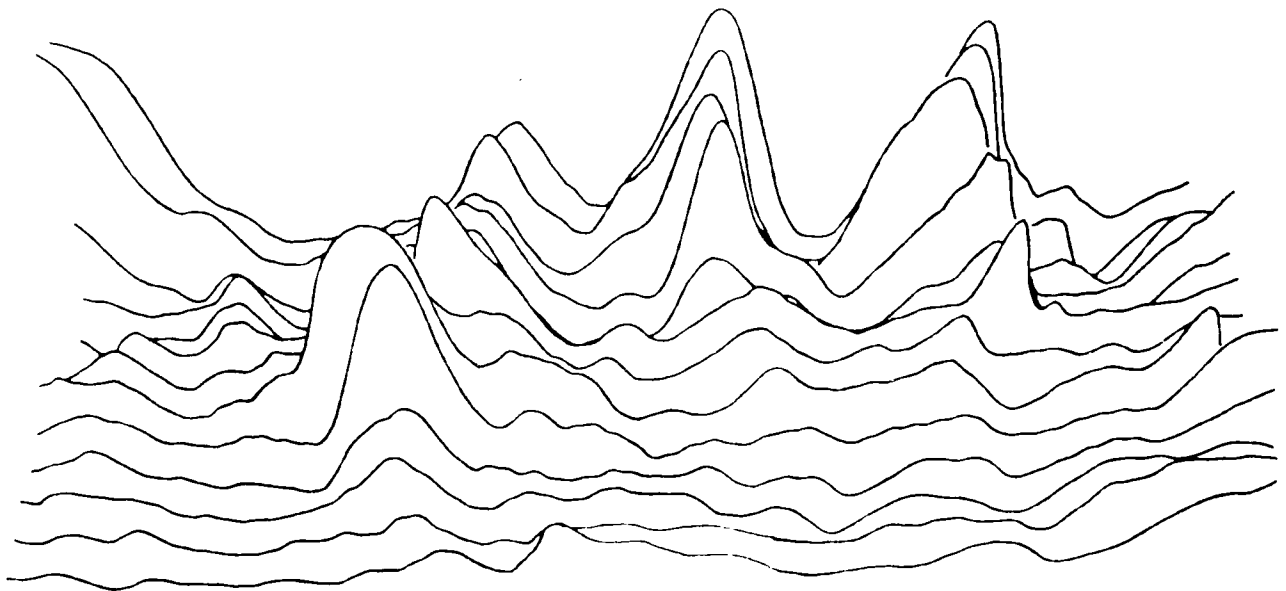
FIG.6 EM conductivity data shows fracture trends in rock.

the instruments. Figure 6 shows the location and orientation of shallow fractures in the rock, based upon EM measurements. Figure 7 shows a radar profile of soil conditions; the anomaly is related to a fracture in underlying rock. By carrying out a number of parallel passes, a linear trend could be established in the soil anomaly which correlated with regional lineament trends. Figure 8 shows a large paleokarst feature (sinkhole) which has been filled in with natural sand deposits. Localized piping, related to rock fractures, are also shown. These features remain totally undetected by experienced geologists from surface observations, but are clearly detected by radar.

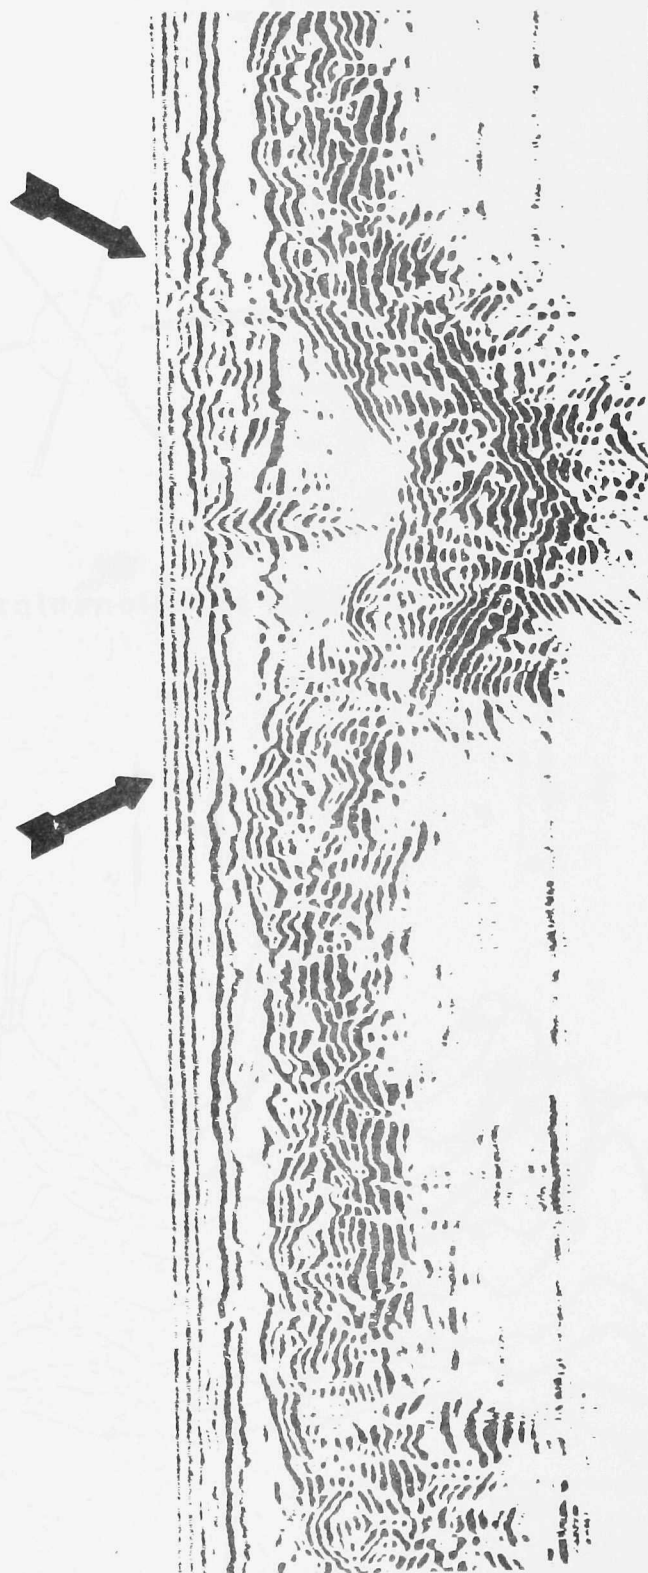
FIG.7 Radar data shows anomalous soil conditions related to underlying fractures in rock.

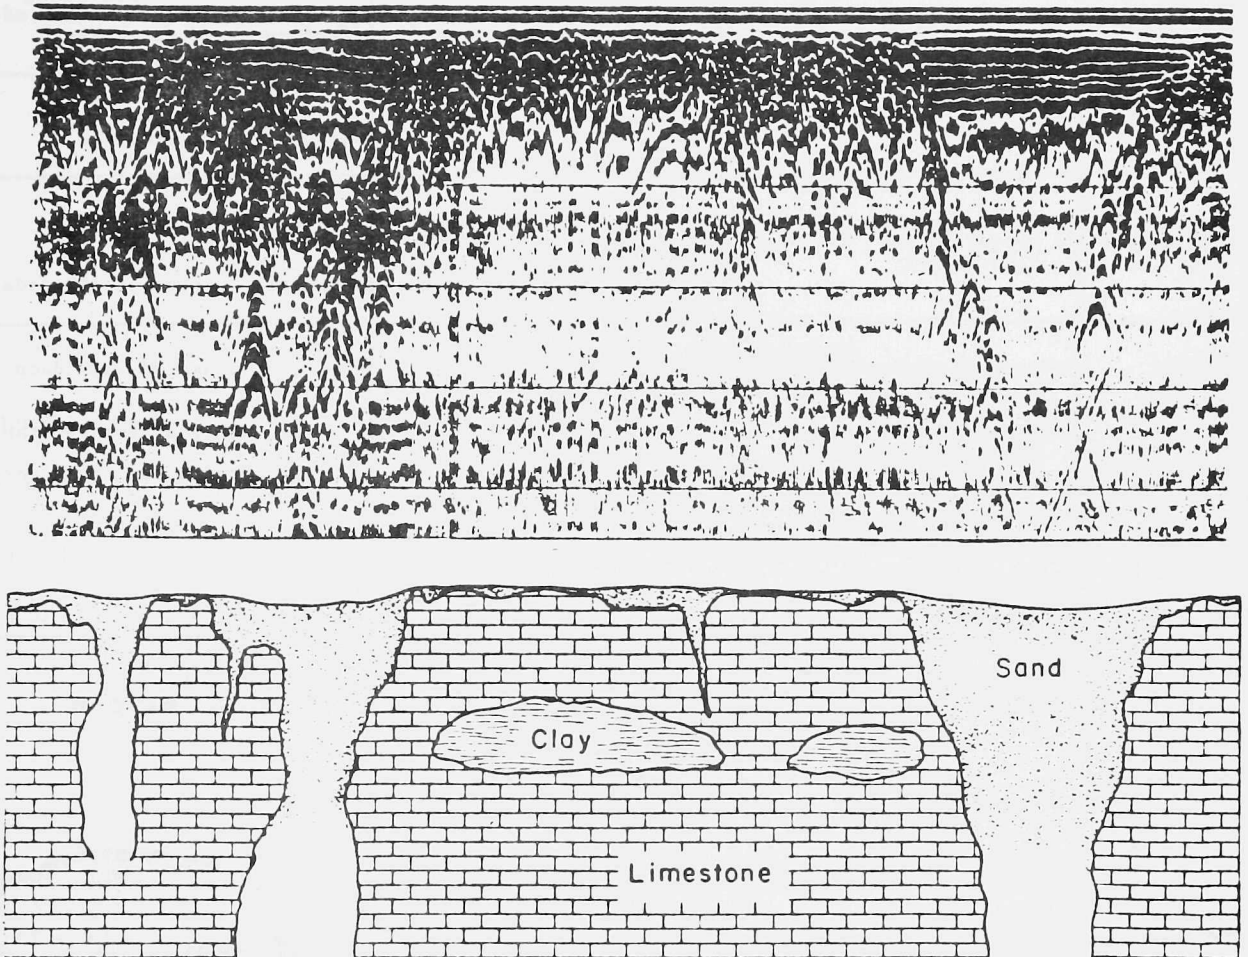
**FIG.8 Radar data and generalized cross section
showing large sinkholes and piping.**

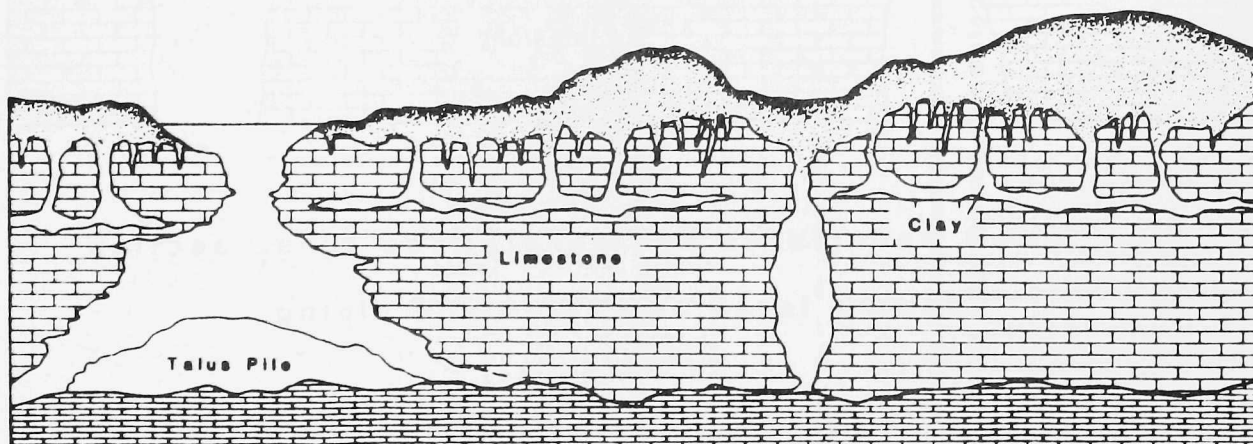
FIG.10 Generalized geologic section based upon integration of all information derived from example project.

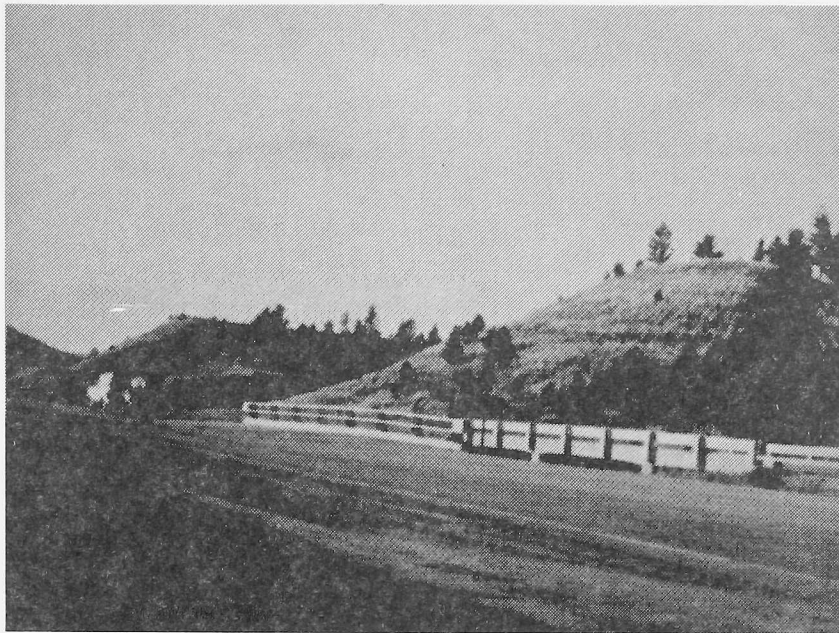
Fig. 1: Note the sag in the bridge rail in behind the pickup truck. I-90 Northeastern Wyoming.

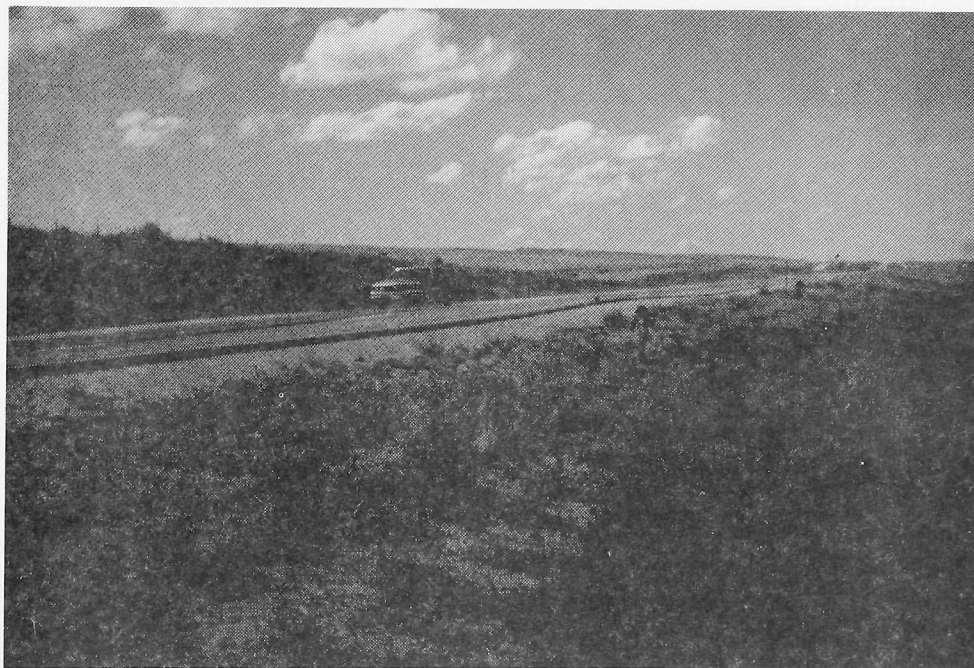
Fig. 2: Heaves due to a swelling shale. On I-25 (a) North Central Wyoming.

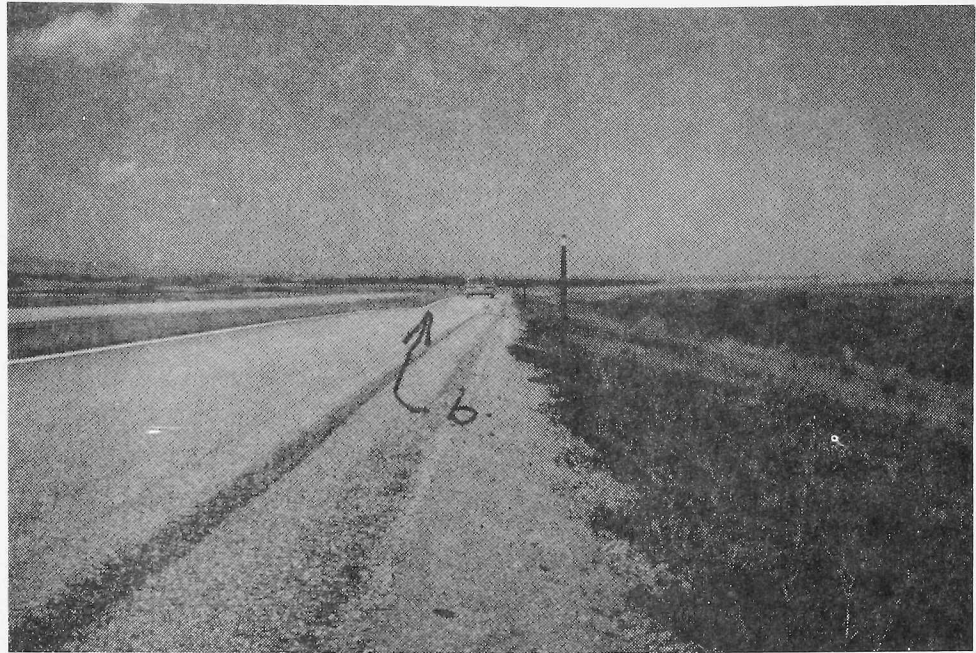
Fig. 3: Settlement failure due to collapsing soils derived from the tertiary shales. I-25 North Central Wyoming.

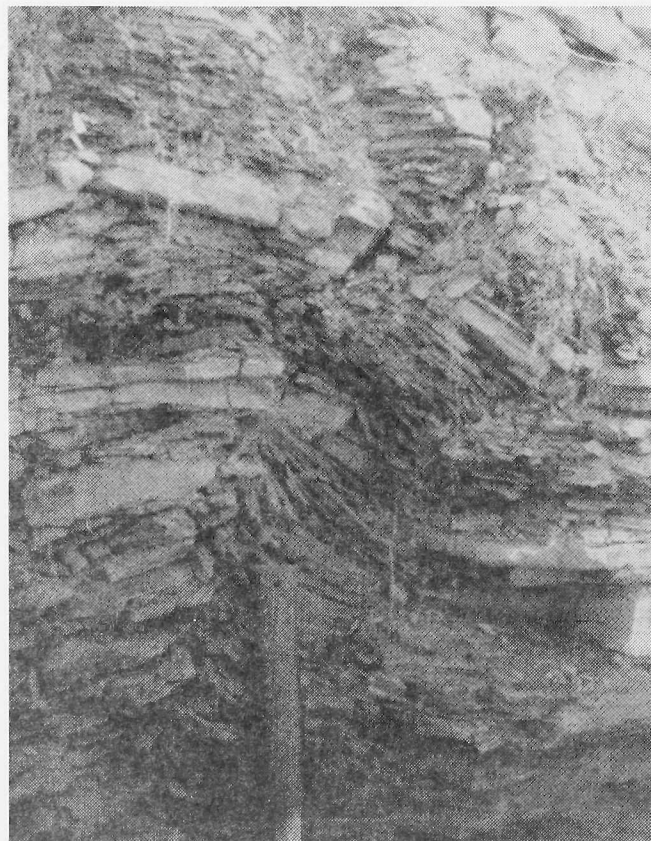
Fig. 4: Heave in the shale bedrock which is the foundation for the roadway. Heaving occurred due to concentration at the surface water by the roadway section.

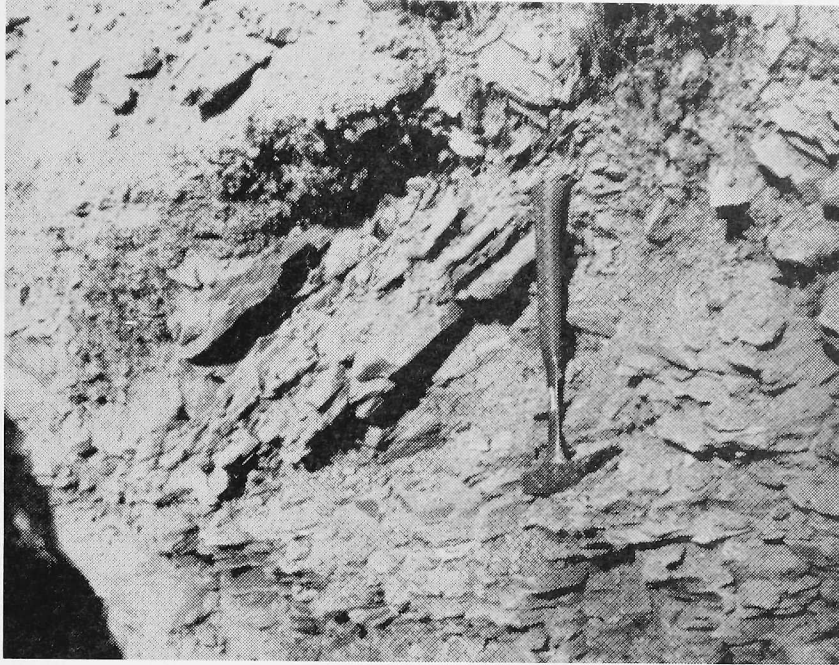
Fig. 5: Heaving in shale below the existing roadway. Note the horizontal beds approximately four feet below the heaved section.

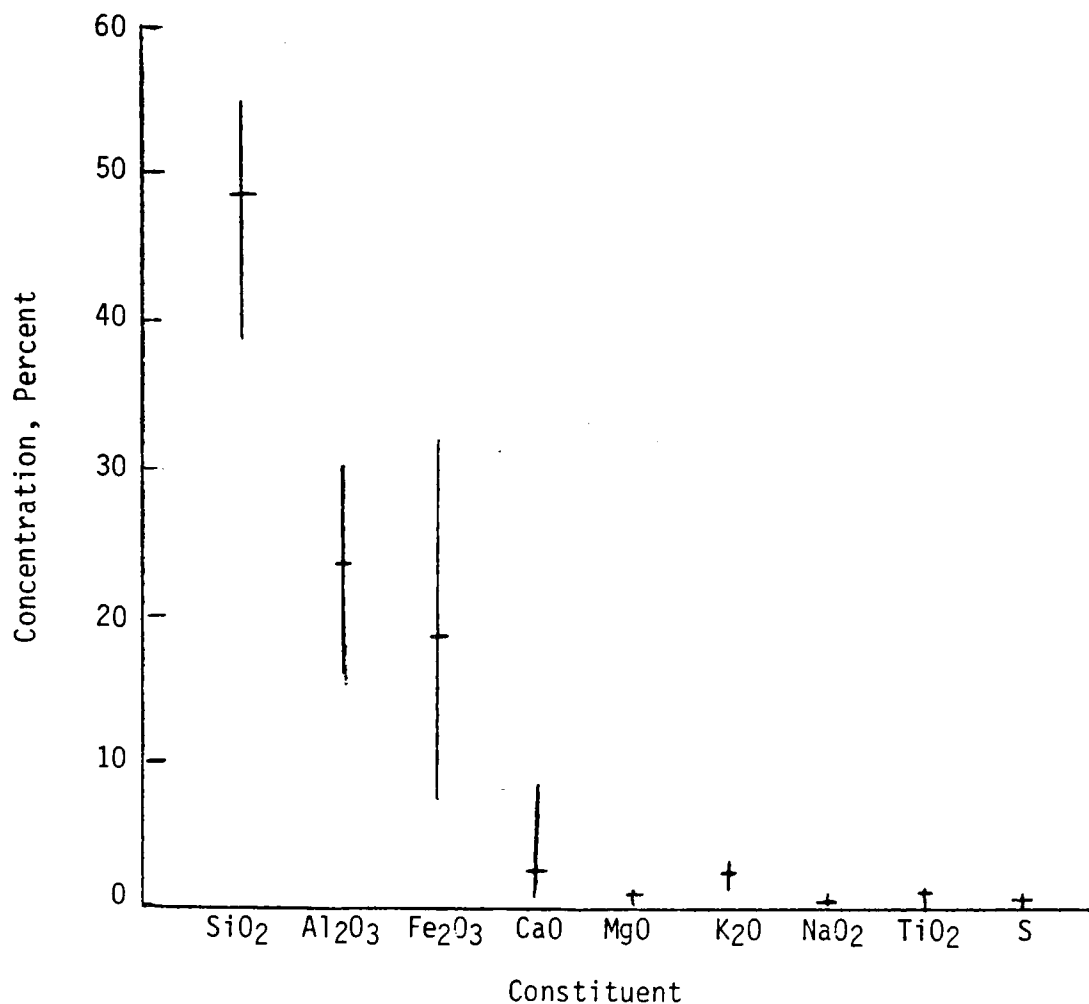
Figure 1. Chemical Constituents of Kentucky Fly Ashes
(From Rose, Lowe, and Floyd, 1979)

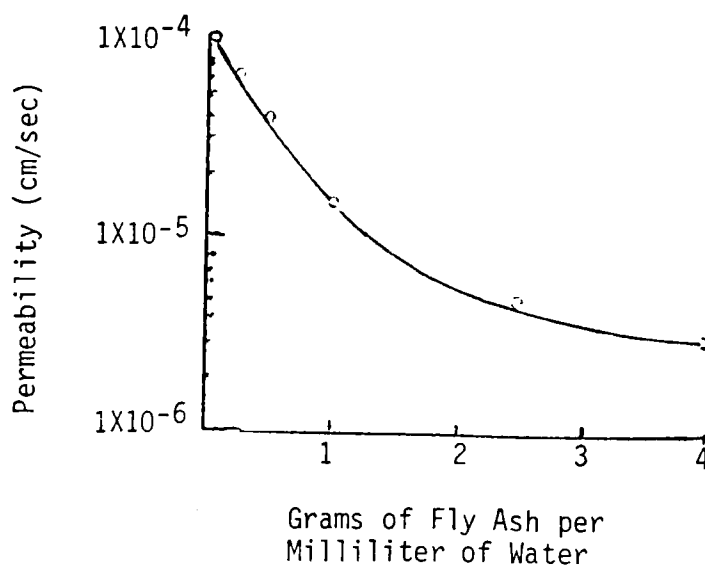
Figure 2. Permeability of Fly Ash -
Water Slurry Mixtures

slurry, a type C (sub-bituminous) Wyoming fly ash had an ASTM D-2434 permeability between 5.8×10^{-5} cm/sec and 3.2×10^{-6} cm/sec (Figure 2). When mixed with sand or clay on a 50% by weight basis, the mixtures had permeabilities in the 10^{-6} cm/sec range. When placed dry, however, the type C Wyoming fly ash developed cracks due to the chemical reaction with water, creating a secondary permeability of 10^{-3} cm/sec. Observed permeabilities of the Michigan fly ashes were in the 10^{-3} cm/sec range (Gray and Lin, April 1972).
