Idaho Springs, Clear Creek County, Colorado, Area Geologic Hazards Map James M. Soule, Colorado Geological Survey April-May, 1975

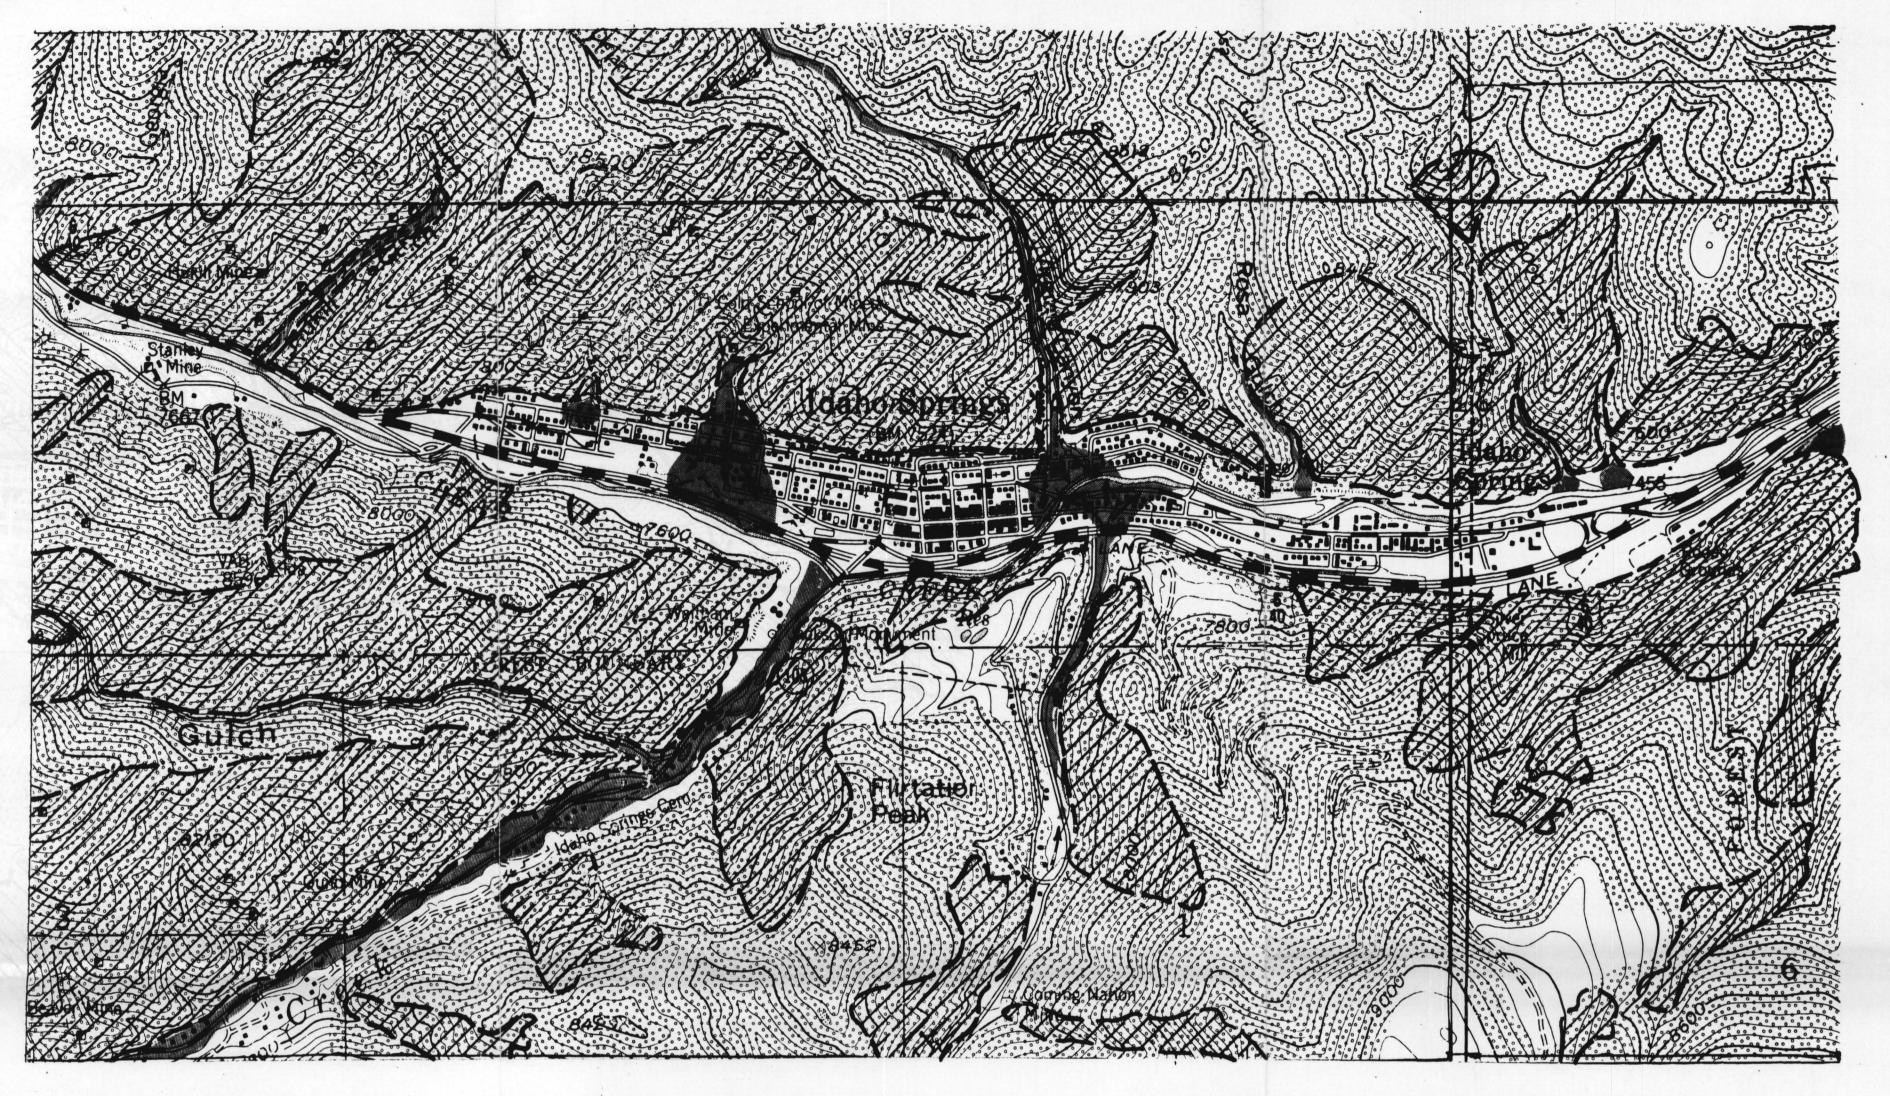
Geologic hazards in the Idaho Springs area are natural geologic conditions that if ignored or poorly planned for can result in loss of life, damage to structures, or high maintenance costs, especially for roads. As such, there are three general kinds of potentially hazardous geologic conditions shown on this map: 1) mudflow-debris fan areas; 2) rockfall and rockslide areas; 3) unstable and potentially unstable slopes. Additionally, much of the Idaho Springs area is undermined and in some places subject to future surface subsidence following collapse of underground mining excavations. Man-made modifications of flood plains of Clear Creek and Chicago Creek make prediction of the nature of future flooding along these drainages difficult.

This map should be used as a guide to location of areas where the indicated geologic condition could cause difficulties for particular land uses. It is not intended to supplant detailed field investigations of building sites, but rather to signal places where the indicated geologic conditions could cause difficulties for particular land uses. If this map is used to designate geologic hazard areas as specified by H.B. 1041 (see Rogers, Wm. P., and others, 1974, p. 120-121), then it is suggested that this map serve as a basis for further investigation of individual sites.
